Evaluation of Underperforming Rooftop PV Plants in India – Moving from kW to kWh

Part II: Evaluation of 10 Rooftop PV Plants in Delhi & Andaman and Nicobar Islands

Report Number: 201802070_II_V2
Berlin, 09.07.2019

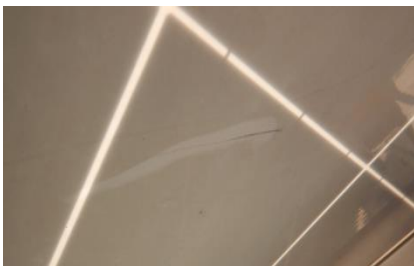
Figure 13: Scratch on the back sheet

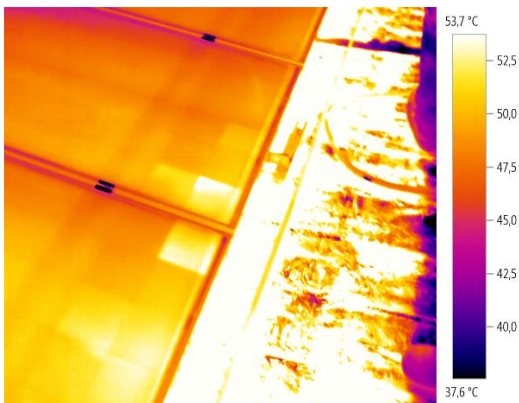
Figure 21: Crack induced hot spots

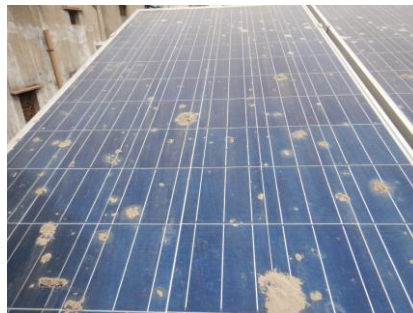
- Some parts of the PV plant are heavily soiled (soiling loss determination was not possible due to bad weather). The loss is estimated to be >10% based on past experiences.

Figure 29: Soiling on the modules

- The broken modules shall be replaced with new modules.
- The cleaning cycles shall be increased based on the results of a soiling study that adjusts the cleaning needs to each season.

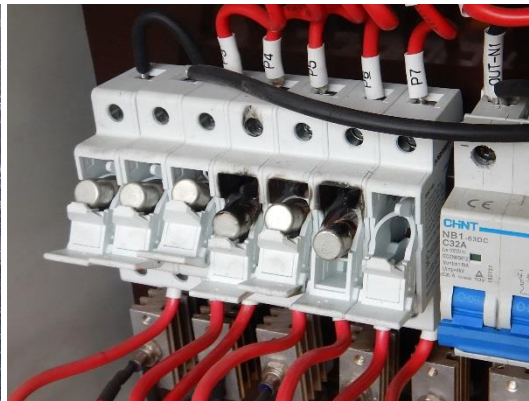
- The module connectors show damages since they were opened with improper tools.
- A loose connection of the module connectors has caused burning.
- A significant number of modules show mechanical damages on the front glass.
- Some fuses in the combiner boxes have burned.
- Cables damaged by monkey bites were observed.

Figure 37: Burned fuses

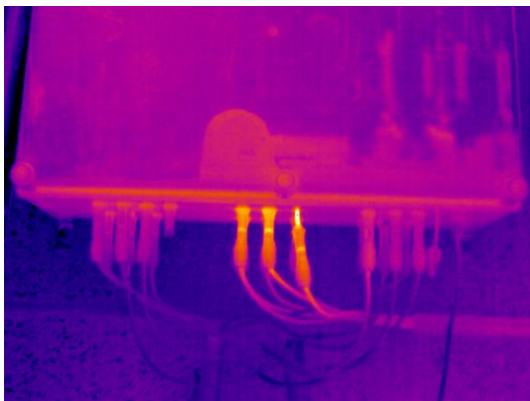
Figure 38: Connections with abnormal temperature

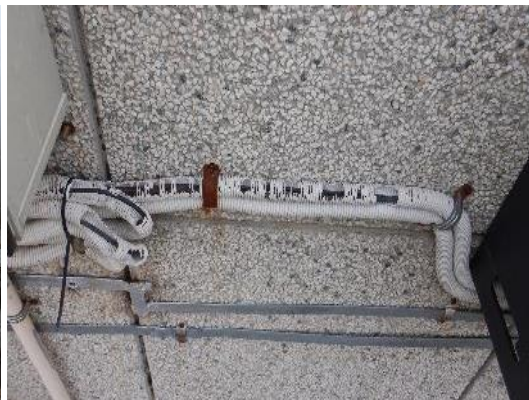
- Tubes protecting cables are not robust and some have already broken.

Figure 51: Broken tube

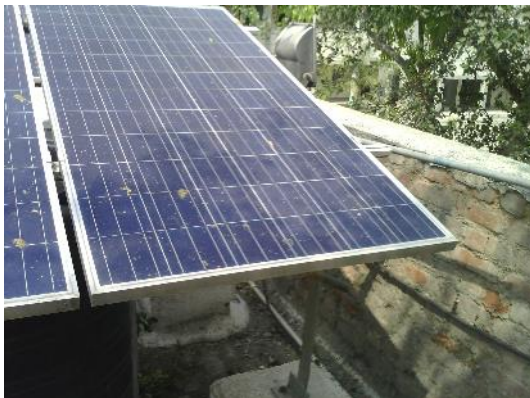
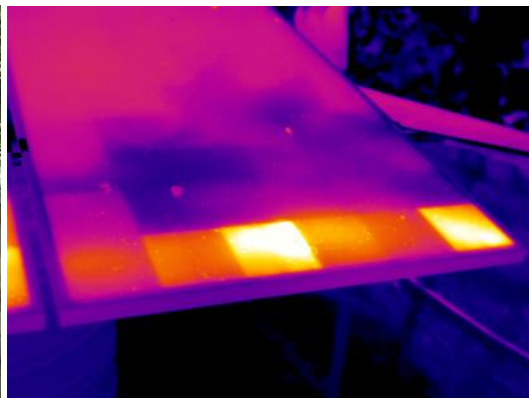
Figure 52: Warm cells caused by shading from trees, VI (left), IR (right)

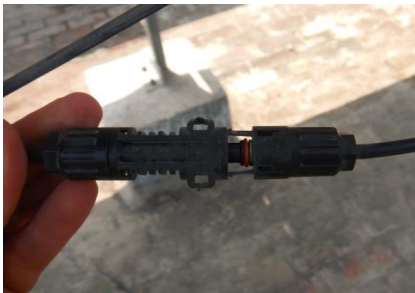
- There is no weather station, and hence no PR monitoring.
- Some connections were found to be loose leading to an increase of the contact resistance.

Figure 53: Loose connection

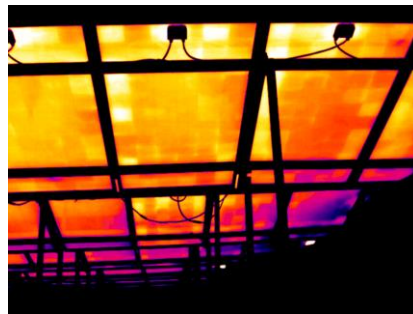
- PID loss was determined based on the on-site measurements to be as high as 56%. The degradation has already reached advanced stage.

Figure 55: IR image of PID modules

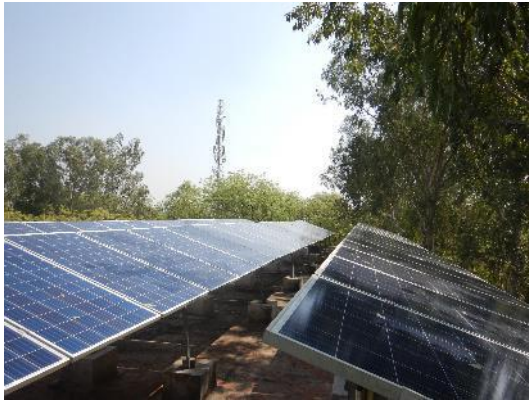
Figure 57: Trees cause significant shading

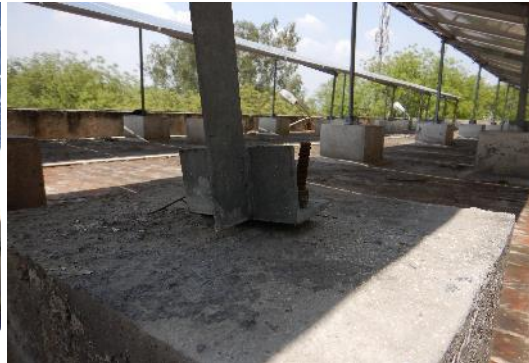
Figure 62: Loose fixation of the mounting structure

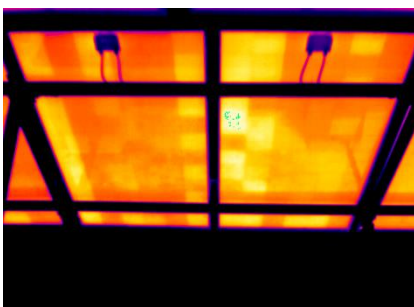
Figure 65: Modules suffering from PID

- Soiling losses were determined based on the measurements on site to be 3% on average.
- Based on the simulation, near shading losses are estimated to be 6% at the system level.
- PID loss was determined based on the on-site measurements and can be as high as 26% at the module level. The degradation has already reached advanced stage and reduces the system performance by at least 10%
- According to the amount of cracks discovered via EL imaging, the system is not expected to have a large power losses due to inactive areas.

- The cleaning cycles shall be increased based on the results of a soiling study that adjusts the cleaning needs to each season.
- An anti-PID measure, such as anti-PID box, shall be implemented in order to stop or reverse the degradation. PV modules showing power drops above the warranty conditions shall be replaced. If the replacement is not possible, the modules shall be regrouped in power classes within the same string and assigned to individual MPPT.

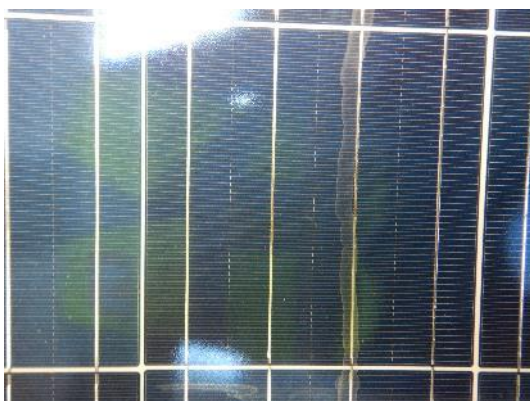
Figure 71: Soil on the module surface

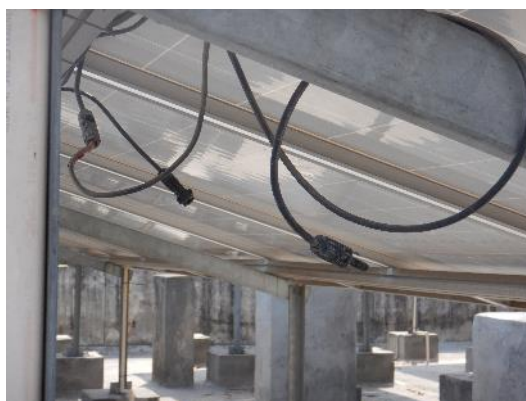
Figure 72: Connectors found disconnected

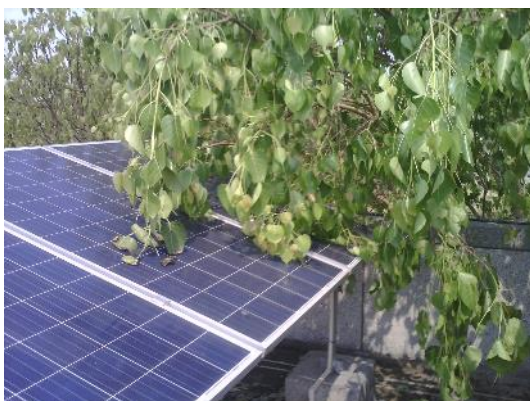
Figure 73: Poor O&M activities

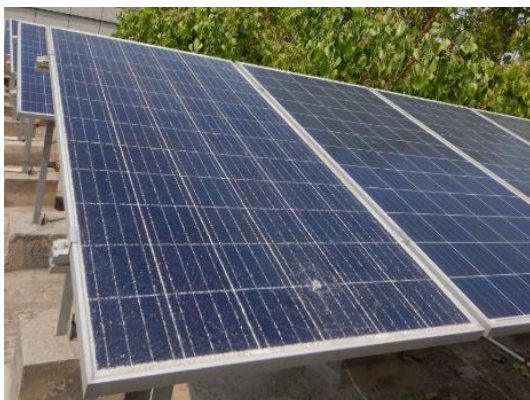
Figure 75: Broken module

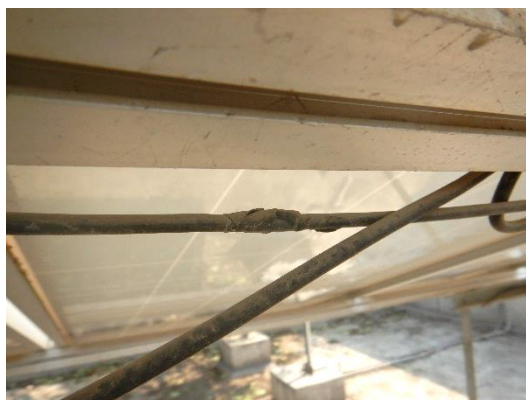
- String cables are built with a diameter of 4mm² which increases the DC cable losses.
- Occasionally string cables damaged by sharp edges have been detected.

Figure 76: Damaged cable from sharp edges

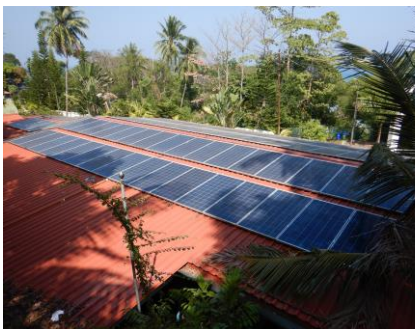
- Nearby trees cause significant shading on the system. There is no weather station.

Figure 77: Near shading situation

- The simulation shows significant shading losses caused by trees, which are close to 15%.
- Based on the amount of cracks and broken cells and corresponding inactive areas, the power loss is estimated to be 5% at the system level.

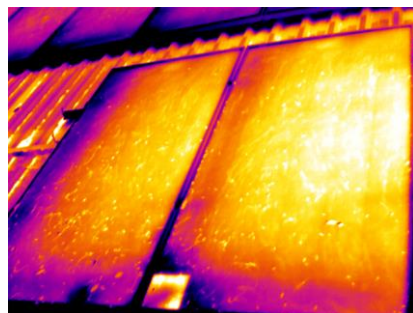
- Soiling losses were determined to be 6% on average, based on the measurements on site.

Figure 81: Soiling conditions

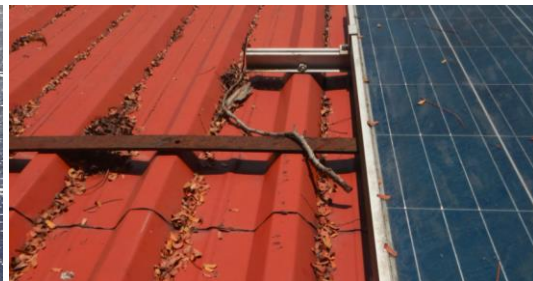
Figure 87: Rusty component of the roof

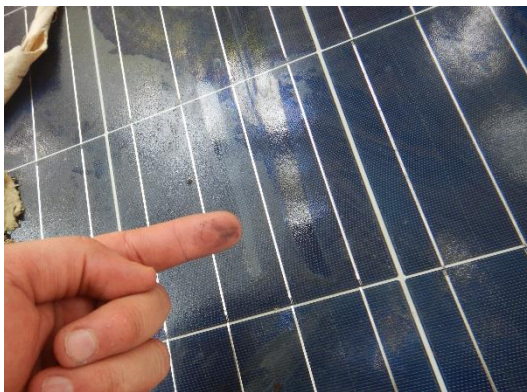
Figure 88: Exhaust residue on the module surface

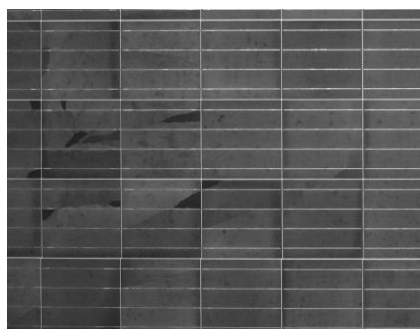
- The access to the roof is difficult. This could have caused module damages during handling and installation. The electroluminescence images show a considerable number of cracks, leading to inactive cell areas.

Figure 90: EL image of a module

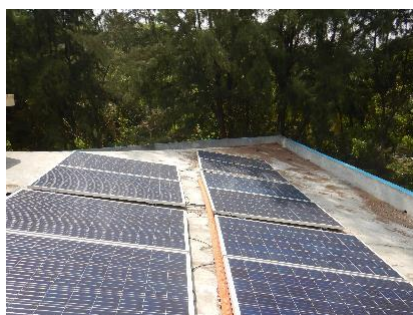
- Near shading losses are estimated to be close to 3% on the system level, based on the simulation.

Figure 91: Shading from trees

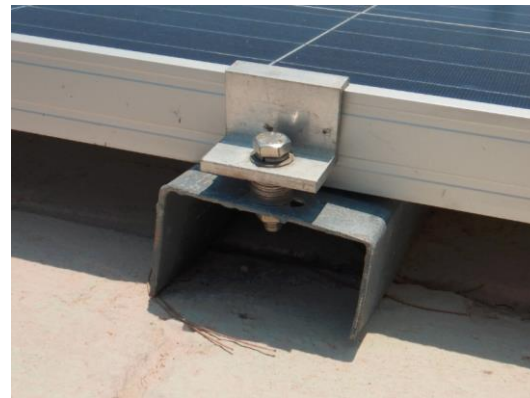
Figure 95: Loose fixation of a module

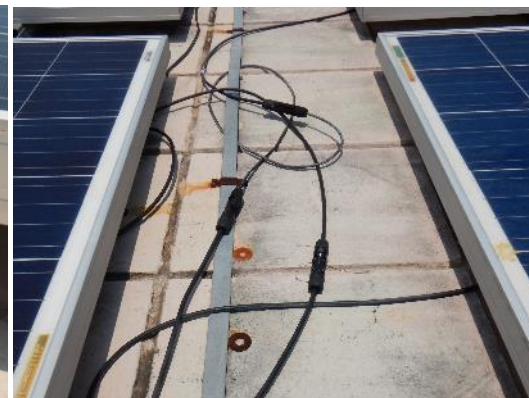
Figure 96: Connectors and cables exposed to UV

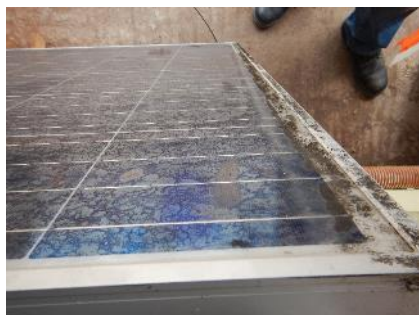
- The modules are heavily soiled. There is no manual cleaning scheduled.

Figure 100: Heavy soiling of the modules

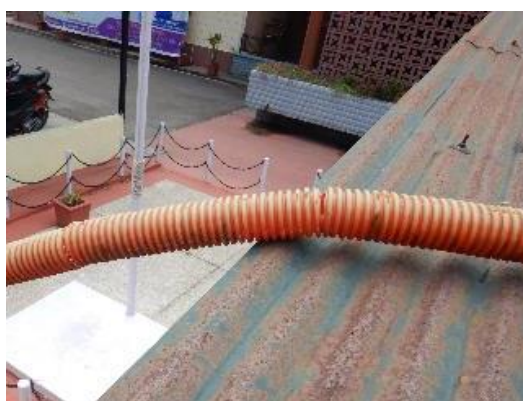
Figure 107: Broken protective tube

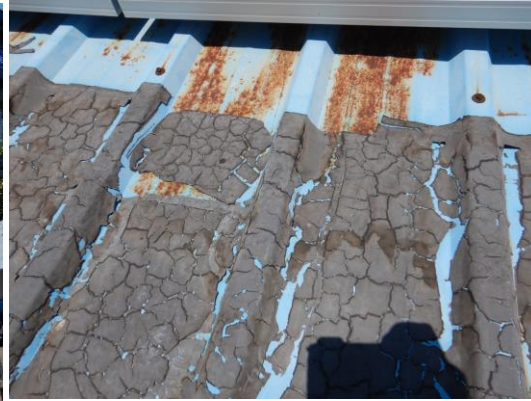
Figure 117: Rusted roof structure

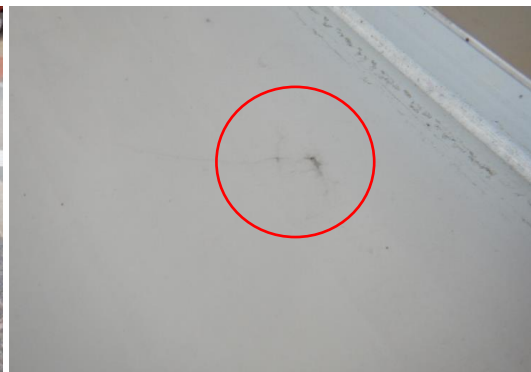
Figure 121: Mechanical damages in module BS

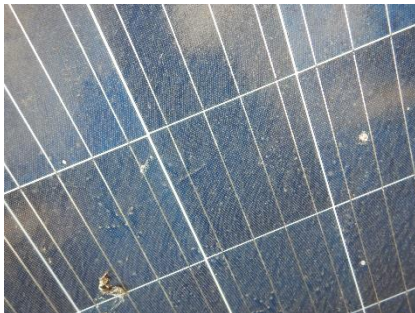
- The roof structure and its components are rusty, and the roof is not robust.
- There is no weather station, and hence no PR monitoring.
- Pipes carrying cables are brittle and some parts have already broken, exposing cables to weather.
- The modules are considerably soiled.

Figure 124: Heavy soil on the modules

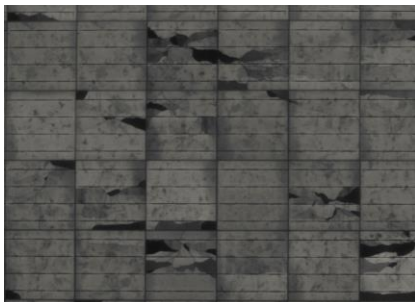
- A significant number of cracks were seen from the EL images, showing considerable amount of inactive areas.

Figure 125: Cracks in a module

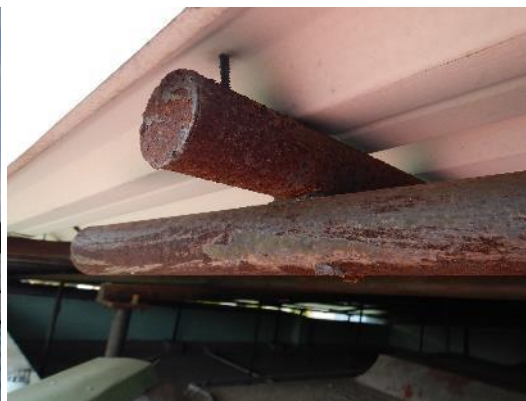
Figure 129: Rusty roof elements

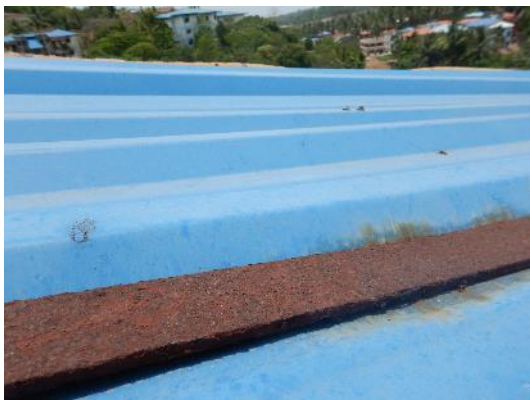
Figure 134: Rusty roof elements

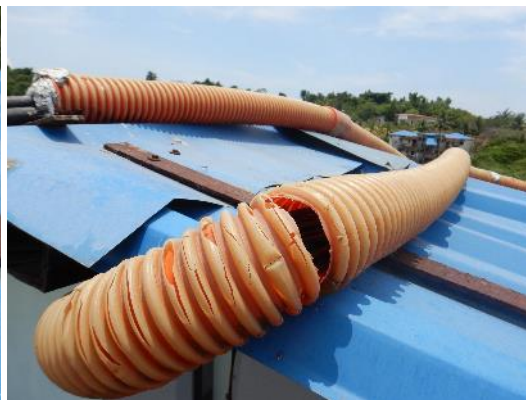
Figure 135: Broken protective conduit

- The cables shall be protected from UV radiation by robust pipes or tubes.
- A weather station, or at least an irradiation sensor on the module plane, shall be installed so that the performance of the system can be properly determined.
- Manual cleaning shall be implemented and scheduled based on the results of a soiling study that adjusts the cleaning needs to each season.
- Modules with heavy cracks shall be grouped in the same string or at least assigned to one MPPT. The grouping will be conducted based on infrared inspection with high irradiation levels and after cleaning. These modules with cracks will be grouped in strings with same MPPT.
- The structural integrity of the roof shall be reinforced.
