# Evaluation of Underperforming Rooftop PV Plants in India – Moving from kW to kWh

## Part I: Evaluation of 10 Rooftop PV Plants in Delhi

Report Number: 201802070\_V4  
Berlin, 09.07.2019

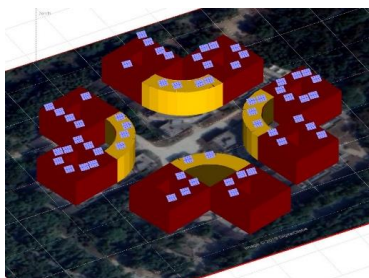
- Heavy soiling even though the visit took place 3 days after a heavy rain and hail storm fell. However, in this period the soiling on the modules was already evident and likely to have an impact on the performance.
- Shading is another common issue throughout the system. Small walls, antennas and other objects are the main source of near shading.
- The PV tables have multiple azimuthal orientations. This leads to current mismatch on string and voltage mismatch on inverter level.

Figure 10: 3D scene

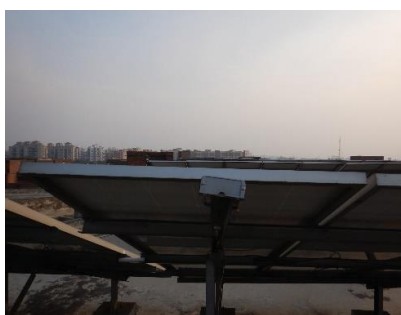
- The installed modules are very hotspot sensitive, which could be detected during the infrared analysis.
- The irradiation sensor is improperly installed providing inaccurate readings, and thus, leading to an inaccurate PR calculation.

Figure 11: Irradiation sensor misaligned

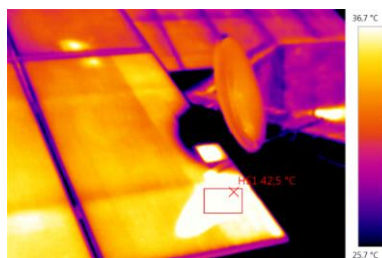
- Soiling measurements were conducted measuring both the short circuit current and nominal power before and after cleaning at irradiances of > 700 W/m².
- The estimated soiling factor is in the range of 5% - 12% depending on the location at site.
- The near shadings are responsible for an irradiation reduction on the tilted plane of approx. 3% at system level.

Figure 12: Hot spots caused by near shadings

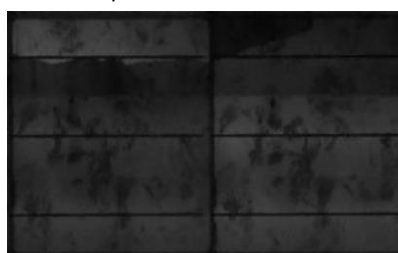
- The inconsistency of the azimuthal orientation leads to a mismatch loss of approximately 1.5%.
- The amount and type of cracks, and cells in short circuit found in the selected modules during the electroluminescence inspection, reduce the nominal power of the PV plant by 2% - 4%. This statement bases on the extrapolation of the results of the sample measures.

Figure 53: Cells cracks

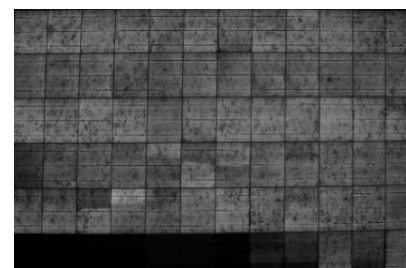
Figure 14: Inactive cells

- A regrouping of the modules shall be conducted in the following way: modules with similar shading conditions shall be installed in the same string or at least assigned to one MPPT.
- Additionally, modules with heavy cracks shall be grouped in the same string or at least assigned to one MPPT. The grouping will be conducted based on infrared inspection with high irradiation levels and after cleaning.

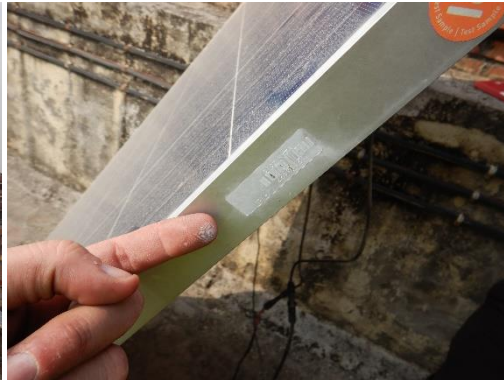
Figure 16: Degraded bar code

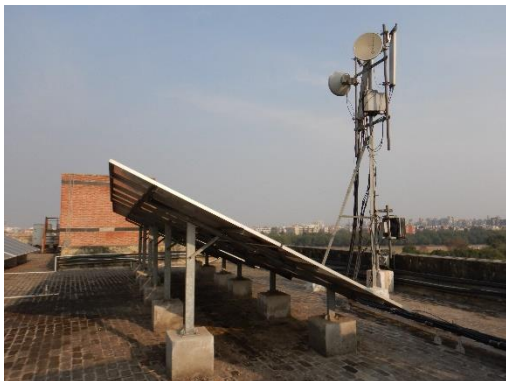
Figure 17: Near shadings on the PV surface

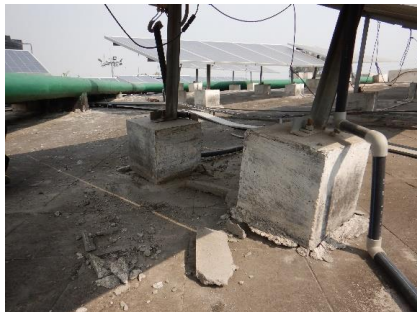
- Heavy soiling detected even though the visit took place 4 days after a heavy rain and hail storm fell.
- A significant amount of modules with inactive cell strings were found during the infrared inspection.
- Near shadings effects are caused by water tanks and metal structures located in the south part of the system
- Wind gusts are able to slowly move the structure due to weak concrete foundations not properly attached to the ground.

Figure 23: Weak foundations

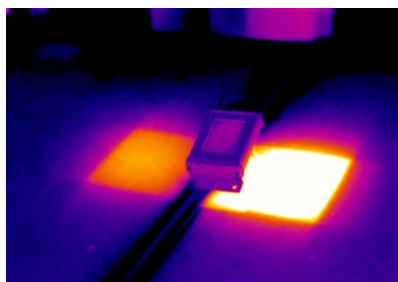
- The tilt angle of the modules is not homogeneous with values varying from 10° to 22°
- The installed modules are very hotspot sensitive.
- The irradiation sensor is installed "on top" of the PV modules.

Figure 24: Sensor shading the PV modules

- Modules with inactive cell strings should be replaced according to the performance warranty terms of the module supplier.
- The irradiation sensor should be properly reinstalled to ensure accurate readings.
- The modules with the same tilt and azimuth will be grouped in strings with the same MPPT.
- A modification of the tilt angle to 24° would lead to a performance boost of 1.7%.

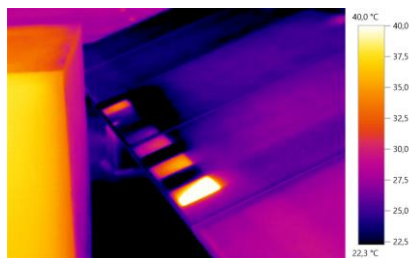
- The near shadings are responsible for an irradiation reduction on the tilted plane of approx. 0.5% at system level.

Figure 26: Hot spots caused by near shading

- The cleaning cycles shall be increased based on the results of a soiling study that adjusts the cleaning needs to each season.
- Objects that cause shading in the south part shall be removed. This exercise is key due to the high hotspot sensitivity of the PV modules.

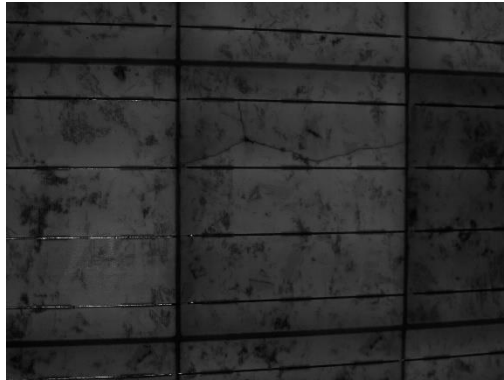
Figure 30: Cell cracks

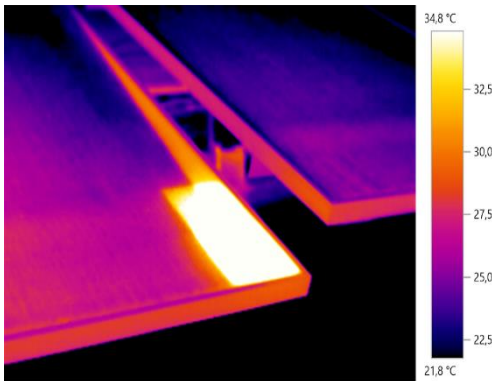
Figure 31: Self shading in E-W direction

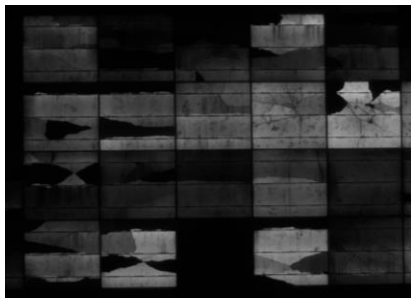
- Heavy soiling caused by bird drops has been detected. A large amount of birds gather on the rooftop system every day.
- Significant cell and modules damages caused by personnel during the installation and O&M activities.

Figure 37: Cells cracks

- The severe cracks on module level account for approximately 4-6% of nominal power drop on system level. This statement bases on the extrapolation of the results of the inspected samples.
- Soiling measurements were conducted measuring both the short circuit current and nominal power before and after cleaning at irradiances close to 800 W/m<sup>2</sup>. The estimated soiling loss of the nominal power is in the range of 4%-13% depending on the location of the analyzed module.

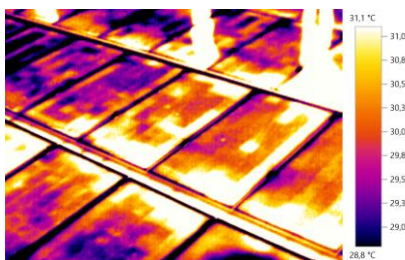
- The infrared and electroluminescence measurements confirm the presence of Potential Induced Degradation. A big reduction of the open circuit voltage has been detected in the IV curve measurement results.

Figure 38: Potential Induced Degradation

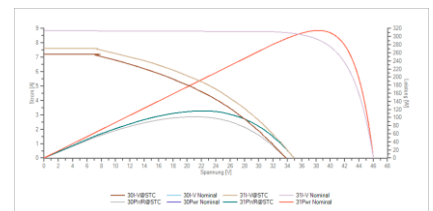
Figure 71: Reduction of  $V_{oc}$  due to PID

- A regrouping of the modules shall be conducted. Modules with similar shading conditions shall be installed in the same string or at least assigned to one MPPT.
- Due to the large number of cracks discovered during the site assessment, a further regrouping of the modules according to their level of affection shall be conducted. The categorization shall be conducted by means of an infrared camera at high irradiances and after the modules have been cleaned.
- An anti-PID box shall be installed in order to stop the module degradation. PV modules showing power drops above the warranty conditions shall be replaced. If the replacement is not possible, the modules shall be regrouped in power classes within the same string and assigned to individual MPPT.

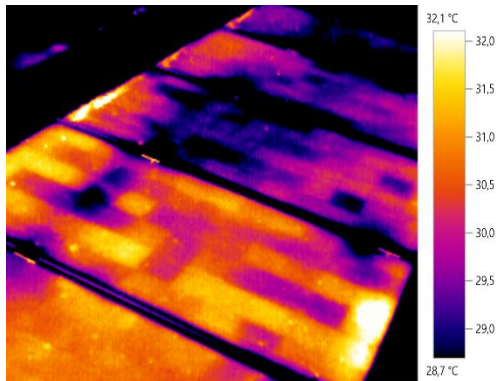
Figure 43: Potential Induced Degradation

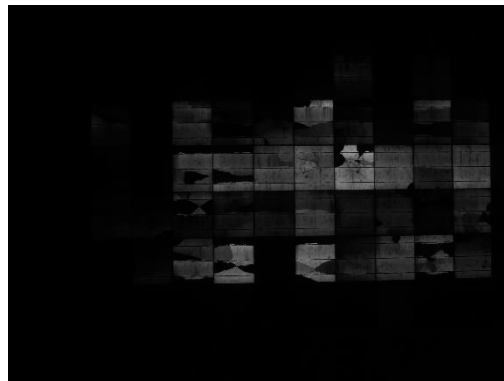
Figure 44: Cell cracks combined with PID

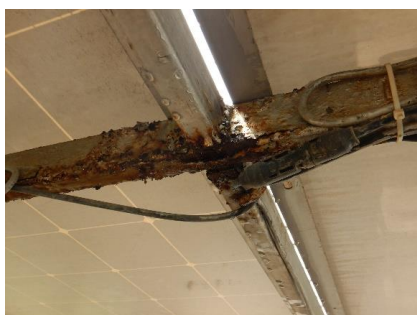
- Heavy soiling has been detected on site. The use of hard water for cleaning increases the accumulation of soil on the module surface. This leads to soiling induced hotspots.
- The mounting structure is heavily rusted and likely not to last until the end of the project's lifetime. Besides, the structure is not robust for the height and number of the installed modules.

Figure 49: Rusted mounting structure

- The mounting structure should be retrofitted immediately.
- Defective and loose connectors should be replaced and the connectors should be homogenized.
- The irradiation sensor should be properly installed in order to ensure accurate performance ratio calculations.
- All modules with inactive cell strings shall be replaced according to the warranty terms. A similar exercise shall be conducted with all modules showing product defects.

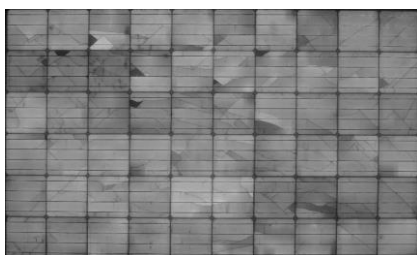
- Loose connectors were found in many PV modules
- Near shadings are caused by the fence, water tank and surrounding structures.
- A significant amount of PV modules show inactive cell strings, scratches and cuts at the backside, junction boxes without lid and browning of the EVA.
- The high amount of cracked cells detected, point towards technicians walking regularly on the modules during installation and maintenance activities.

Figure 50: Cell cracks

- The irradiance losses caused by near shading is quantified as ca. 3%.
- Based on the crack distribution and types detected with electroluminescence, it is likely that the modules perform 2-4% less. Furthermore, these types of crack could eventually lead to inactive areas and higher power losses in the midterm.
- Modules with inactive cell strings underperform 33% to 66% depending on the amount of affected strings. The extrapolation of the inspected sample to the whole system leads to a loss of 3% at system level.

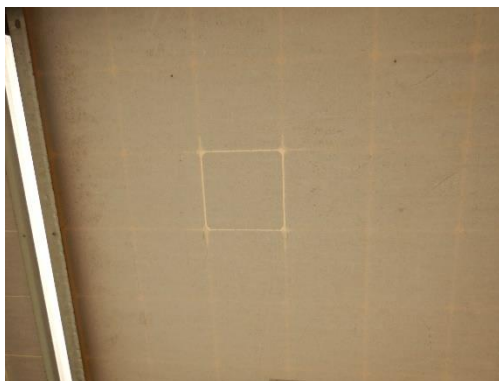
Figure 53: Degraded backsheet

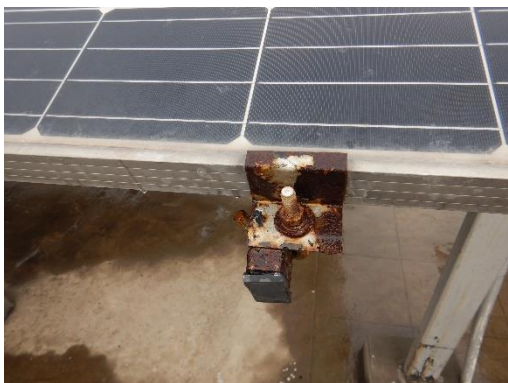
Figure 54: Rusty clamps

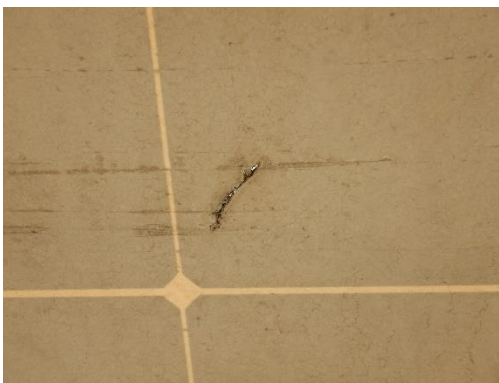
Figure 55: Scratched backsheet

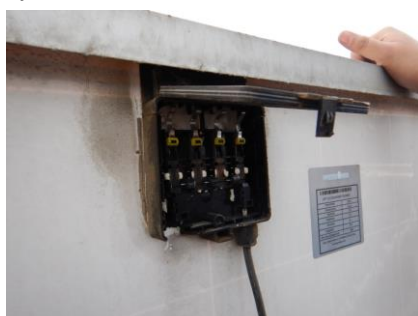
- Heavy soiling caused by bird droppings has been detected. A large amount of birds gather on the rooftop system every day.
- The PV tables have multiple orientations and tilts lacking homogeneity. The Adani modules in the third system were shaded by the system containing the Medors modules.
- The system containing JJ modules showed a significant amount of snail trails, multicracks, hotspots and broken junction boxes.

Figure 60: Loose junction box lid

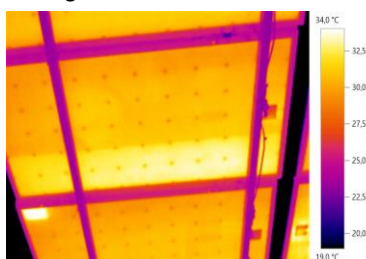
- The system showed hotspots as well as a significant amount of inactive cell strings.

Figure 61: Inactive cell strings

- All modules showing product and performance issues shall be replaced according to the warranty terms.
- All cable connections to the inverter shall be checked.

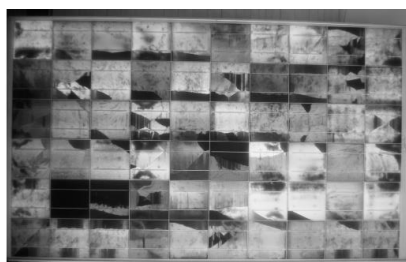
- Based on the crack distribution and type found during the electroluminescence inspection, it is likely that the module's nominal power has been reduced by approximately 4%. Furthermore, these types of cracks could eventually lead to inactive areas and higher power loss in the midterm.

Figure 102: Cell cracks

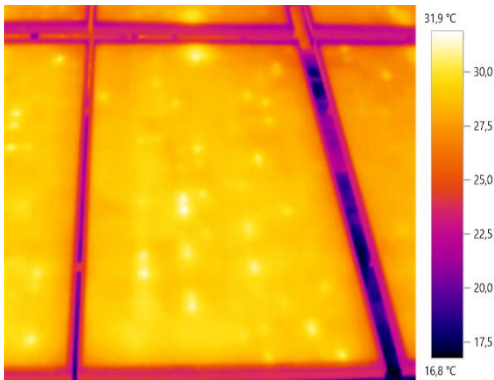
Figure 67: Hot spots cause by bad soldering

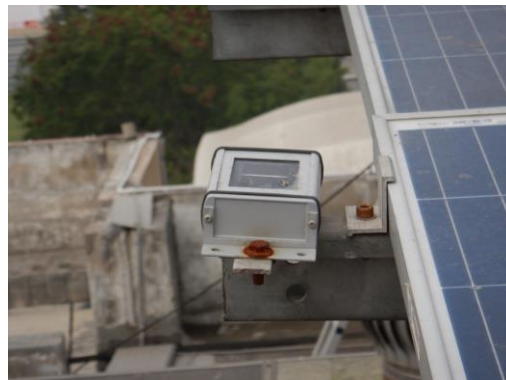
Figure 68: Misaligned irradiation sensor

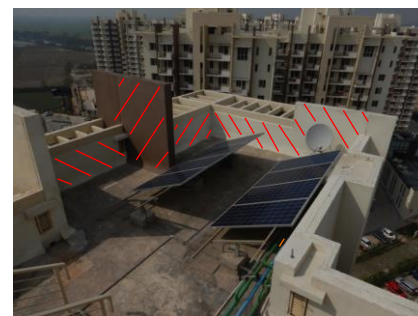
Figure 75: Area marked with reflective coating

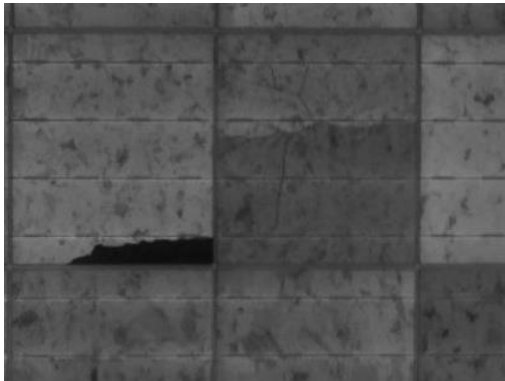
Figure 77: Cell cracks

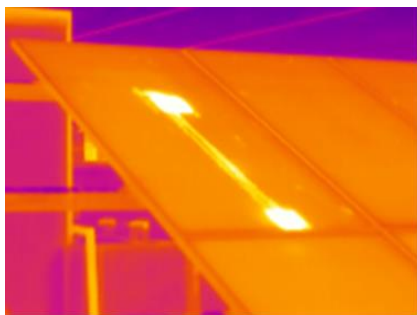
- Heavy soiling caused by bird droppings has been detected. A large amount of birds coming from the nearby wasteland, gather on the rooftop system every day.

Figure 83: Hotspots induced by bird drops

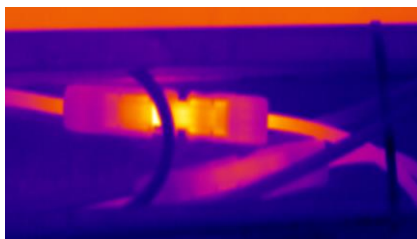
- The near shadings were ignored during the design phase of this system.
- A significant amount of modules with inactive cell strings were detected. This effect is mainly caused by shading and heavy soiling.
- Scratches at the backside were detected posing safety risks and increasing the risk of inverter disconnection due to loss of insulation.
- The installed irradiation sensor is from a different technology, and has a different tilt angle. The module temperature sensor is not properly fixed.
- A significant of connectors showed overheating due to improper installation.

Figure 84: Hot connectors

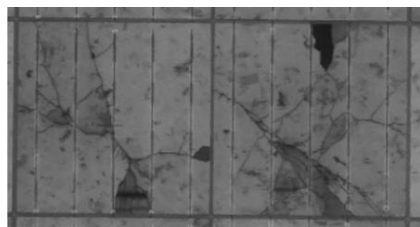
- The electroluminescence inspection revealed branched cracks in the modules caused by improper handling during installation and maintenance.

Figure 95: Cell cracks

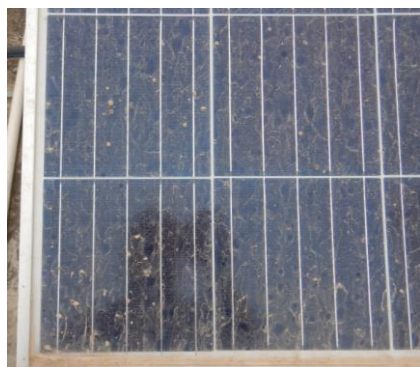
- Heavy soiling caused mainly by debris was detected.

Figure 96: Bird drops on the module surface

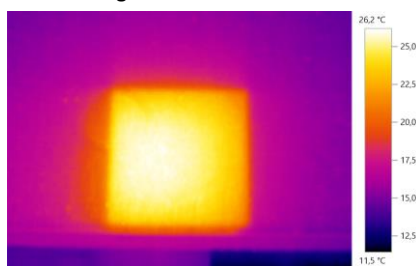
- The amount and type of cracks is likely to induce a performance loss of around 3%.
- Scratches on the module backsheet were detected posing safety risks and increasing the risk of inverter disconnection due to loss of insulation.
- Soiling measurements were conducted measuring both the short circuit current and nominal power before and after cleaning at irradiances higher than 750W/m<sup>2</sup>. The estimated soiling factor is in the range of 6% - 8%.

Figure 97: Hot spot

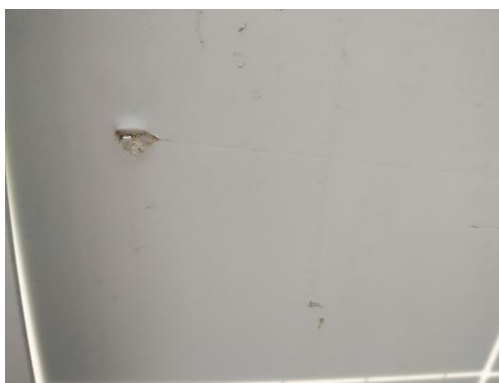
Figure 101: Backsheet damage

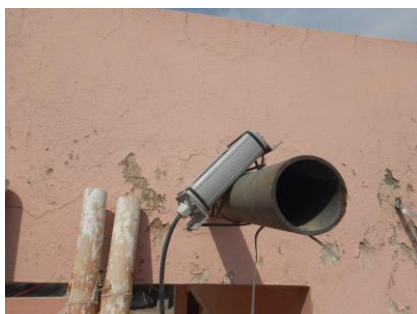
- The PV modules have a strong orientation towards South-West (220°).
- High presence of near shading objects and E-W shading caused by different mounting table heights.
- A significant level of soiling was detected. The soiling is mainly caused by the presence of birds and nearby vegetation.
- The irradiation sensor was installed at the wrong tilt and was significantly soiled.

Figure 106: Inaccurate fixing of the sensors

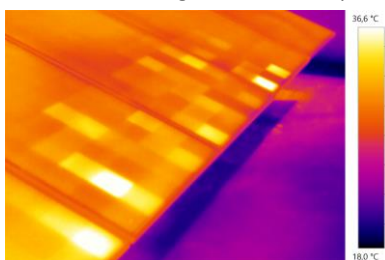
Figure 107: Hot spots caused by near shading

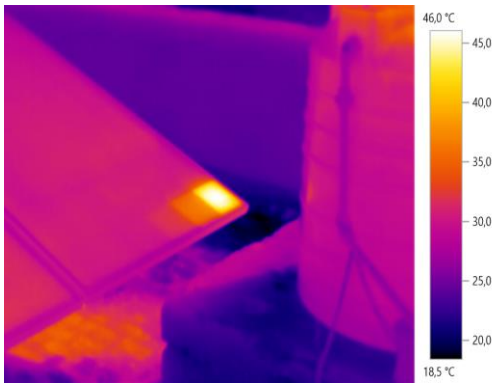
Figure 112: Hotspot caused by near shadings

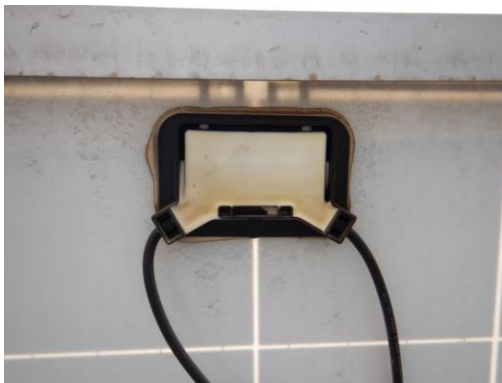
Figure 113: Junction box without lid

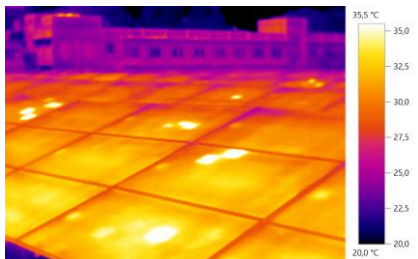
- Heavy soiling caused by bird droppings and the nearby industrial area has been detected.

Figure 116: Soiling induced hotspots

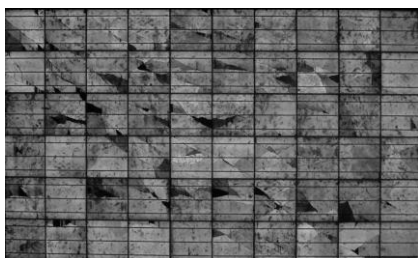
- The PV tables showed inconsistent tilts at the time of the visit. The mounting structure has a seasonal tracking system but the tilt is not kept consistent.
- Due to the difficult access to the roof it is likely that the modules suffered mechanical stress during transport, handling and installation. The electroluminescence inspection revealed a big number of cracks in the analyzed modules. This was evidenced by the large number of snail trails detected.

Figure 117: Cell cracks

- The tilt and shading angles throughout the system shall be homogenized.
- Modules with heavy cracks shall be grouped in the same string or at least assigned to one MPPT. The grouping will be conducted based on infrared inspection with high irradiation levels and after cleaning.

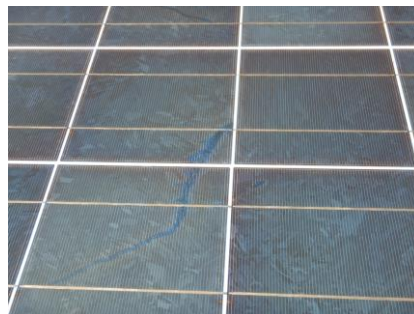
- Soiling measurements were conducted measuring both the short circuit current and nominal power before and after cleaning at irradiances close to 900 W/m<sup>2</sup>. The estimated soiling factor is in the range 7–10%.
- The amount and type of cracks found during the electroluminescence inspection is likely to induce a drop of the nominal power of around 8-10%. Many cracks are evidenced with clearly visible snail trails.

Figure 118: Snail trails

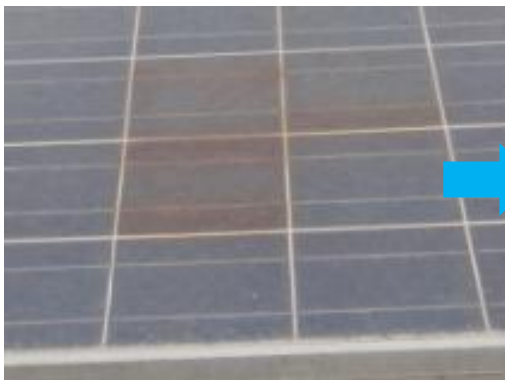
Figure 127: Burned cell (VI)

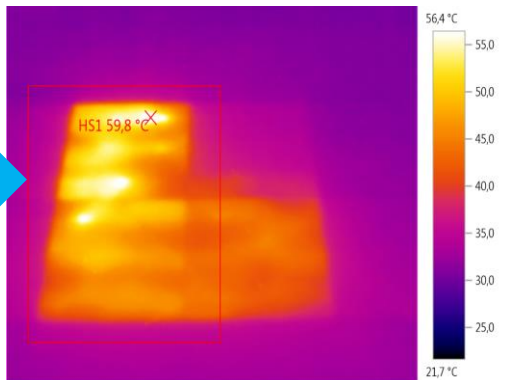
Figure 128: Burned cell (IR)
