Evaluation of Underperforming Rooftop PV Plants in India – Moving from kW to kWh

Part III: Evaluation of 10 Rooftop PV Plants in Pune

Report Number: 201802070_III_v1
Berlin, 25.06.2020

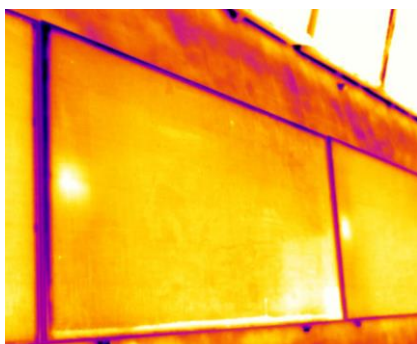
- Foot prints, likely from walking on top of the modules, were spotted throughout the plant.

Figure 11: IR inspection of the soiling conditions

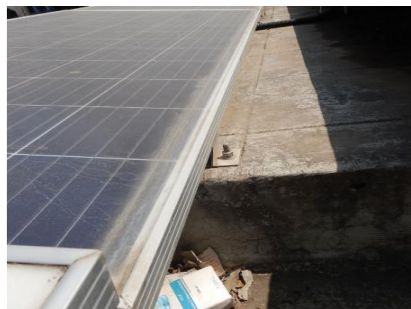
- Although the soiling induces a shading in the bottom cell string, the landscape orientation reduces the impact of the current reduction.

Figure 13: Soft soiling on landscape modules

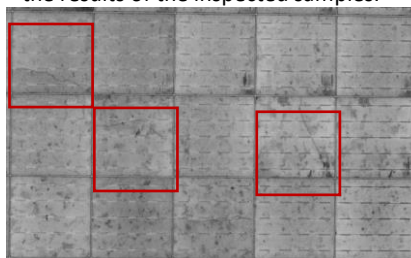
- Severe cracks on module level account for approximately 4-6% of nominal power drop on system level. This statement bases on the extrapolation of the results of the inspected samples.

Figure 14: Example of module with cracks

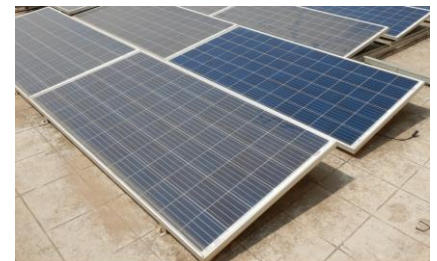
Figure 15: Better cleaning cycles required

- In order to guarantee module long-term reliability and safety, the module J-boxes shall be assessed. Modules with open or detached J-boxes shall be replaced.
- Modules with a large amount of cracks shall be grouped in the same string or at least assigned to one MPPT. The grouping shall be conducted based on an infrared inspection with high irradiation levels and after cleaning activities.
- The manual cleaning cycles shall be implemented and scheduled based on the results of a soiling study that adjusts the cleaning needs to each season.

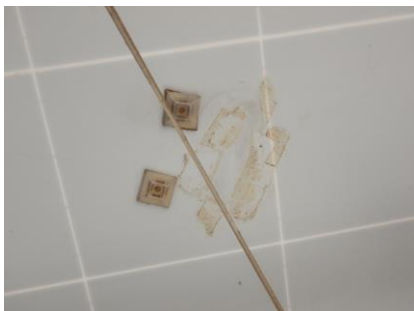
- The azimuth deviation from the optimum (South) represents a 2% loss.
- The high concentration of dust on top of the modules is likely originated in the construction site next to the system.
- Additionally, the water used for cleaning the modules leaves a gray residue that intensifies the soiling in the long term.
- On the module where the irradiation sensor is located, there is evidence that a cell temperature sensor was previously attached and the surface not cleaned.

Figure 25: Temperature sensor missing

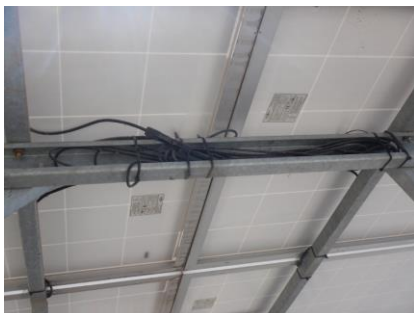
- Although the infrared inspection did not reveal warm cables, the minimum bending radius was partially disregarded when the cables were forced to fit in the structure.

Figure 26: Bending radius partially respected

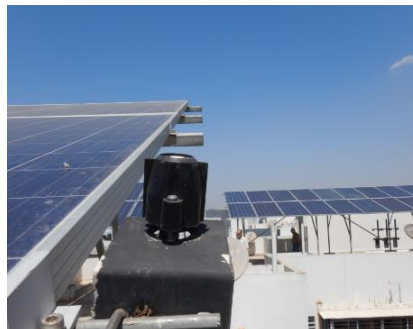
- Soiling losses in the selected section at Florida State were calculated in 4.7% on average.
- The simulation did not reveal shading losses caused by the overhead cables.
- The lack of calibration of the irradiation sensor will not directly affect the performance of the system. However, the accurate recording of the onsite irradiation will provide confidence to the plant's KPIs.

Figure 27: Non-calibrated irradiation sensor

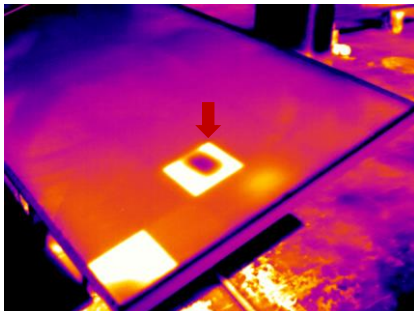
Figure 41: Modules are hotspot sensitive

- The modules are hotspot sensitive. This defect could compromise the long-term reliability of the modules.

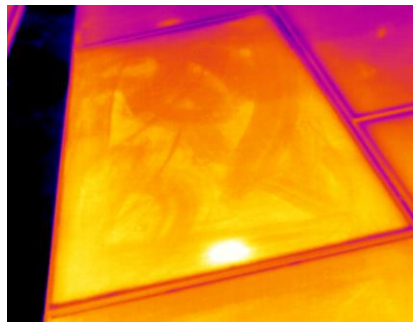
- Soiling measurements were conducted via short circuit current reduction and nominal power before and after cleaning. The estimated soiling loss averages 3%.
- The device used for cleaning the modules (mop), does not achieve a homogenous cleaning.

Figure 43: IR inspection of soiling conditions

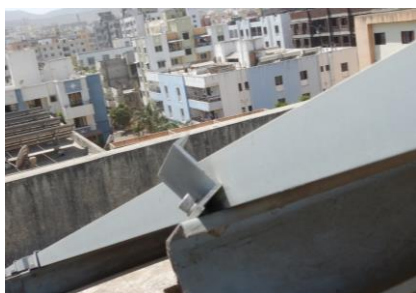
- No weather station has been installed and the Performance Ratio is not tracked.
- The filters of the inverters should be cleaned.
- Open fastening screws were observed on the fixing clamps.

Figure 54: Open fastening screws

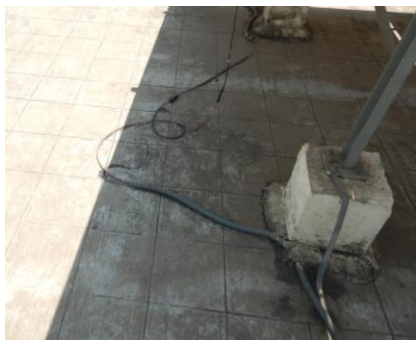
- Missing cable ties, hence the module cables and connectors were loosely hanging.

Figure 55: Loose cables

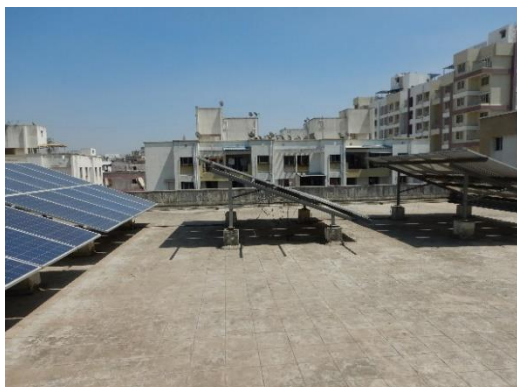
Figure 59: Missing cable ties

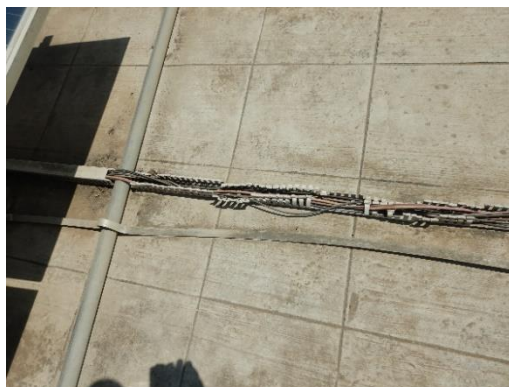
Figure 60: Broken cable ducts

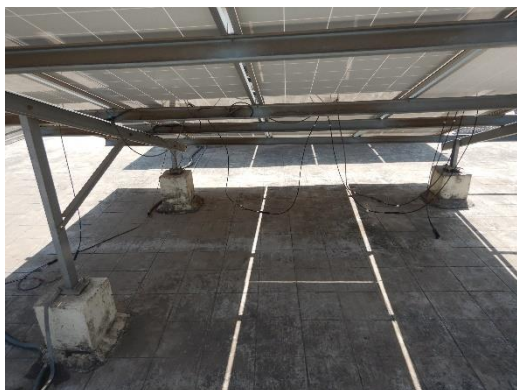
Figure 65: Missing cable ties

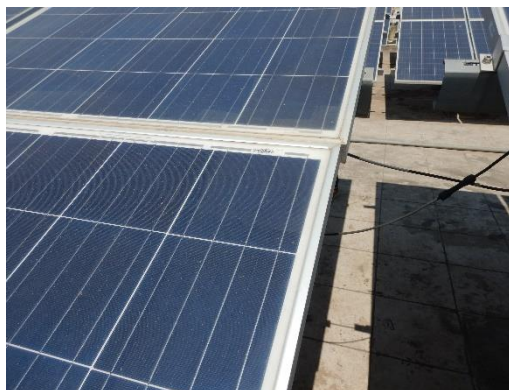
Figure 66: Cables exposed to UV radiation

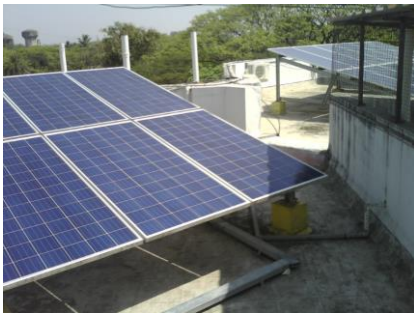
- Although the cleaning activities were performed the day before the inspection, a few modules were discovered to still have significant amounts of dust.
- Near shadings effects are caused by shading structures, overhead cables and cooling equipment were visible.

Figure 67: Near shadings disregarded

- The module most affected by the shades from the shading structure can be easily relocate. This will reduce the impact of the shadings on the whole string. Furthermore, after the relocation, modules with hotspots (>100°C) shall be monitored to assess the damage and their possible replacement.
- Grounding cabling shall be replaced to guarantee a proper grounding throughout the system.
- The cleaning cycles shall be increased and defined based on a soiling study that adjusts the cleaning needs to each season. Cleaning once a month during the dry season might not suffice.

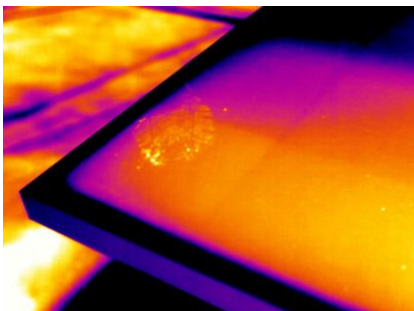
- In the DC distribution box II, some cable terminals of the negative pole are burned, likely due to a faulty contact.
- Inverter 3 is slightly oversized, leading to overload losses of approximately 3%.
- The limited access to the southeast section of the plant is likely the reason why there are footprints on the first module of the table. This will likely induce cell damages and hotspots.

Figure 68: IR inspection of shoe footprints

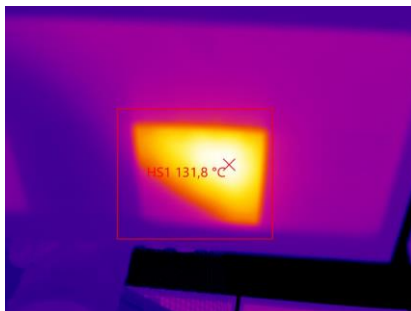
- Electroluminescence imaging did not reveal a significant amount of cracks. However, module backsheet scratches could lead to safety hazards and increased risk of inverter disconnection due to loss of insulation.
- A soiling loss of 5.9% was determined from IV curve measurements of a sample module before and after cleaning.
- The near shadings are responsible for an irradiation reduction on the tilted plane of approx. 1.5% at the system level.

Figure 69: Hotspots likely induced by shading

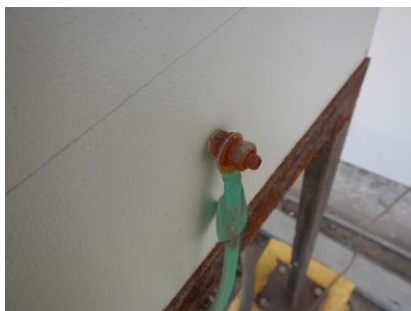
- Advanced corrosion in the grounding cables might reduce the effectiveness of the insulation.

Figure 70: Advance corrosion in grounding cables

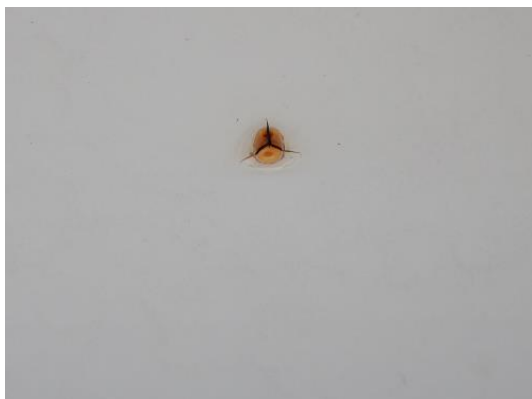
Figure 77: BS degradation due to hotspot

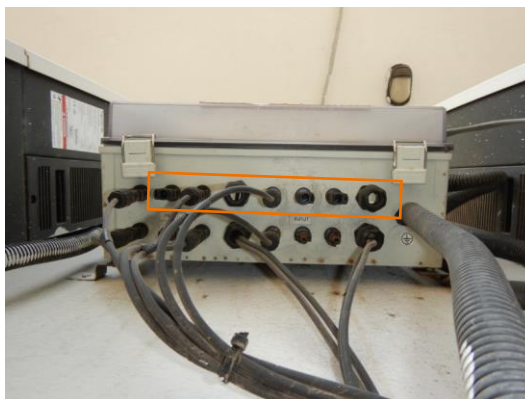
Figure 78: Combiner box with open glands

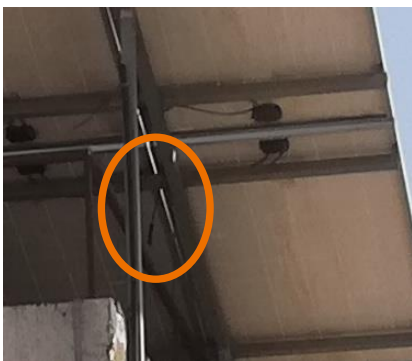
- The module fasteners cannot be opened, which makes maintenance impossible.
- Open module plugs lead to not producing strings. This could be measured on the inverter.

Figure 82: Open connectors

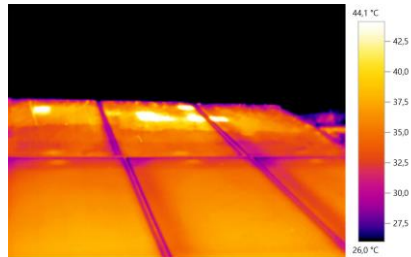
- Soiling measurements were conducted before and after cleaning. The estimated soiling loss is on average 3.5%. However, the measured modules were much cleaner than modules that are more difficult to access.
- Heavy partial pollution creates hotspots. These not only lower the yield but also make the modules age faster.

Figure 83: Hotspots created by pollution

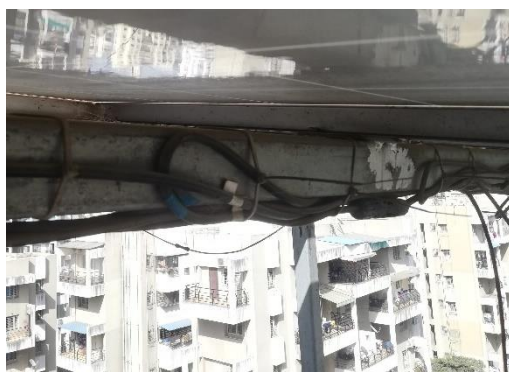
Figure 90: Loose cable

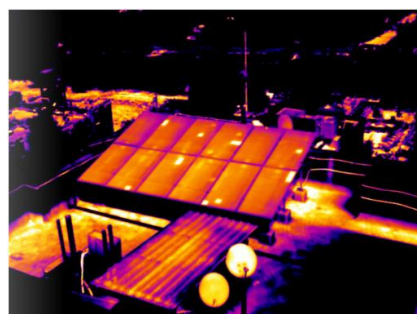
- An important amount of warm cells were spotted via thermographic inspection.

Figure 96: Modules with warm cells (full cells)

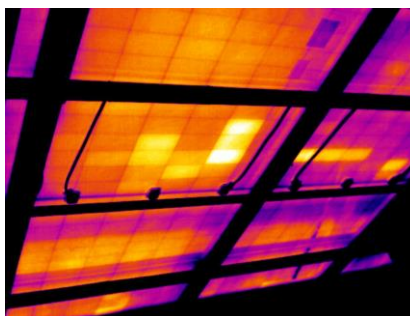
- Although half-cut cell modules have been recently installed, the cells already have an abnormal thermal behavior.

Figure 98: Modules with HC warm cells

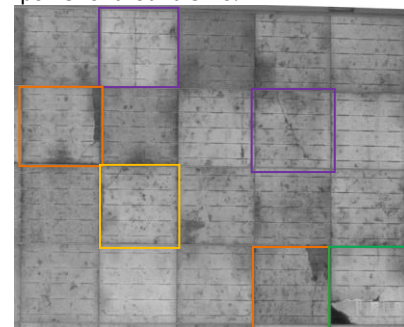
- The amount and type of cracks found during electroluminescence inspection is likely to induce a drop of the nominal power of around 8-10%.

Figure 99: Variety of cracks discovered via EL

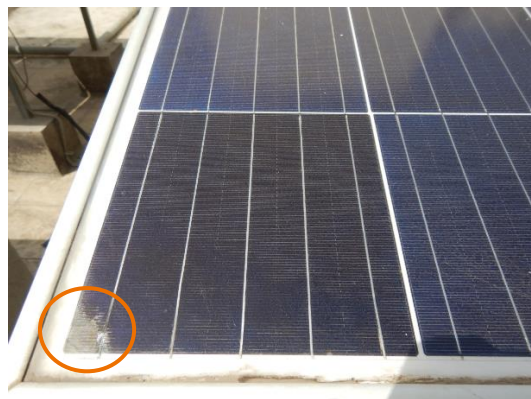
Figure 105: Module corrosion/delamination

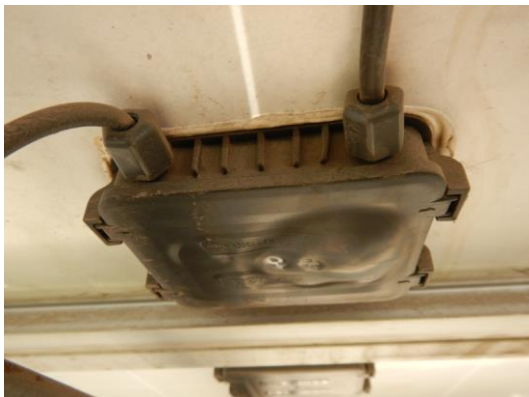
Figure 106: Overheated J-box (likely blown diode)

- Modules with any defect on the J-box shall be immediate replaced (safety, operation and reliability issues).

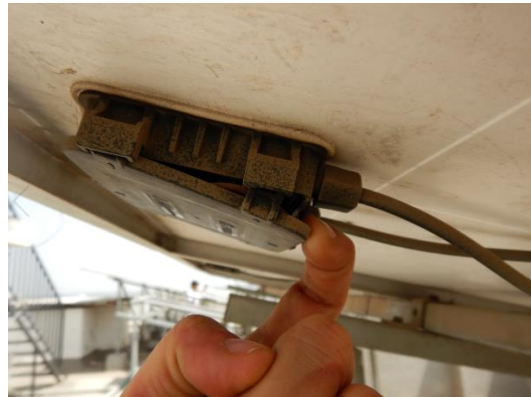
Figure 107: Open and loose J-boxes

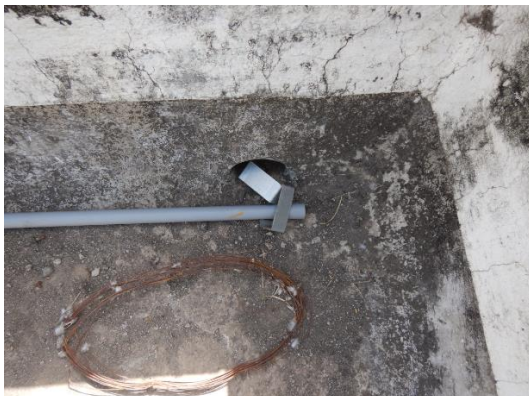
Figure 108: Blocked drainage

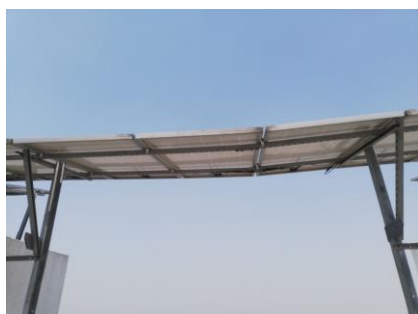
- No weather station has been installed and the Performance Ratio is not tracked.
- The mounting structure is made up of many small beams. This endangers the stability of the system.

Figure 110: Unstable mounting structure

- The individual beams of the mounting structure should be reinforced.
- A weather station, or at least an irradiation sensor on the module plane, shall be installed so that the performance of the system can be properly determined.
- The cables and plugs should be checked for temperature and functionality.
- The modules should be cleaned regularly.
- The loose hanging cables should be fixed and the bending radii checked.
- The causes of the local shadings should be removed.
- The filters of the inverter should be cleaned.

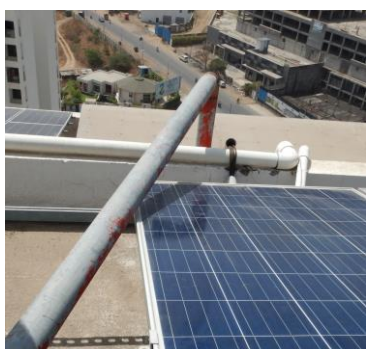
- The filters of the inverter have been found dirty.
- Some modules are affected by local shading. These cause hotspots and burned cells.

Figure 111: Partial shading

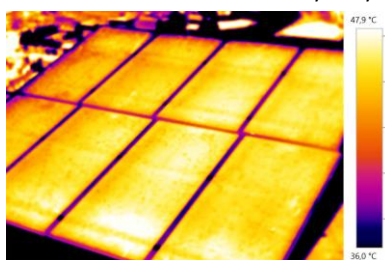
- Soiling measurements were conducted before and after cleaning. The estimated soiling loss is on average 14.1%. Two levels of pollution were measured. The highest losses were 26.1%.
- Heavy partial pollution creates hotspots. Some modules were extremely dirty.

Figure 112: Hotspots created by pollution

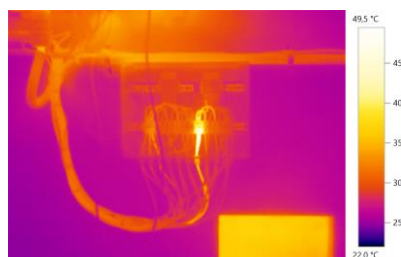
- Several hot cables were found on the distribution boxes and inverters.

Figure 114: Overheated connector

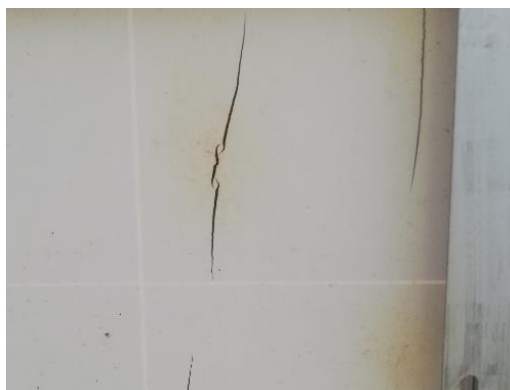
Figure 121: Burnt cells due to hot spot

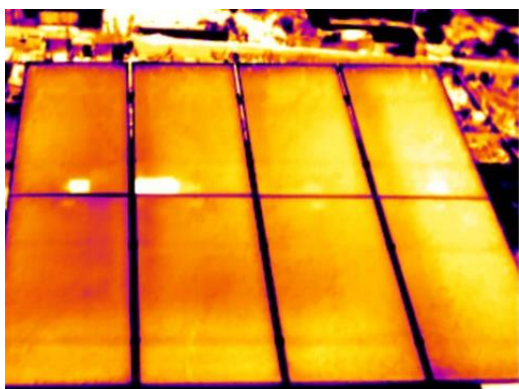
Figure 122: Hotspots created by pollution

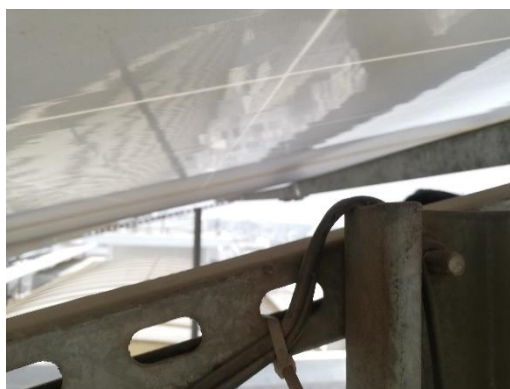
Figure 123: Improperly routed cables

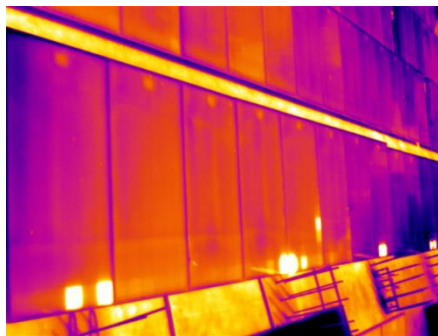
- The remaining pillar beams (from the building) induce microshading on several modules.

Figure 124: Microshading from pillar beams

- The remaining pillar beams shall be cut or bent to avoid microshading.
- A weather station, or at least an irradiation sensor on the module plane (GTI), shall be installed so that the performance ratio of the system can be properly calculated.
- Manual cleaning shall be implemented and scheduled based on the results of a soiling study that adjusts the cleaning needs to each season.
- Modules with similar amount of cracks shall be re-grouped in the same string or at least assigned to one MPPT. The grouping will be conducted, ideally based on EL imaging, otherwise through IR inspection with high irradiation levels and after cleaning activities.

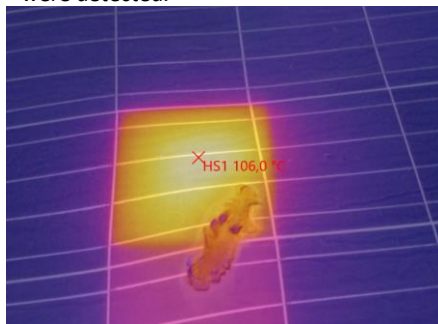
- The mounting system includes *power snap fastening & grounding clips*. Although the installation time is reduced, O&M activities are limited since individual modules, from inside of the table, cannot be removed.
- Through IR inspection, a handful of modules with inactive cell strings were spotted.
- Moving between module rows is usually done by crossing over the tables, i.e., walking on the modules. Thus, mechanical stress is inevitable (cracks and broken cells). The cracks could also have been initiated during handling and installation.
- Cabling installation failures at string level, such as hot cables at the inverter inputs, inaccurate soldering or loose connectors, were detected.

Figure 125: Hotspot induced by foreign objects

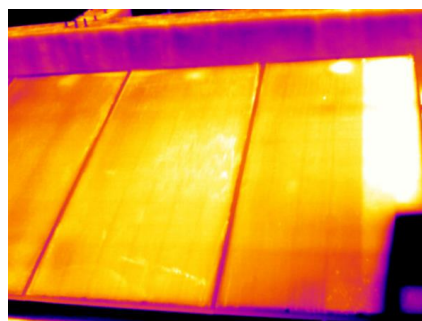
- Based on the crack distribution and type found during the electroluminescence inspection, the module nominal power could be reduced by 4-8%. Furthermore, these types of cracks could eventually lead to inactive areas and higher power loss in the midterm.
- Modules with inactive cell strings could underperform 33% to 66% depending on the amount of affected strings. The extrapolation of the inspected sample to the whole system leads to a loss of 6% on string level.

Figure 127: Module with inactive cell strings

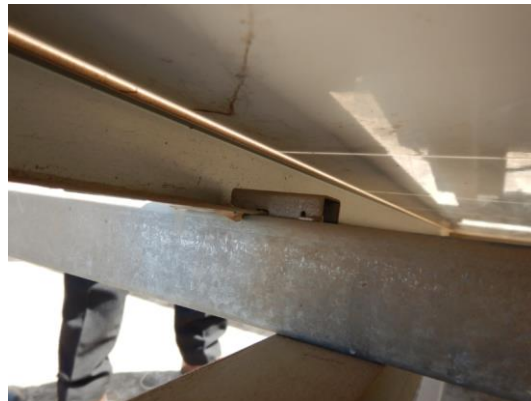
Figure 133: Clamps (easy to install/difficult to replace)

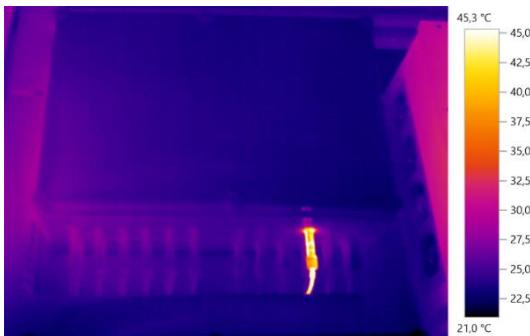
Figure 134: Warm string cable in the inverter input

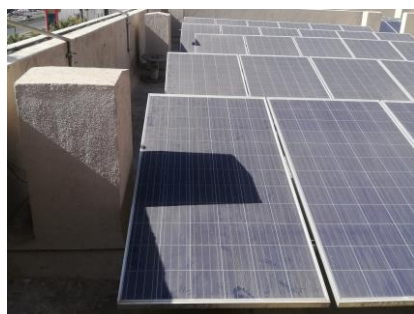
Figure 138: Shading on module

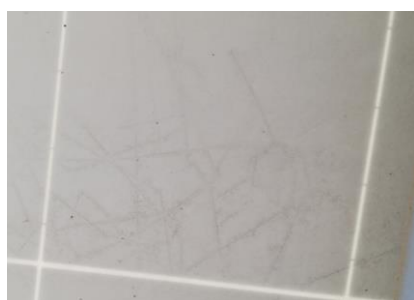
- The complicated clamping system makes maintenance of the modules almost impossible.
- The back sheet shows signs of aging in the form of cracks.

Figure 139: Cracks in the back sheet
