Evaluation of Underperforming Rooftop PV Plants in India – Moving from kW to kWh

Part IV: Evaluation of 10 Rooftop PV Plants in Surat

Report Number: 201802070_IV_v1
Berlin, 24.06.2019

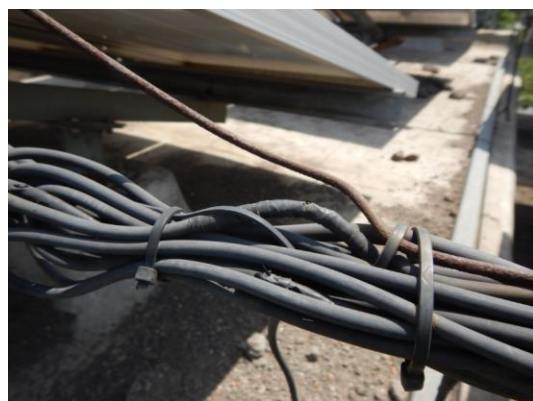
Figure 19: Cable management (damaged/bending)

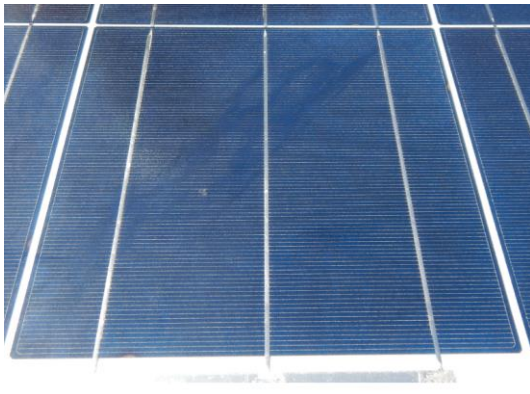
Figure 20: Snail trails (microcracks)

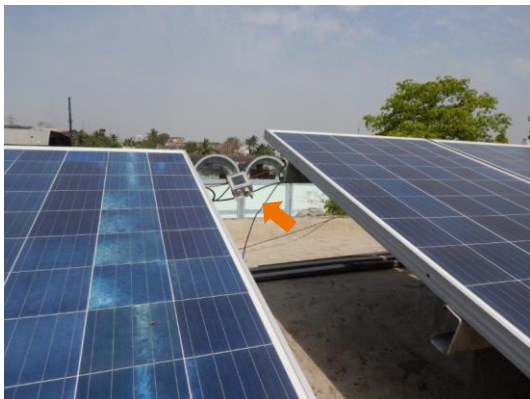
Figure 22: Improper installation of reference Si-sensor

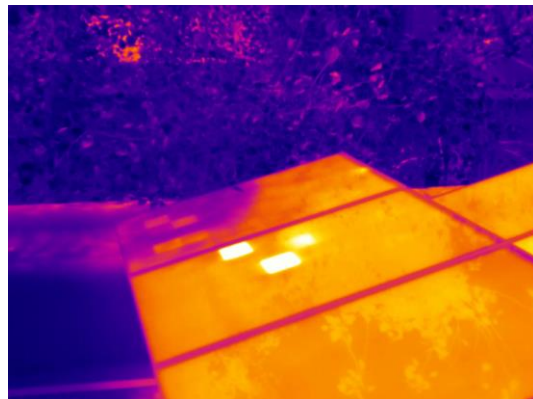
Figure 23: Near shadings from surrounding trees (IR)

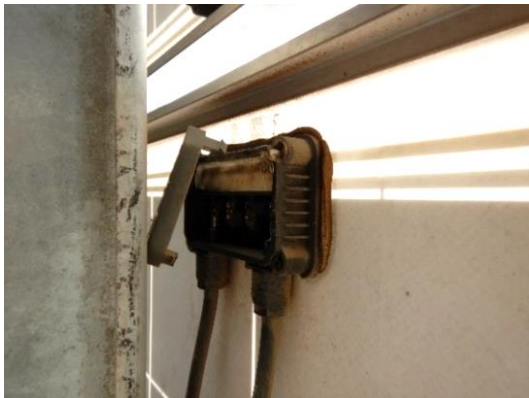
Figure 33: Broken J-Box lid

- Modules with any defect on the J-box should be immediate replaced (safety, operation and reliability issues).
- The simulation of the system showed a shading loss of 6.9%.

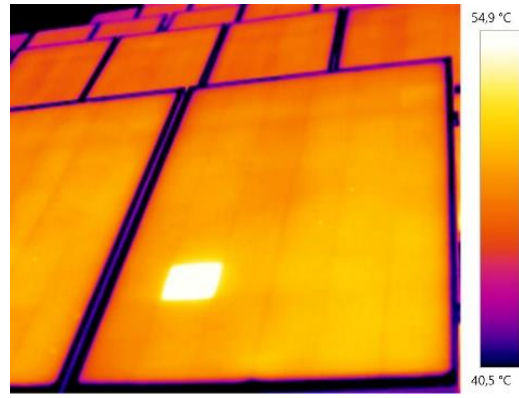
Figure 34: Module with warm cells

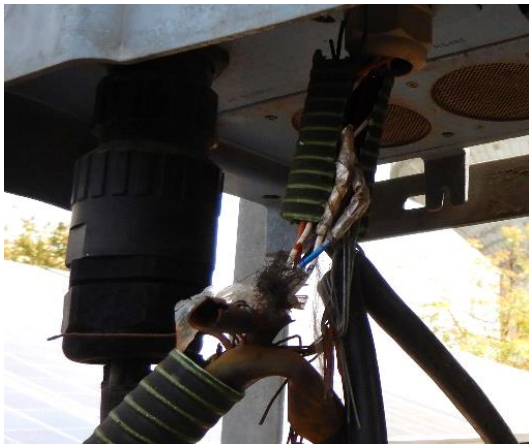
Figure 35: Broken sensor wiring

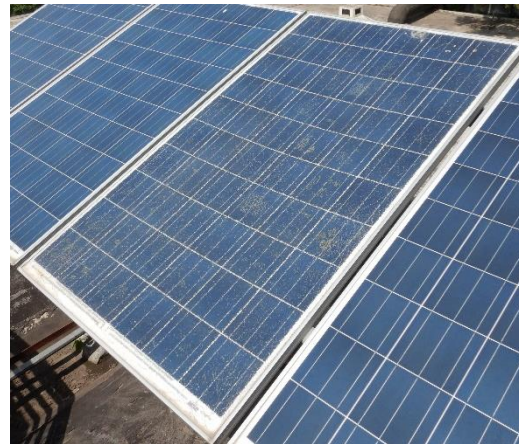
Figure 36: Broken modules

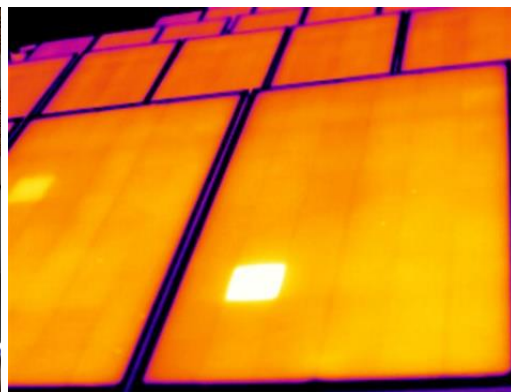
Figure 49: Hot spot

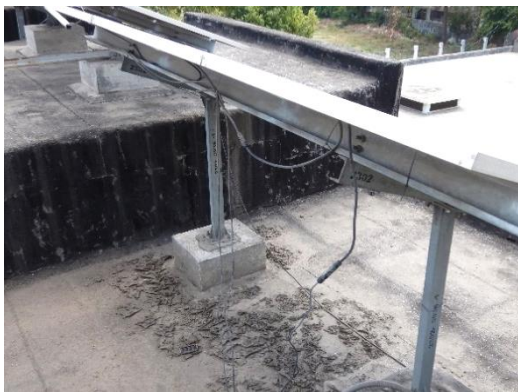
Figure 50: Loose hanging cables

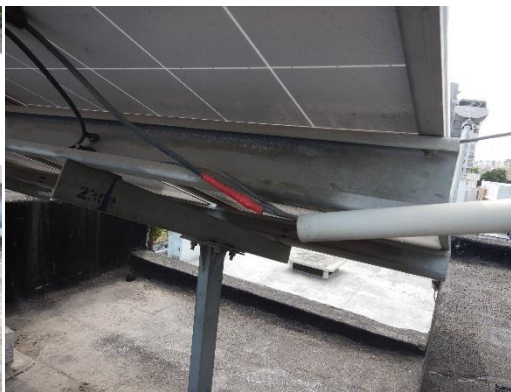
Figure 51: Cables connected with duct tape

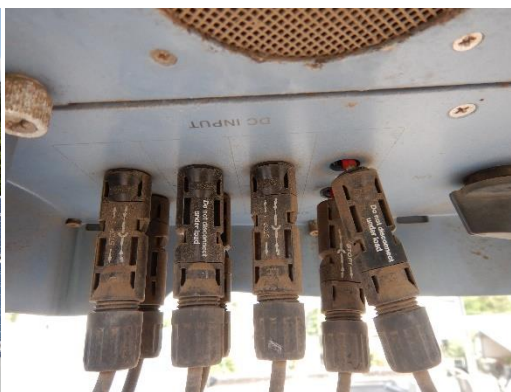
Figure 53: Broken MC connector

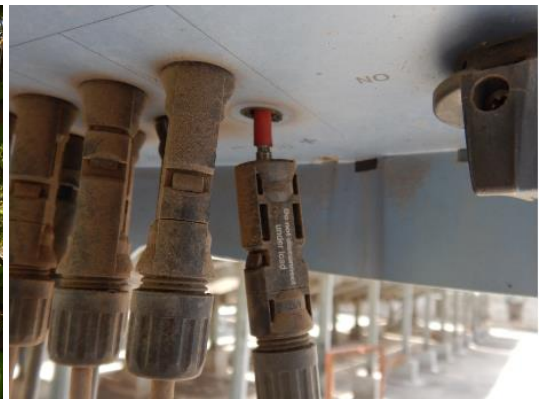
Figure 63: Loose connectors in the inverter inputs

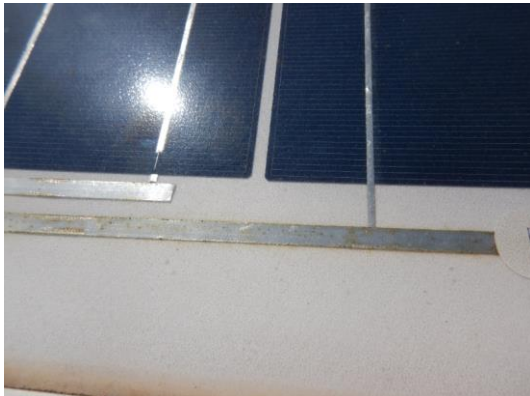
Figure 64: Corrosion in the busbars (lower edge)

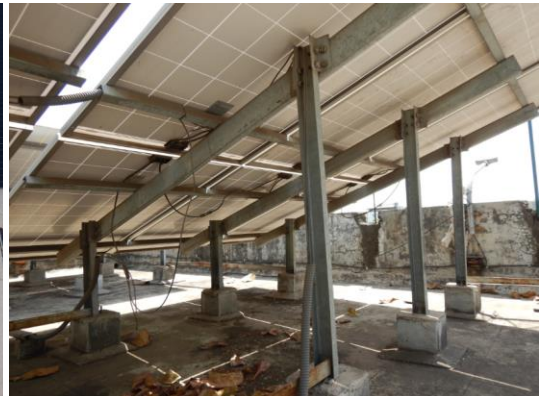
Figure 65: Cables in contact with sharp edges

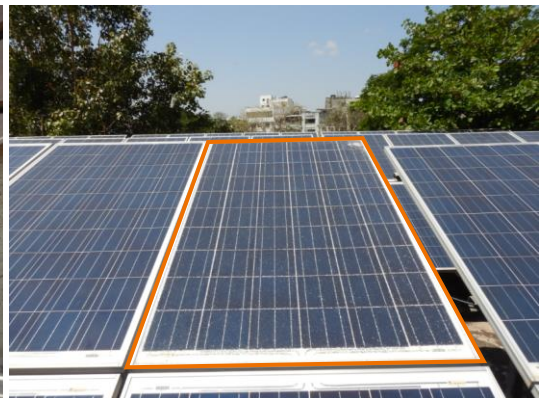
Figure 67: String with a module with broken glass

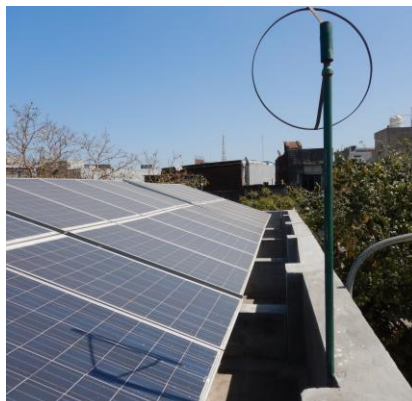
Figure 71: Shading through antenna

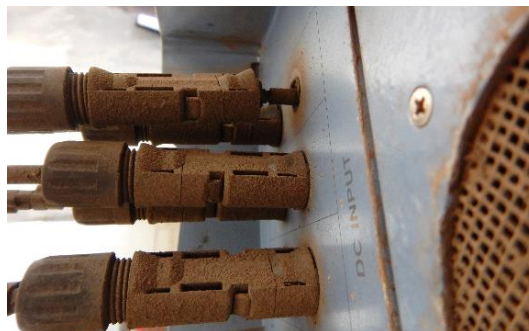
Figure 78: Broken connectors on inverter

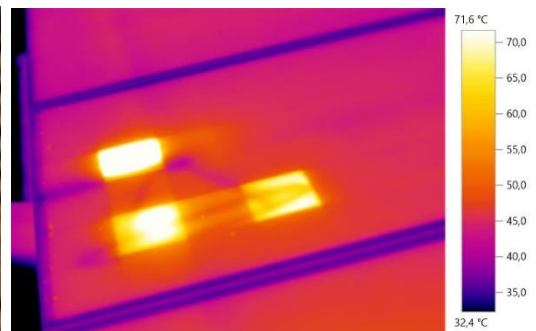
Figure 79: Hot spot caused by shading from antenna

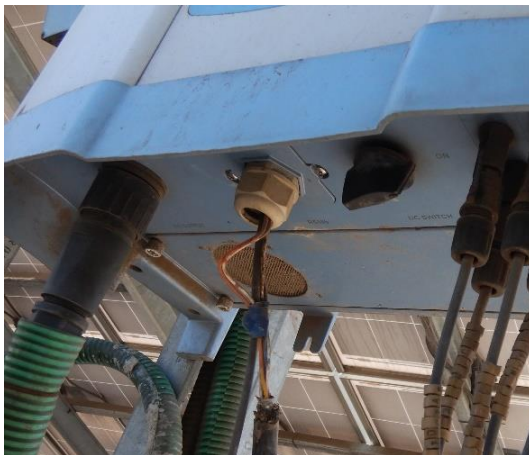
Figure 80: Broken sensor wiring

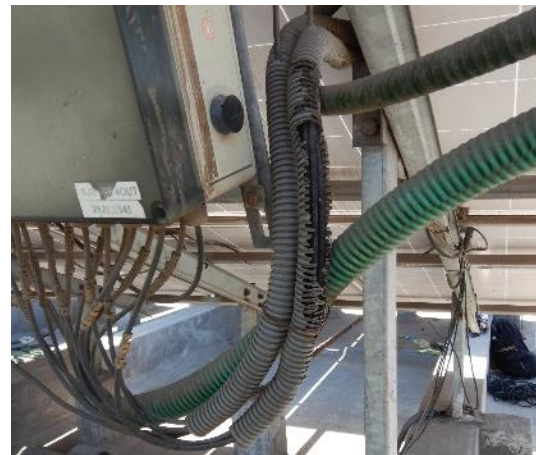
Figure 81: Broken cable duct

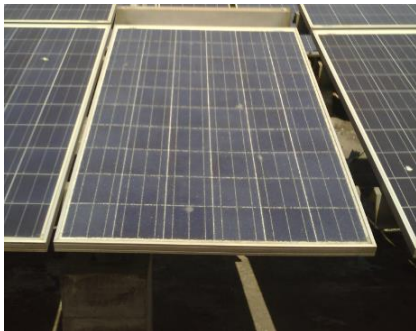
Figure 84: String with module with broken glass

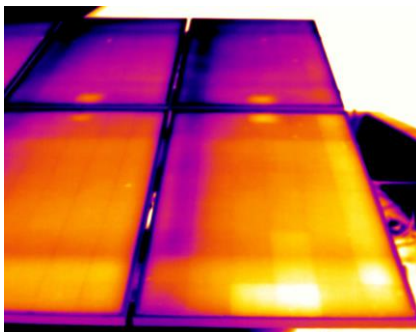
- The inverter fan filters (outlets) are partially blocked, leading to a higher risk of inverter shut down.
- PID presence was discovered via on-site IV curve and thermographic inspection.

Figure 85: PID affected modules

- Anti-PID measures shall be implemented in order to stop and reverse the degradation. PV modules (without PID), showing power drops above the warranty conditions shall be replaced. If the replacement is not possible, the modules shall be regrouped in power classes within the same string and assigned to individual MPPT.
- Damaged modules by wind loads and broken glass shall be replaced and properly installed.
- Module product defects (corrosion in busbars, defective labels) shall be monitored, whether the degradation continues or it has stabilized.

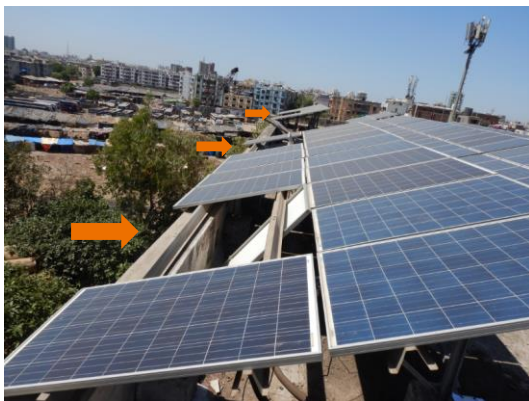
Figure 91: Strings in open circuit (broken modules)

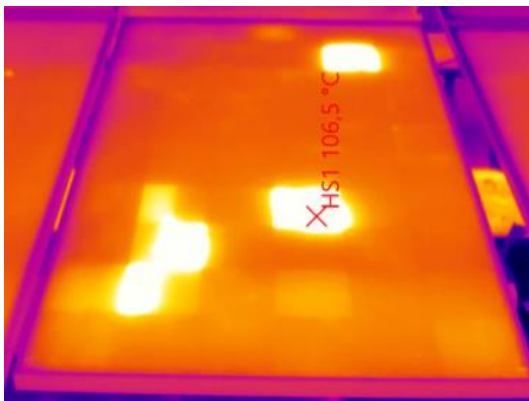
Figure 93: String with module with broken glass

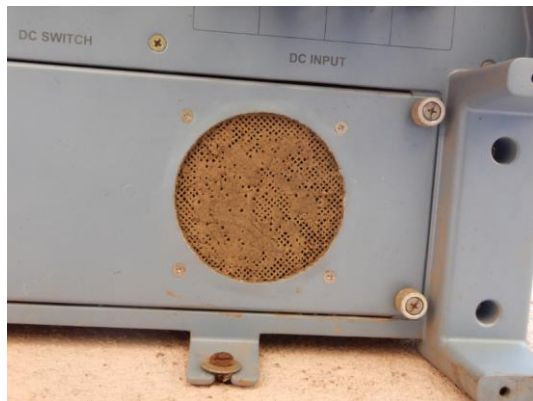
Figure 94: Inverter fan filters (outlet) partially blocked

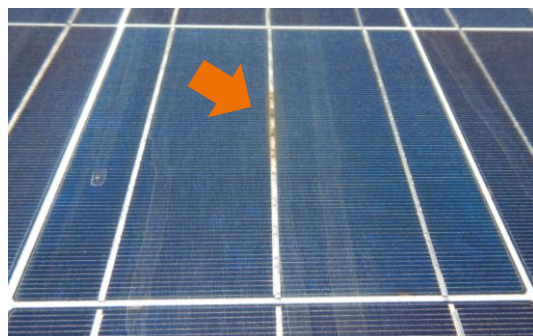
Figure 96: Modules with busbar corrosion

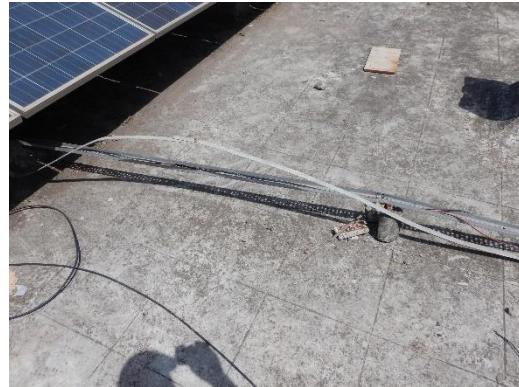
Figure 105: Open and broken cable ducts

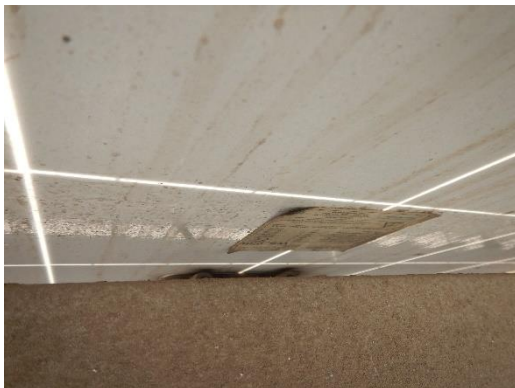
Figure 106: Module label issues

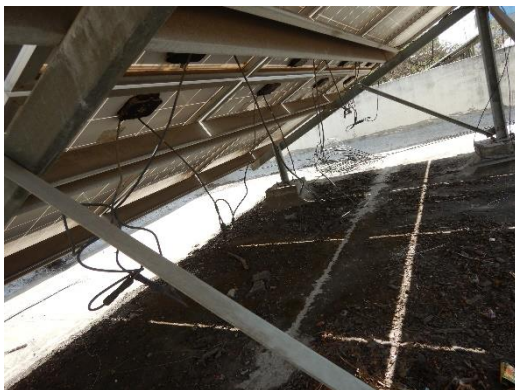
Figure 108: Loose hanging cables

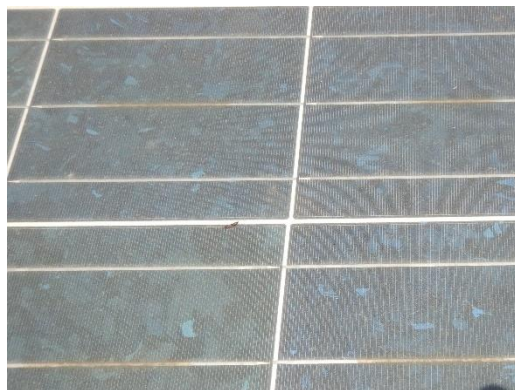
Figure 109: Corrosion in bus bars

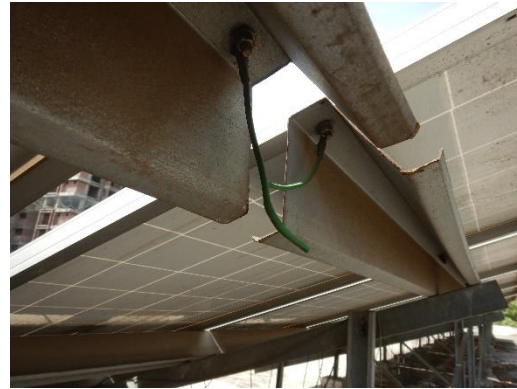
Figure 120: Broken ground wire

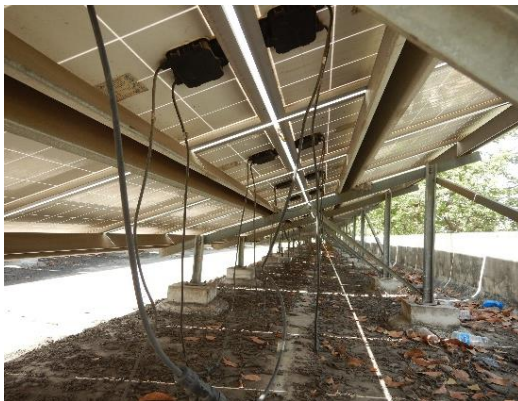
Figure 121: Loose/hanging cables

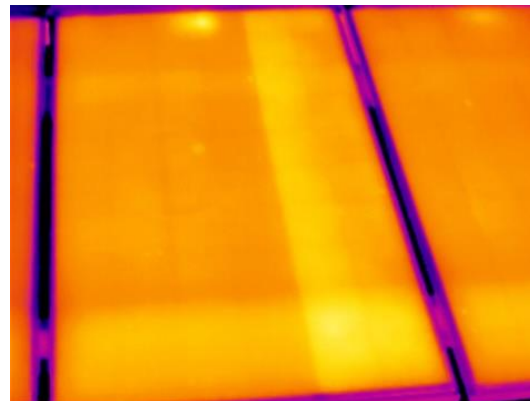
Figure 122: Active diode

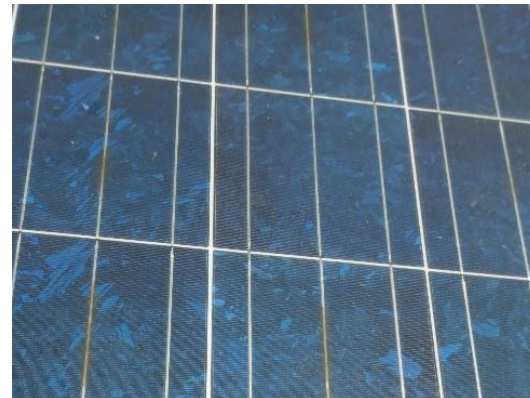
Figure 124: Broken and burned cells

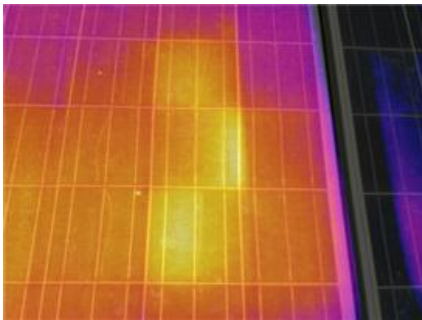
- The system displays poor cable management, e.g., loose connectors, cables in contact with sharp edges and loose DC cables behind the modules.
- Through IR inspection, hotspots induced by soiling, near shading and cracks were detected.

Figure 127: High temperature cracks (IR)

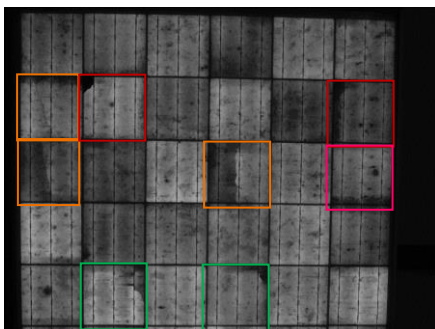
- Electroluminescence imaging revealed an important variety of cell cracks.

Figure 128: Module with multiple cracks

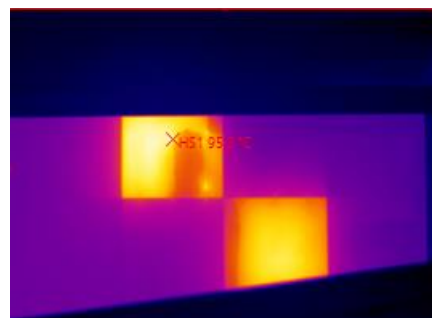
Figure 130: Module with hotspots

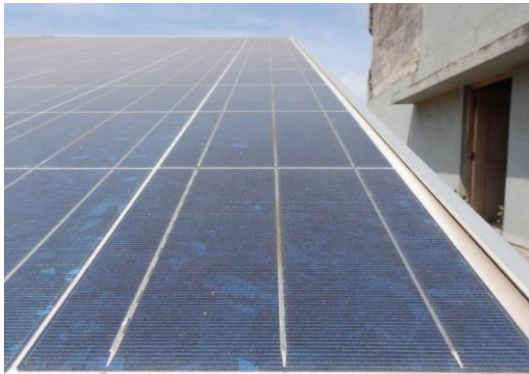
Figure 135: Modules with busbar corrosion

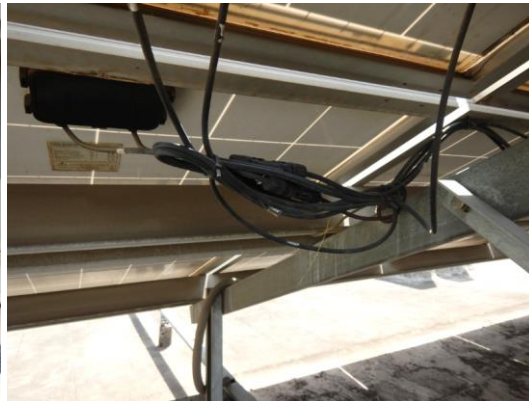
Figure 136: DC cabling management

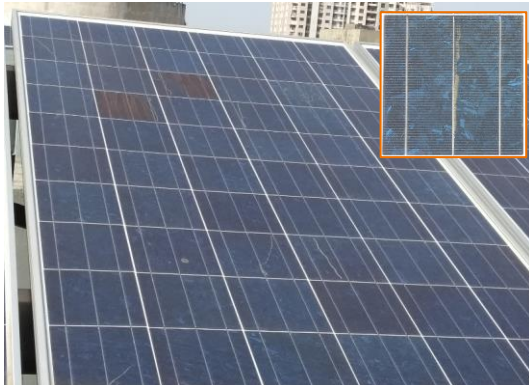
Figure 137: Advanced degradation cracks & hotspots

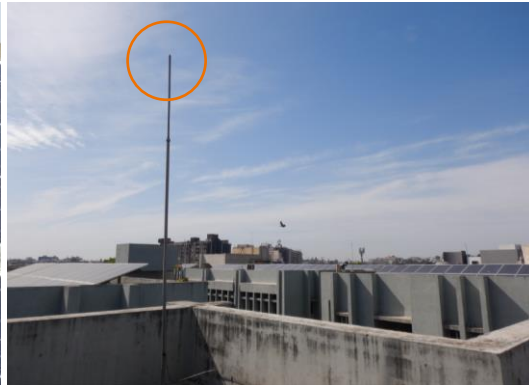
Figure 138: Lightning arrester without spikes

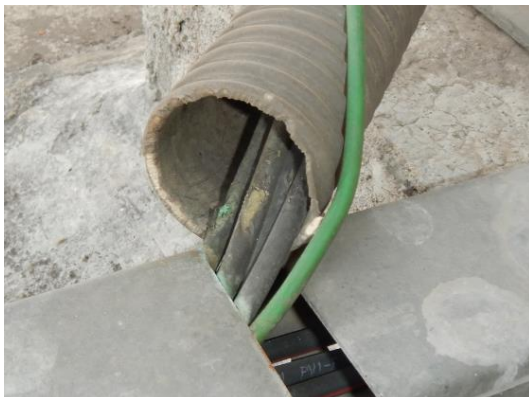
Figure 139: Cables damaged by sharp edges

- Damaged cables shall be replaced and those in contact with sharp edges shall be protected.
- The inverter configuration (i.e., "waiting for sun") shall be validated to eliminate the possibility of an internal failure. This issue shall be only related to "DC voltage not sufficient to allow for connection to the main network".

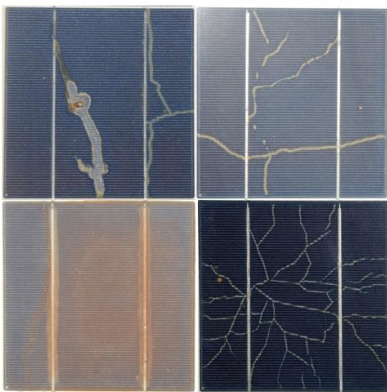
Figure 141: Examples of "cracks" found

- Due to the difficult access to the roof, it is likely that the modules suffered mechanical stress during transport, handling and installation. The resulting microcracks are one of the sources of the snail trail effect in the modules.

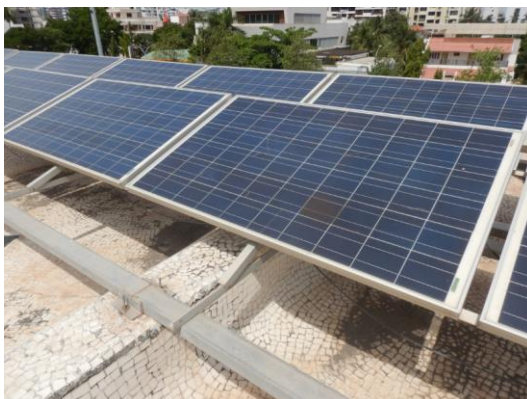
Figure 150: Advanced cell degradation (temperature)

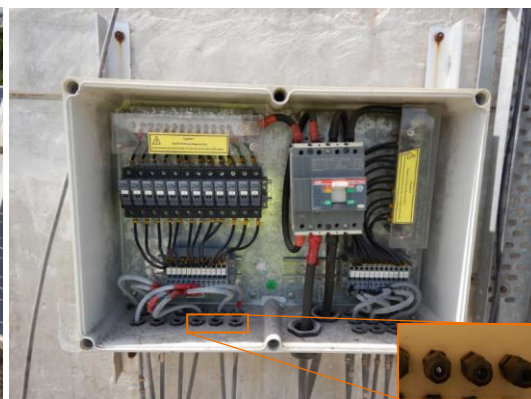
Figure 151: Combiner box with open glands
