Evaluation of Underperforming Rooftop PV Plants in India – Moving from kW to kWh Part II

Phase I: Evaluation of 65 Rooftop PV Plants in India
(Jammu, Uttar Pradesh, Gujarat, Maharashtra, West
Bengal, Himachal Pradesh, Punjab and Kerala)

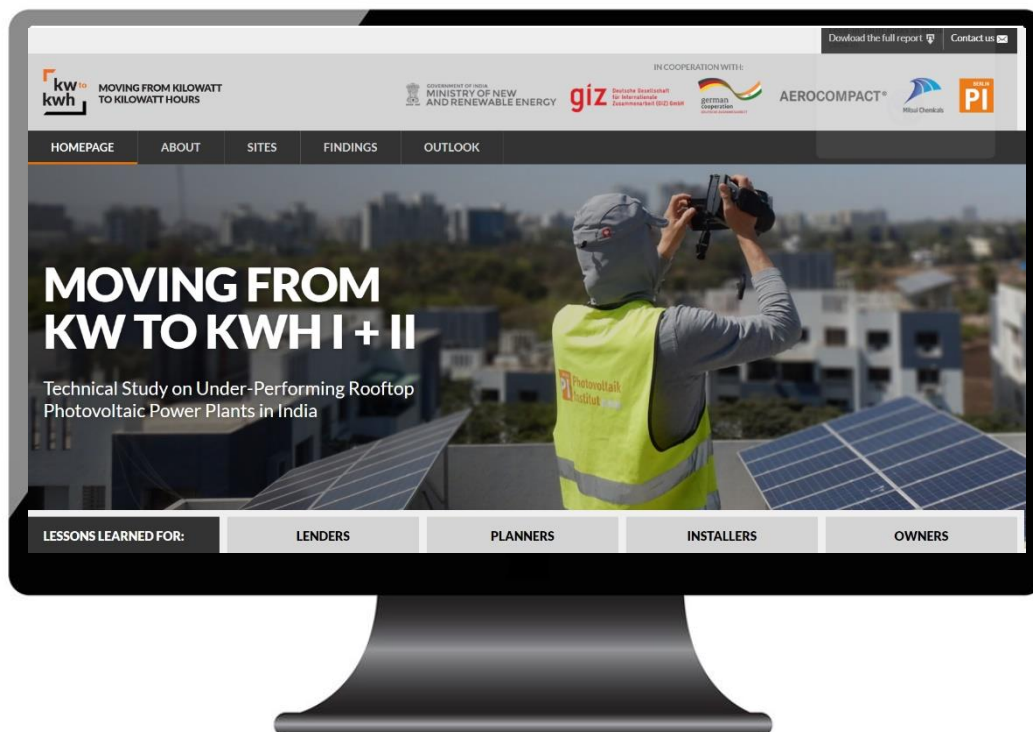
5. List of the Selected Sites

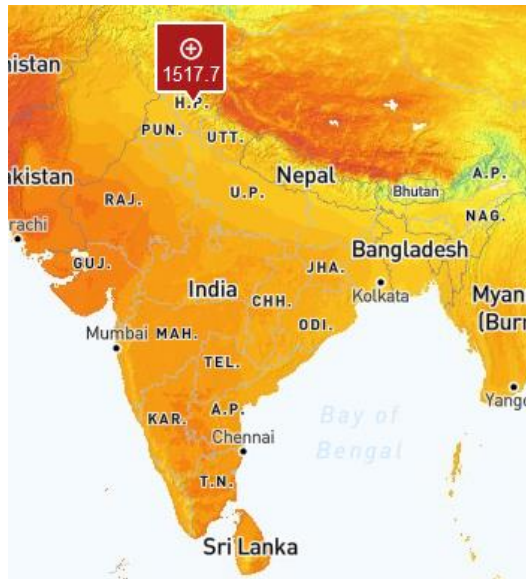
Figure 8: Global horizontal irradiation map of Himachal Pradesh. GHI: 1518kWh/m². Specific yield PVout 1504kWh/kWp [source: SolarGIS]

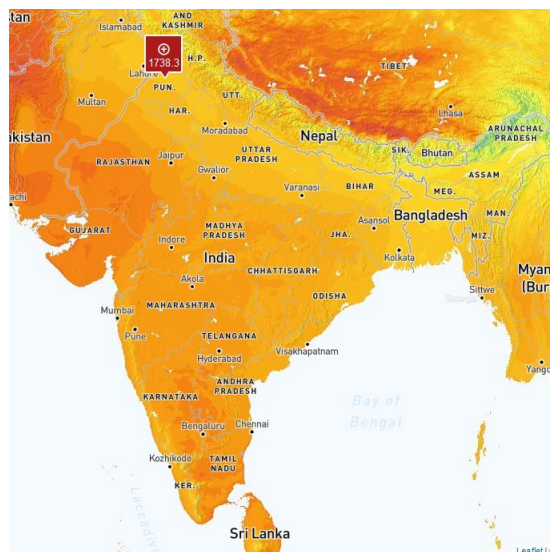
Figure 9: Global horizontal irradiation map of Punjab. GHI: 1738kWh/m². Specific yield PVout 1507kWh/kWp [source: SolarGIS]

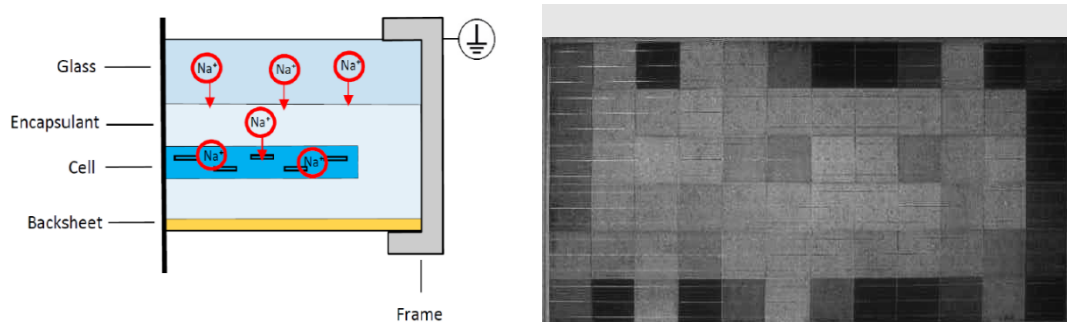
Figure 11: p-n junction damage (left) and typical PID pattern (right) [source: PI Berlin]

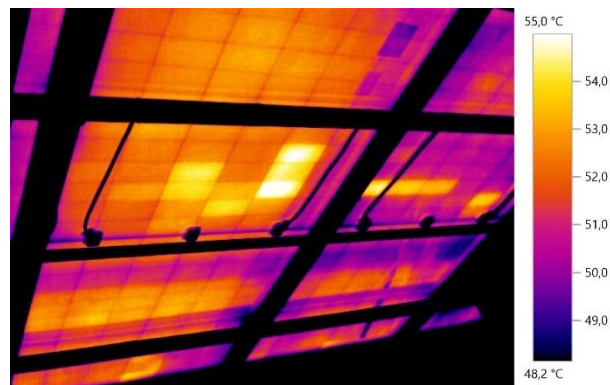
Figure 12: p-n junction damage (left) and typical PID pattern (right) [source: PI Berlin]

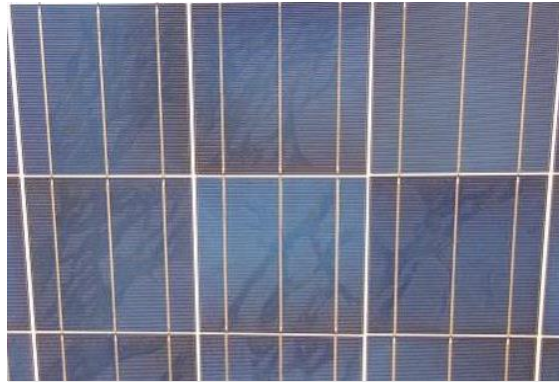
Figure 13: PV module showing snail trails [source: PI Berlin]

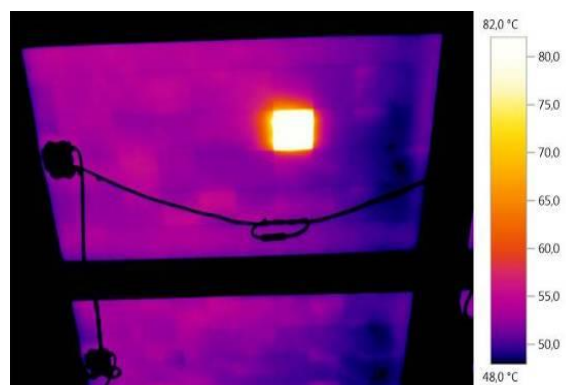
Figure 14: PV Module affected by a hot spot [source: PI Berlin],

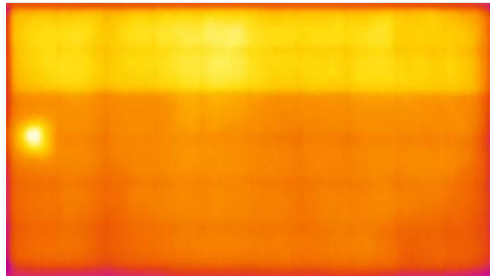
Figure 15: PV Module with an inactive cell string [source: PI Berlin]

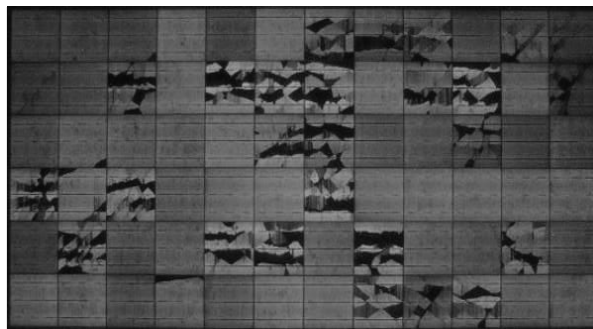
Figure 16: PV Module showing cracks and microcracks [source: PI Berlin]

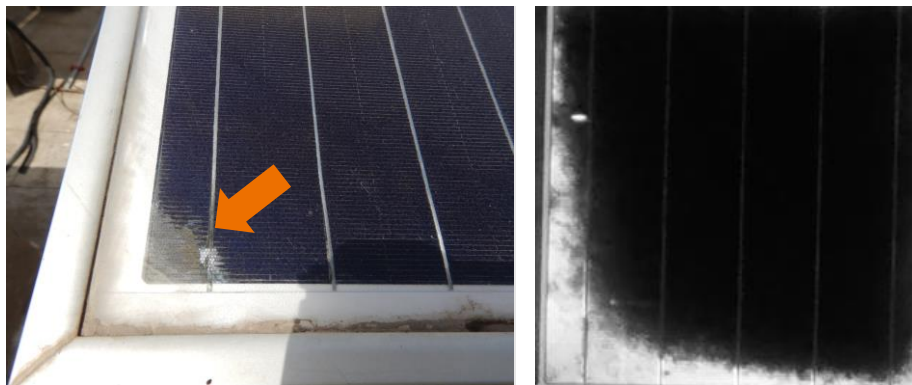
Figure 17: PV Module showing delamination. Left, VI, right, EL [source: PI Berlin]

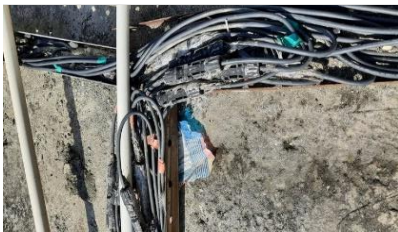
Figure 19: Poor cable layout and labeling.

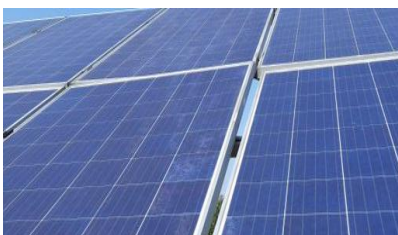
Figure 20: Clamps missing.

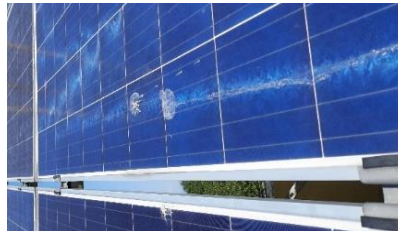
Figure 21: Soiling – bird droppings.

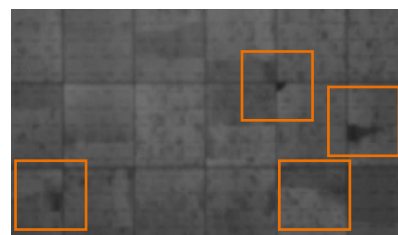
Figure 22: EL-Image with multiple cracks

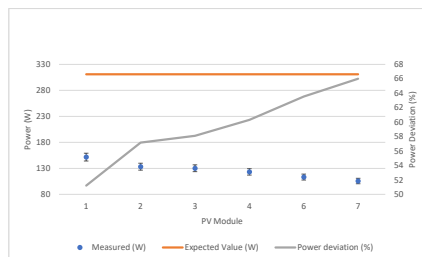
Figure 23: IV curve measurements

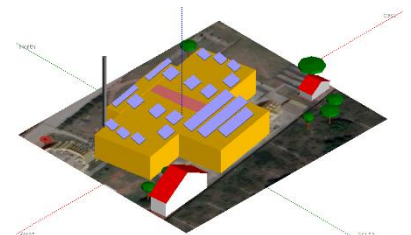
Figure 24: 3D model constructed in PVsyst.

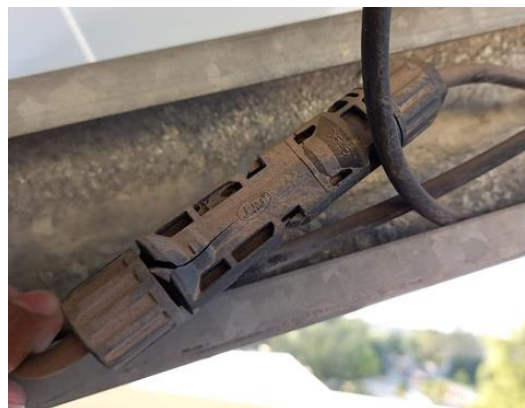
Figure 28: Broken MC4 connectors.

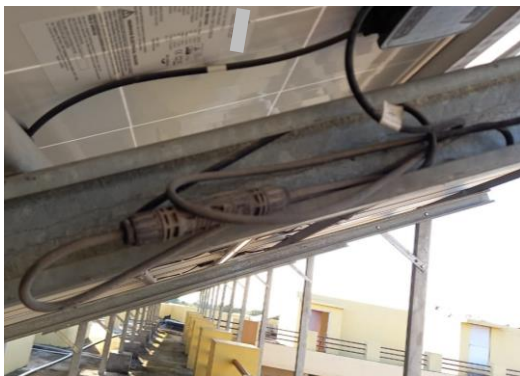
Figure 29: Poor cable management.

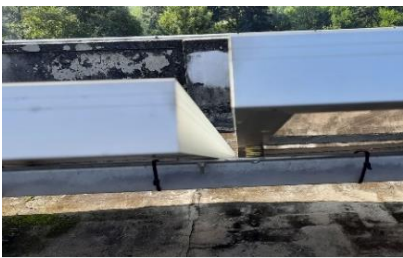
Figure 31: Modules with misalignment EW

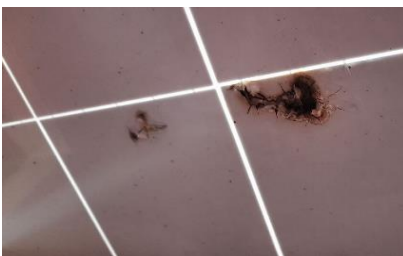
Figure 32: Damaged module, Hotspots

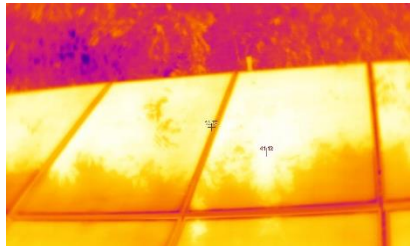
Figure 33: Shading caused by trees in the surroundings.

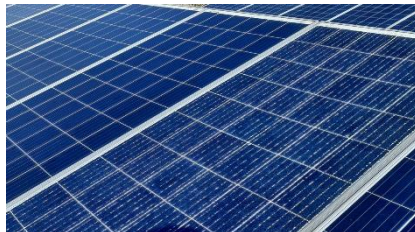
Figure 34: Module with broken glass

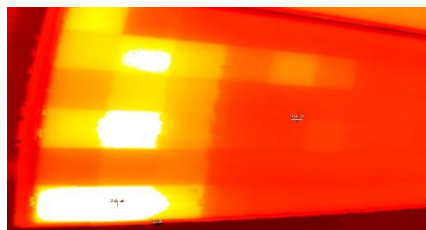
Figure 35: Cells with inhomogeneous temperatures, potential PID effect

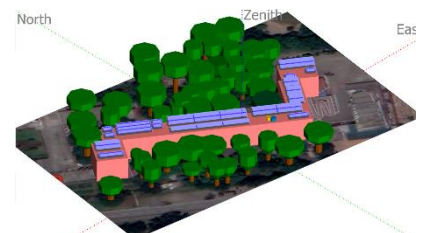
Figure 36: 3D modeling in PVsyst.

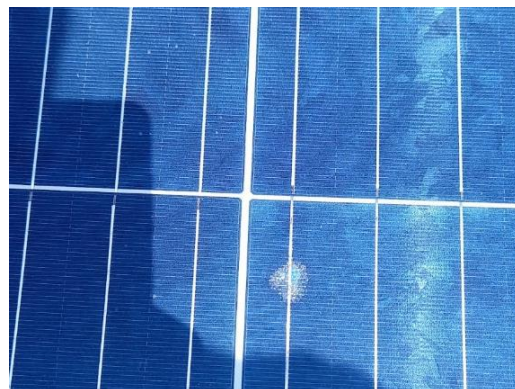
Figure 41: Corrosion in busbars.

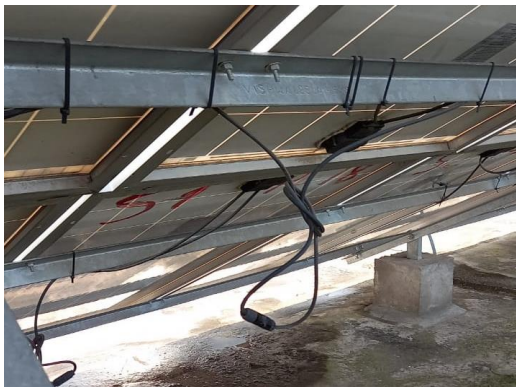
Figure 42: Poor cable management.

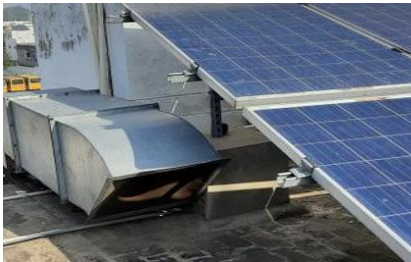
Figure 46: Exhaust ventilation under modules.

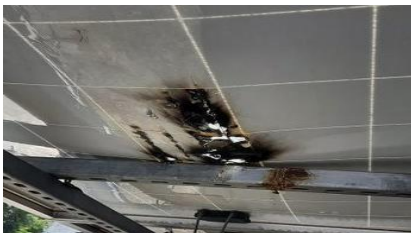
Figure 47: Burned module

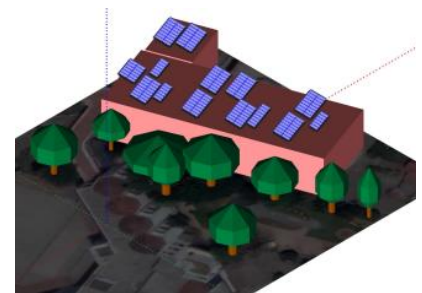
Figure 51: 3D model constructed in PVsyst.

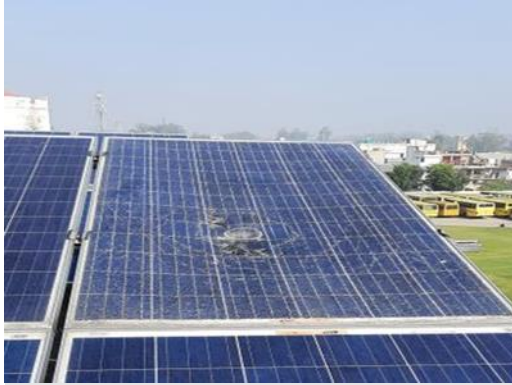
Figure 52: Broken module due to mechanical impact.

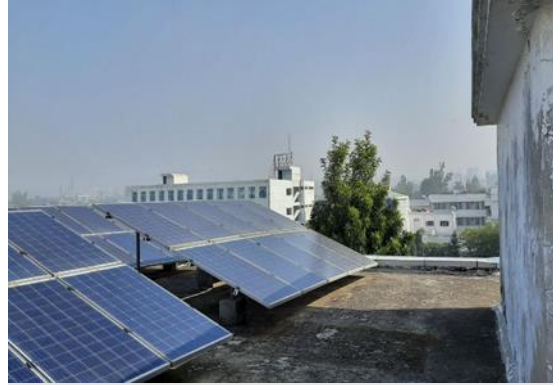
Figure 53: Shading from nearby building.

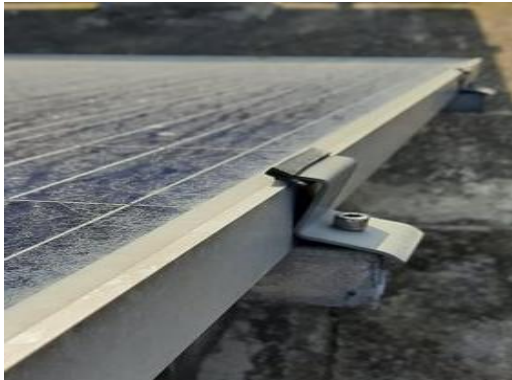
Figure 56: Bent and loose clamps.

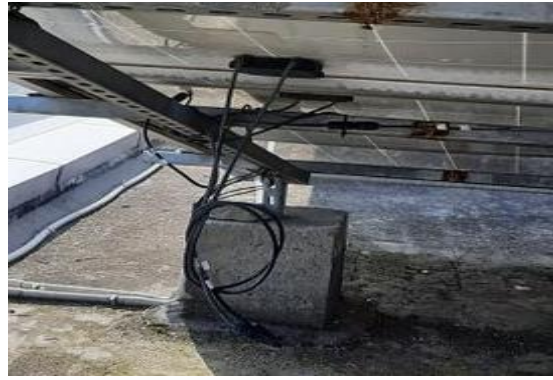
Figure 57: Missing cable fixation.

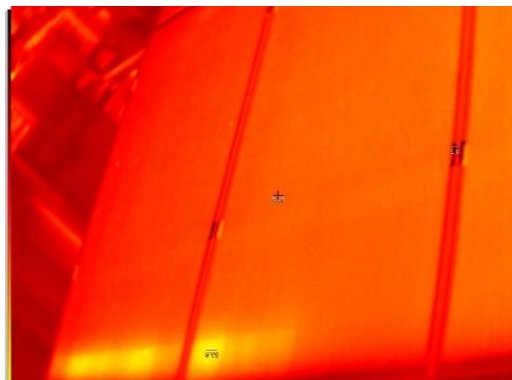
Figure 58: Soiling effect on lower edge (IR).

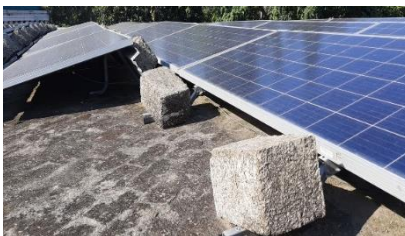
Figure 60: Poor mounting system.

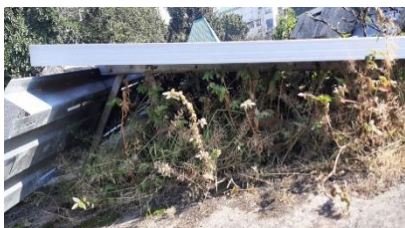
Figure 61: Poor vegetation management.

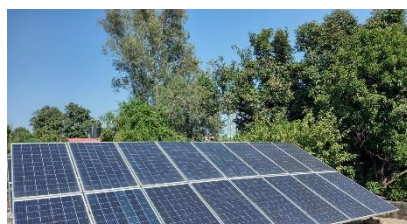
Figure 79: System surrounded by trees.

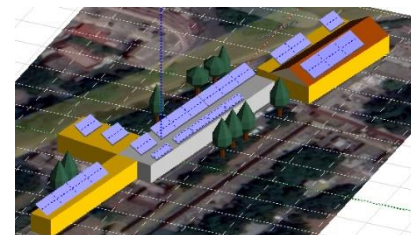
Figure 81: 3D Model created with PVsyst.

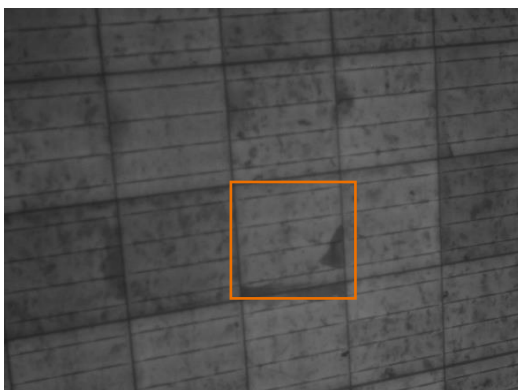
Figure 88: Module with micro-cracks.

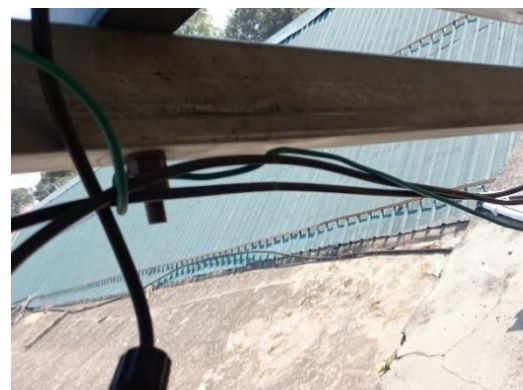
Figure 89: Poor cable management.

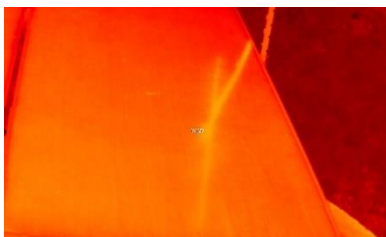
Figure 91: Hot spots due to module shading.

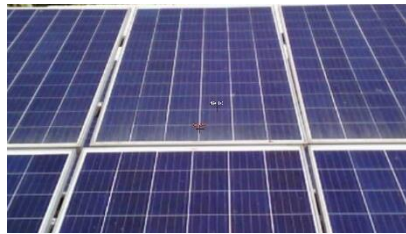
Figure 92: Soiling deposition on module.

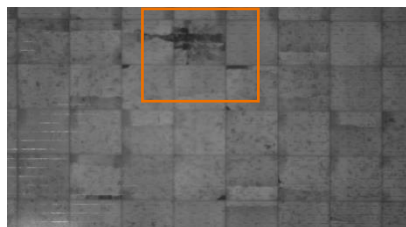
Figure 93: multi-cracks identified during EL imaging.

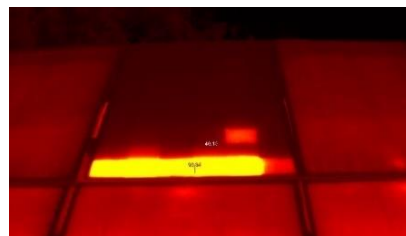
Figure 94: warm cells due to soiling.

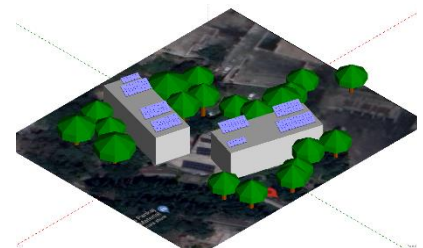
Figure 95: 3D model constructed in PVsyst.

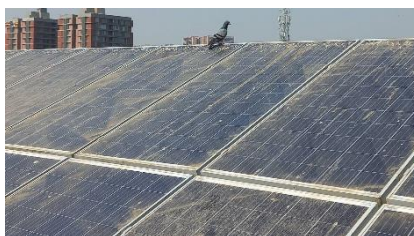
Figure 105: Heavy soiling - Bird droppings

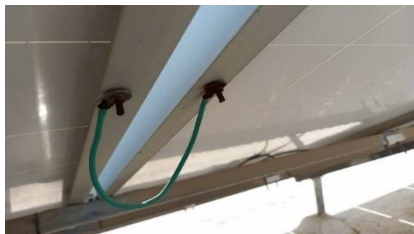
Figure 106: Corroded PEB grounding between modules.

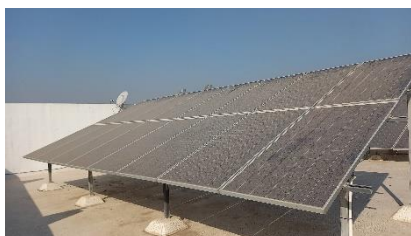
Figure 108: Modules heavily soiled.

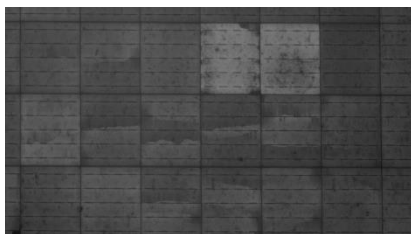
Figure 109: Broken cells discovered via EL imaging.

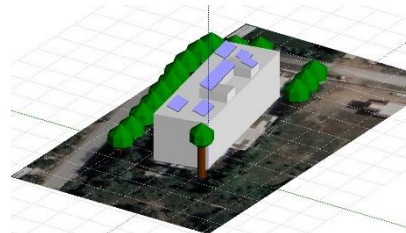
Figure 110: 3D model constructed in PVsyst.

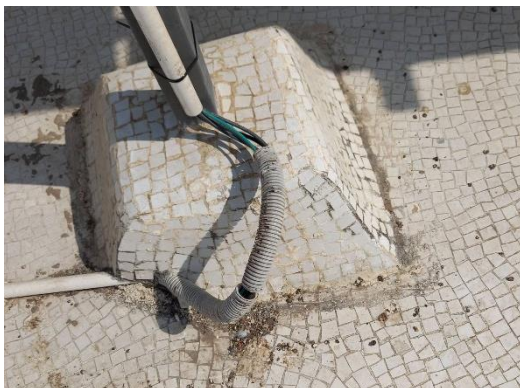
Figure 116: cable ducting damaged.

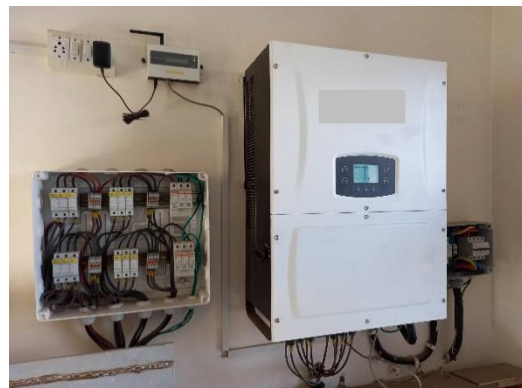
Figure 117: Inverter and AC board.

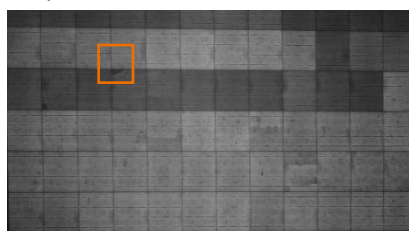
Figure 123: Isolated cell parts.

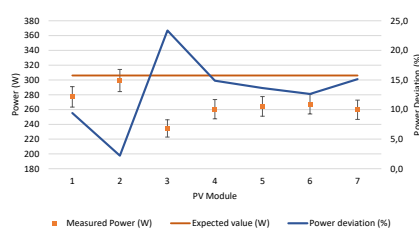
Figure 124: IV curve measurement results

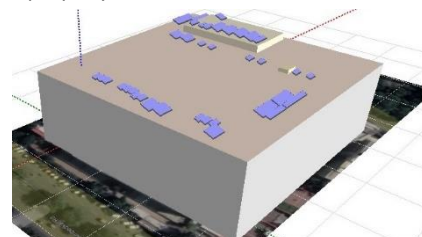
Figure 126: 3D Model created with PVsyst.

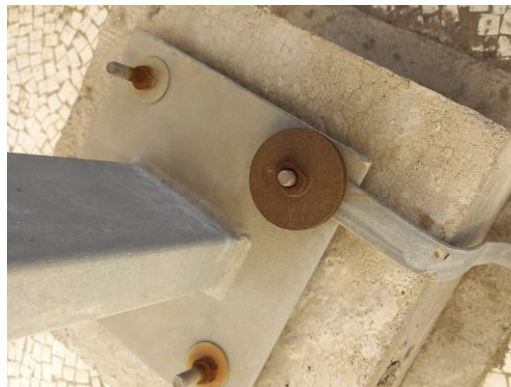
Figure 128: Rusted fastener for PEB and foundations.

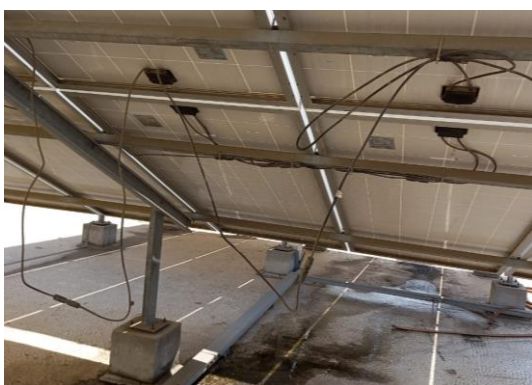
Figure 129: Poor cable management.

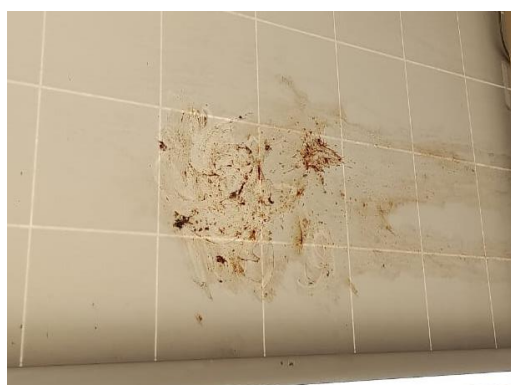
Figure 130: Dirty module from mechanical damage.

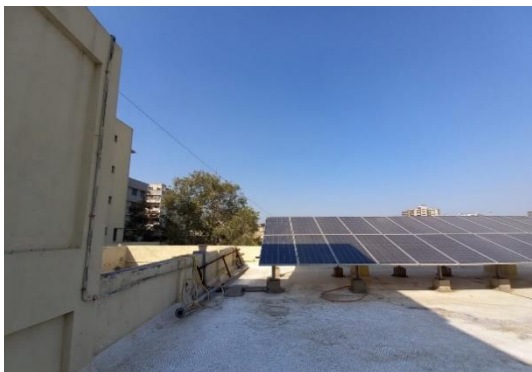
Figure 131: Module shading by near objects.

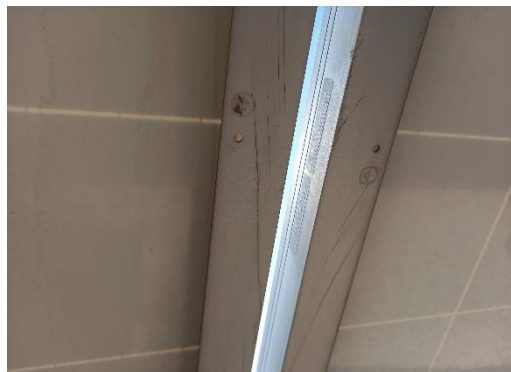
Figure 132: Missing PEB grounding between modules.

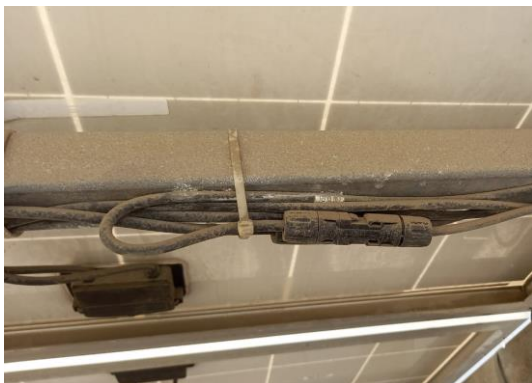
Figure 133: Minimum bending radius not considered.

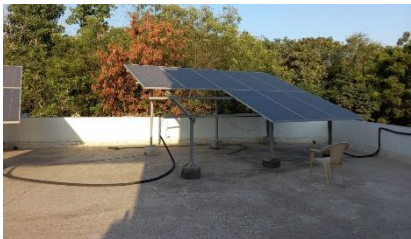
Figure 135: Near Shading.

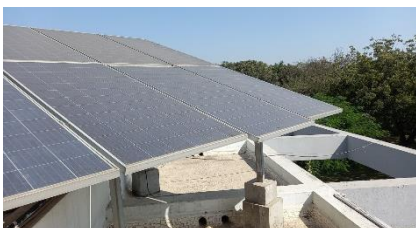
Figure 137: Poor module fixation (loose module).

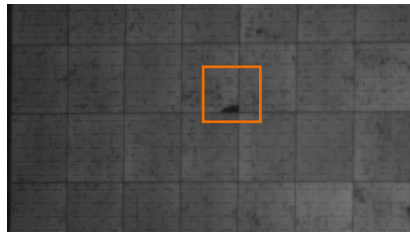
Figure 138: cell with isolated parts.

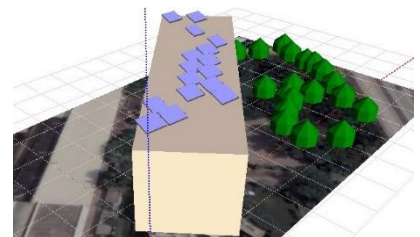
Figure 141: 3D Model created with PVsyst.

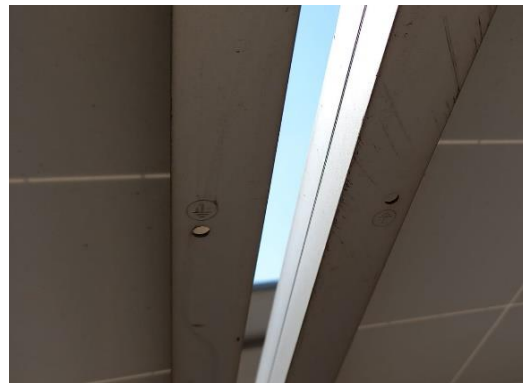
Figure 145: Missing module PEB grounding.

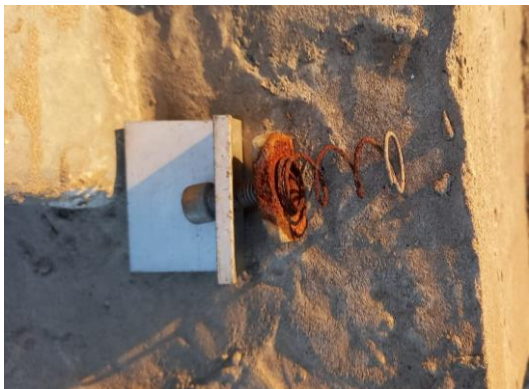
Figure 146: Rusty and fallen module clamp.

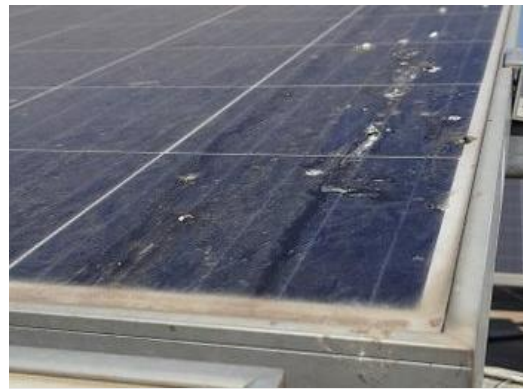
Figure 147: Heavy soiling due to bird drops.

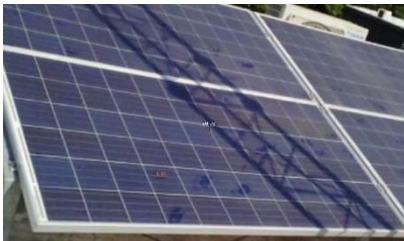
Figure 150: Near Shading

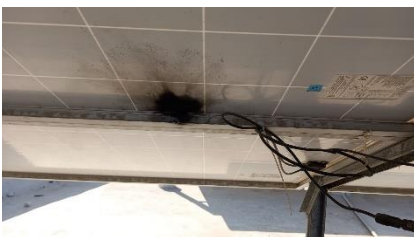
Figure 151: Burned module

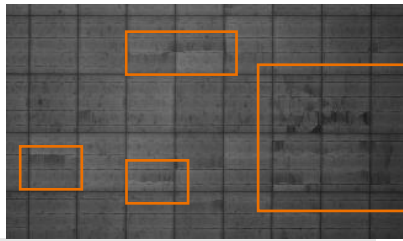
Figure 152: Module with several cracks via EL

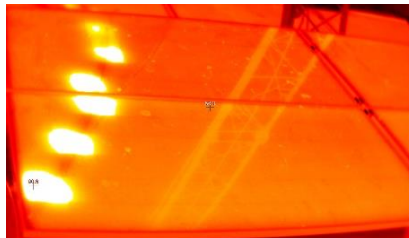
Figure 153: Warm cells due to shading

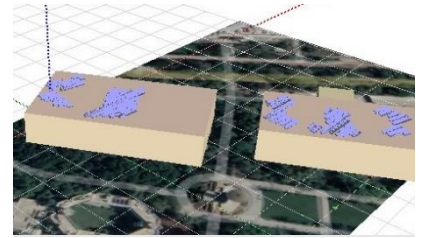
Figure 155: 3D Model created with PVSyst

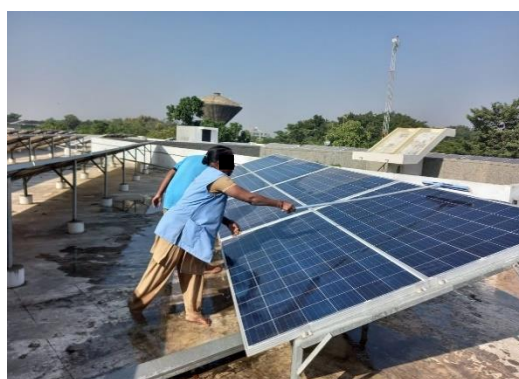
Figure 159: On-site O&M personnel missing PPE

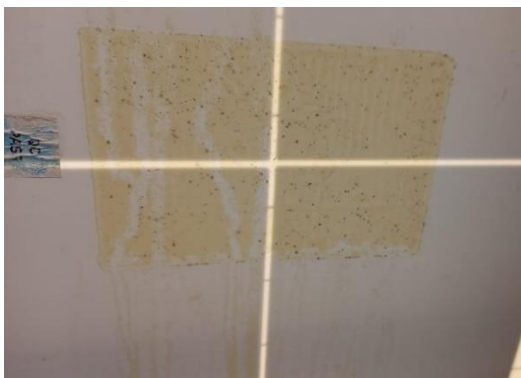
Figure 160: Module missing label

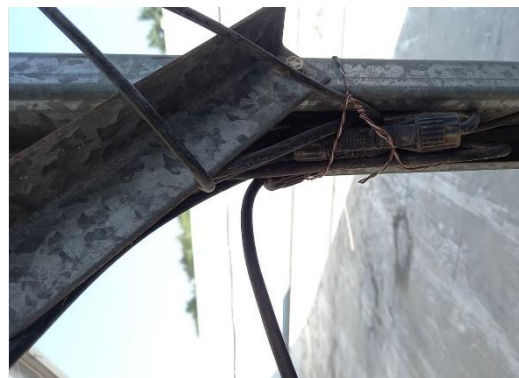
Figure 161: Minimum bending radius disregarded

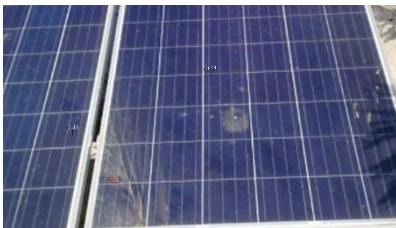
Figure 164: Module with broken glass.

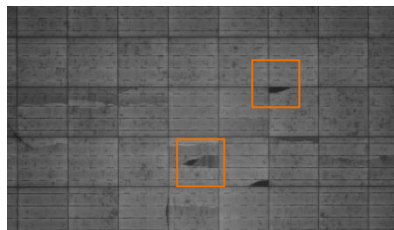
Figure 166: Isolated parts and micro-cracks.

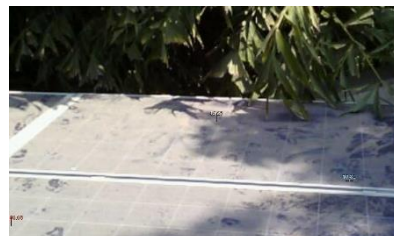
Figure 167: Heavy soiling and shading.

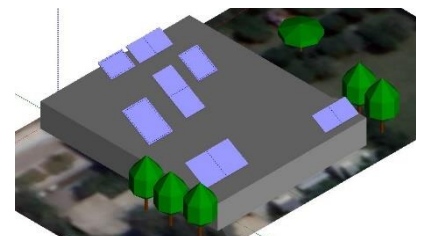
Figure 169: 3D Model created with PVsyst.

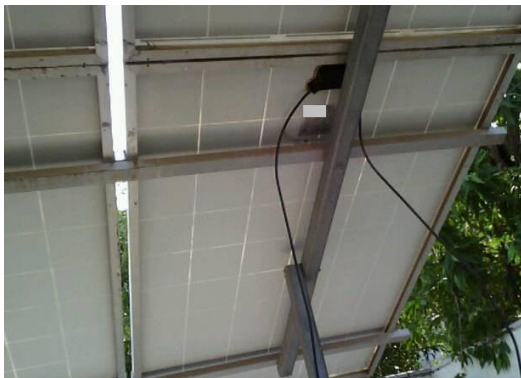
Figure 170: Loose hanging module cables

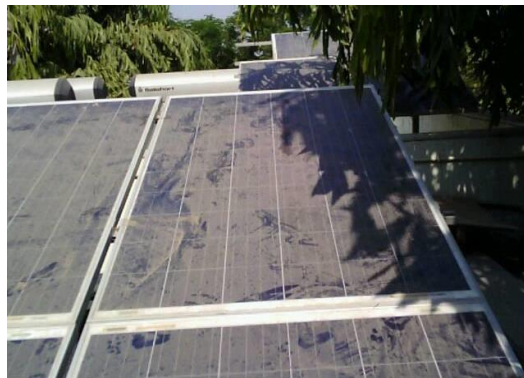
Figure 171: Evidence of walking on the modules

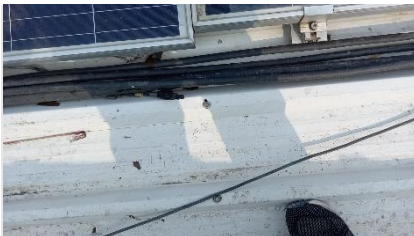
Figure 178: module sub-array disconnected

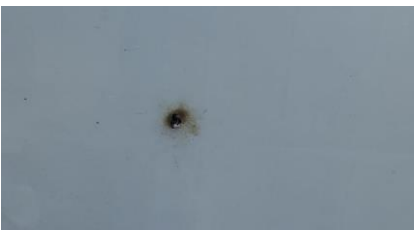
Figure 179: Burn mark on module's backsheet

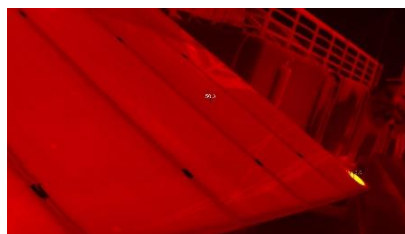
Figure 181: Hot cell due to near shading

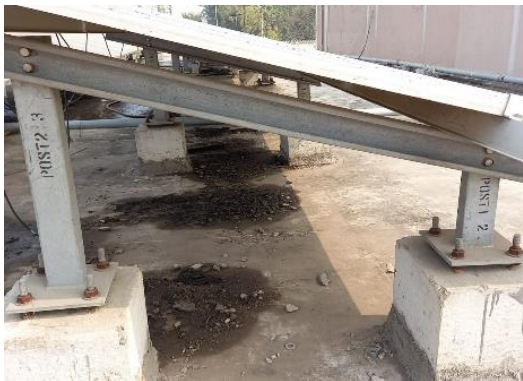
Figure 185: Rusted bolts in mounting structure

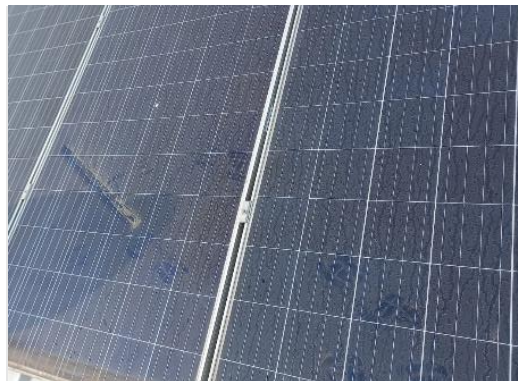
Figure 186: Footprints over module

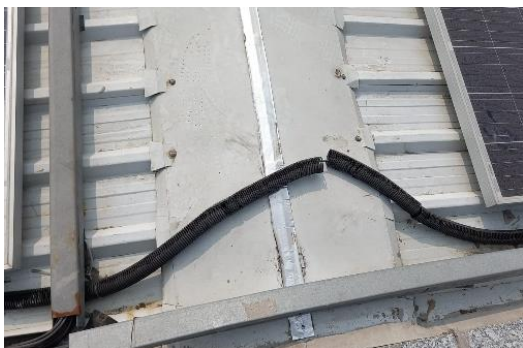
Figure 189: Broken cable ducting

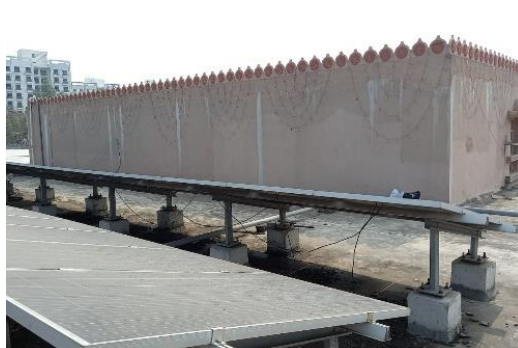
Figure 190: 3-meter wall in front of system (near shading)

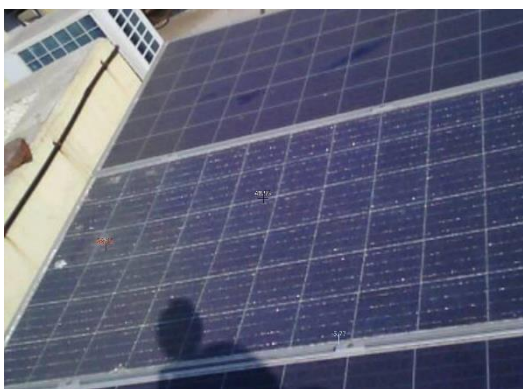
Figure 191: Broken module

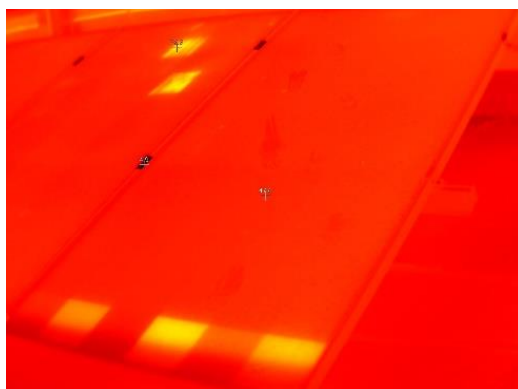
Figure 192: Hot cells developed on modules due to soiling and shadows on system

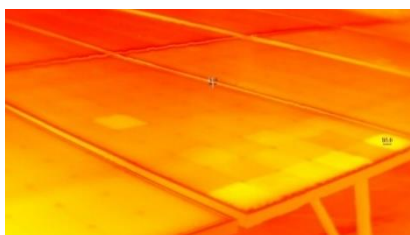
Figure 193: Hot Spots due to soiling.

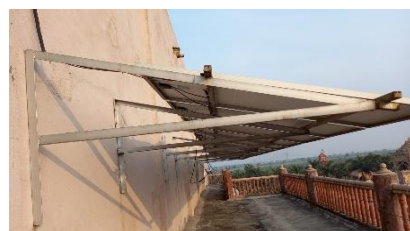
Figure 194: Poor mounting structure installation.

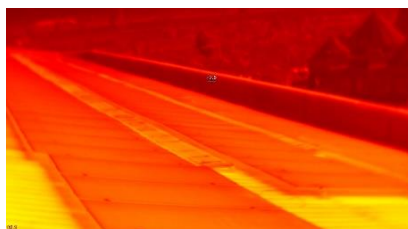
Figure 195: Insufficient module ventilation.

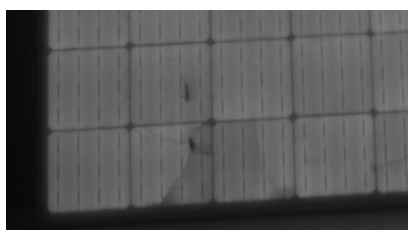
Figure 196: Broken cells via EL.

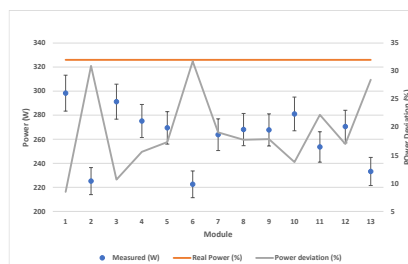
Figure 197: On site power measurement.

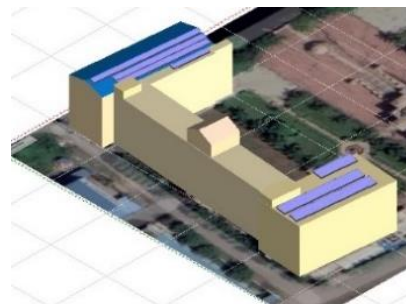
Figure 198: 3D model constructed in PVsyst.

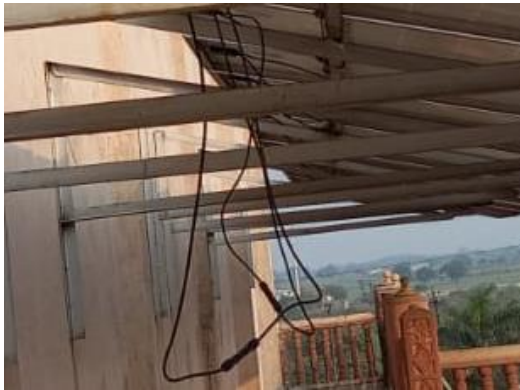
Figure 199: Loose DC cabling

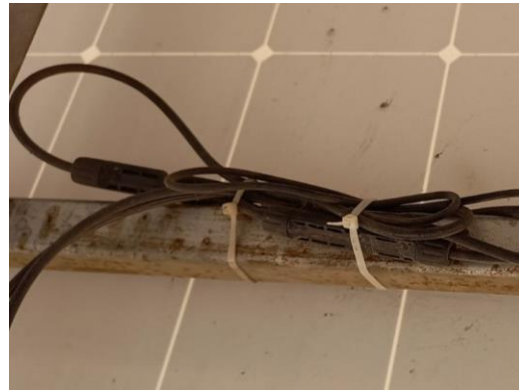
Figure 200: Minimum bending radius disregarded

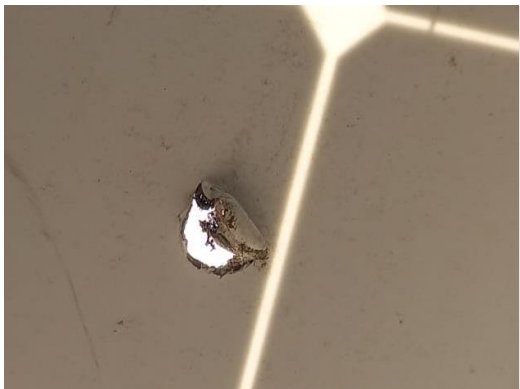
Figure 203: Broken Modules – hot spot.

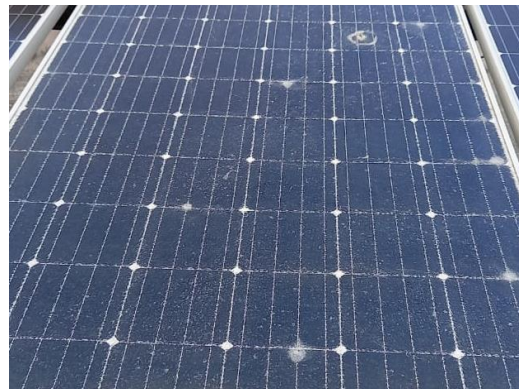
Figure 204: Broken Module.

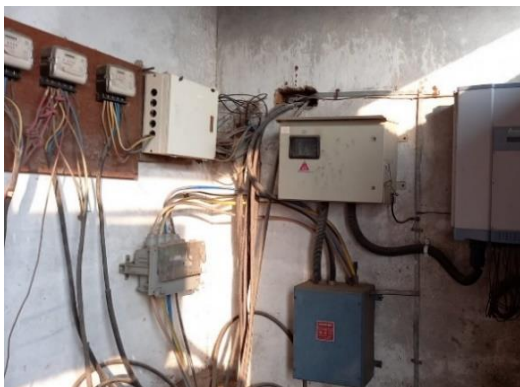
Figure 205: Main AC board overview.

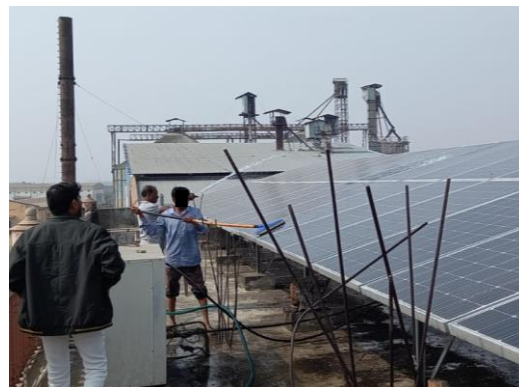
Figure 206: On-site O&M personnel missing PPE.

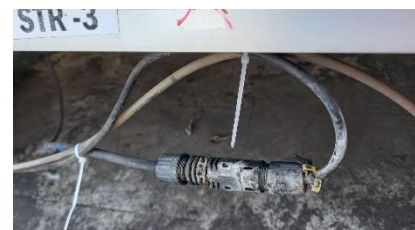
Figure 208: Broken and burned connector

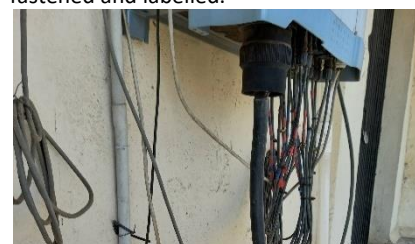
Figure 209: Inverter cabling.

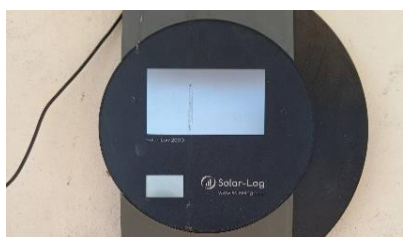
Figure 211: Data logger damaged.

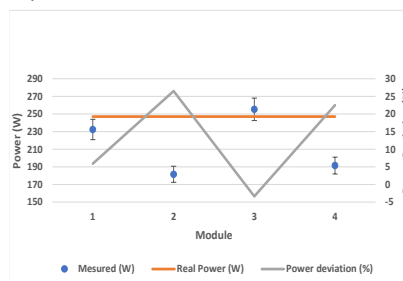
Figure 212: IV curve measurement results.

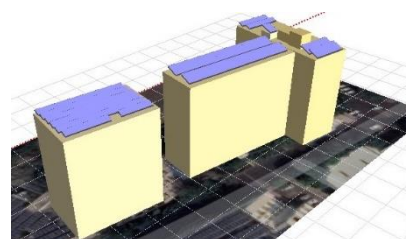
Figure 213: 3D Model created with PVsyst.

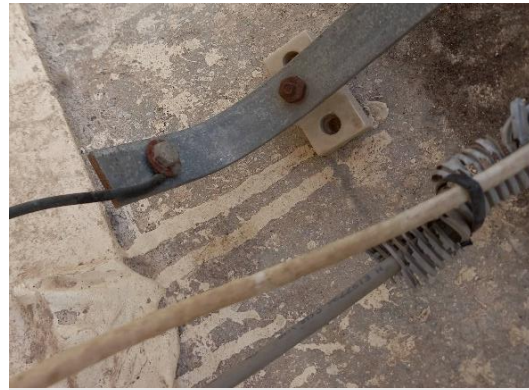
Figure 215: Corroded screws.

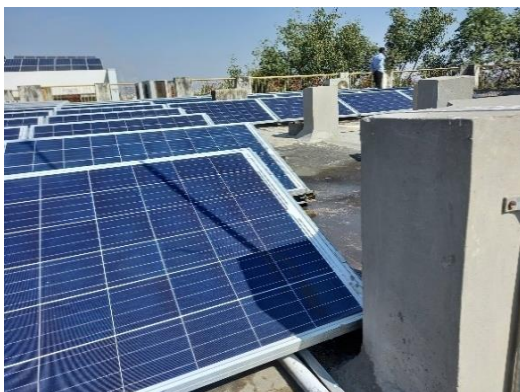
Figure 216: Near shading on modules.

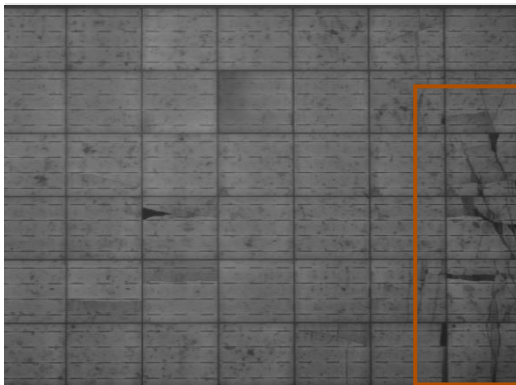
Figure 218: Cell with cracks and isolated parts.

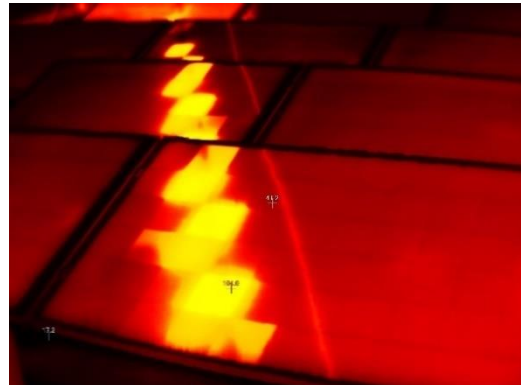
Figure 219: warm cells due to shading.

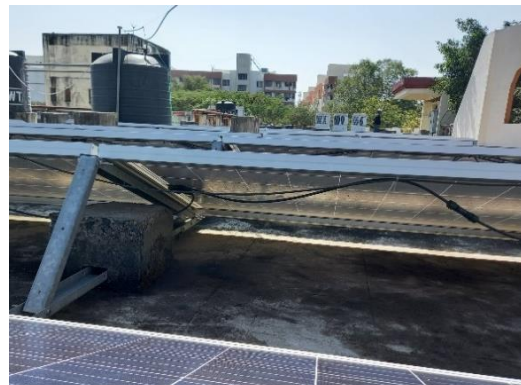
Figure 221: Loose hanging cables.

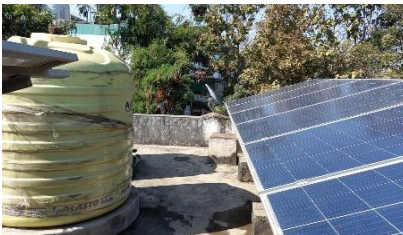
Figure 222: Near shading due to different objects

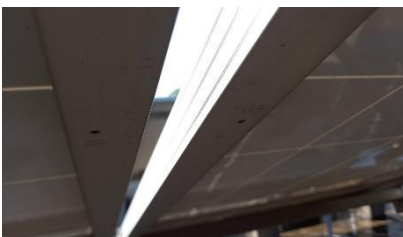
Figure 223: PEB grounding missing between modules

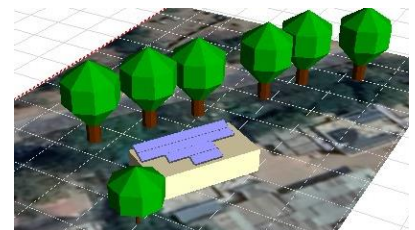
Figure 227: 3D model constructed in PVsyst

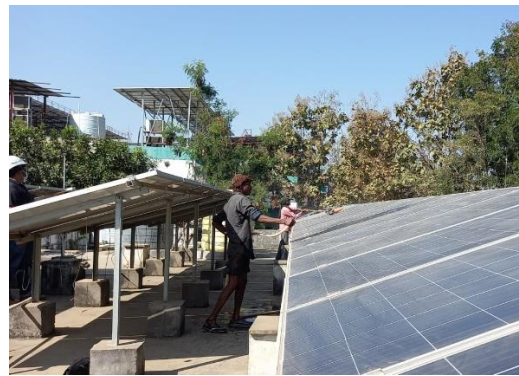
Figure 232: On-site O&M personnel missing PPE

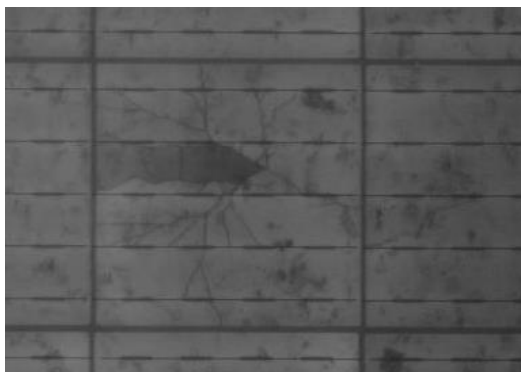
Figure 233: Cell with branched crack that will likely develop into inactive areas.

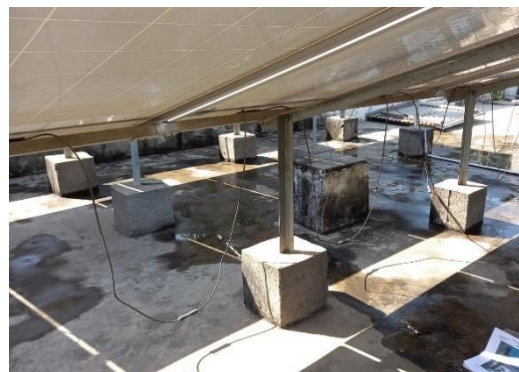
Figure 234: Poor cable management

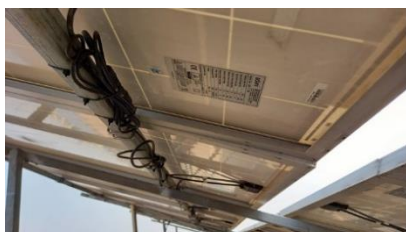
Figure 237: Poor cable management and module misalignment.

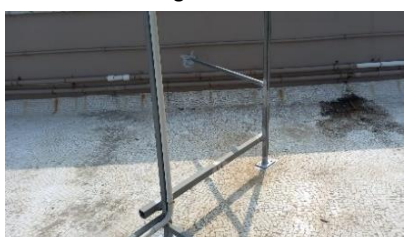
Figure 238: Poor structure management.

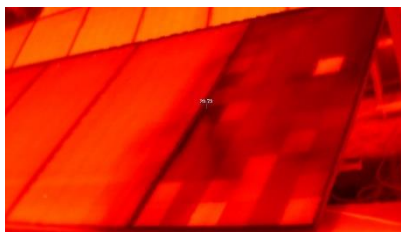
Figure 239: Potential PID-affected module.

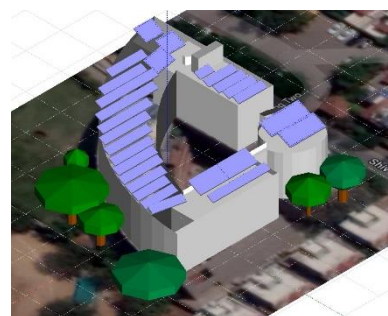
Figure 242: PVsyst constructed 3D model

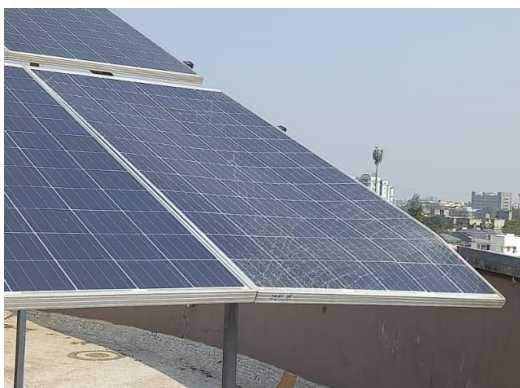
Figure 245: Broken module.

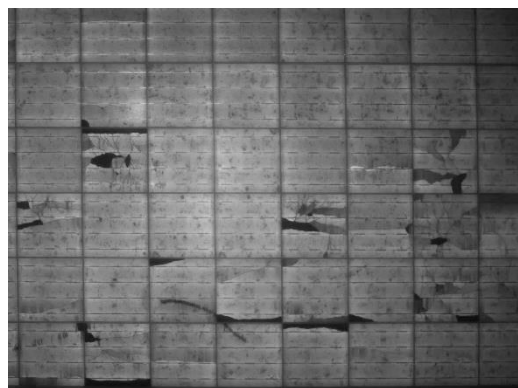
Figure 246: EL imaging of broken module.

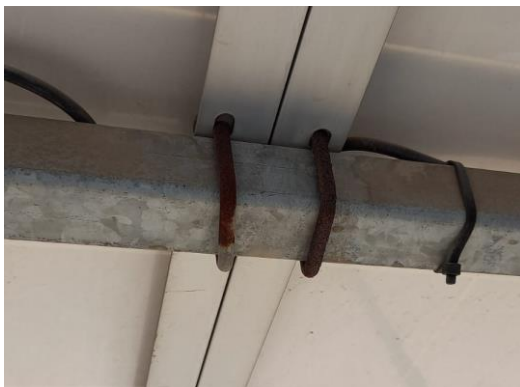
Figure 247: Rusty J-hooks used as modules fixation.

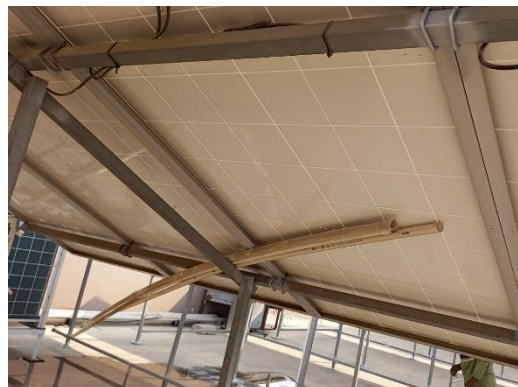
Figure 248: Pipes stored under the modules.

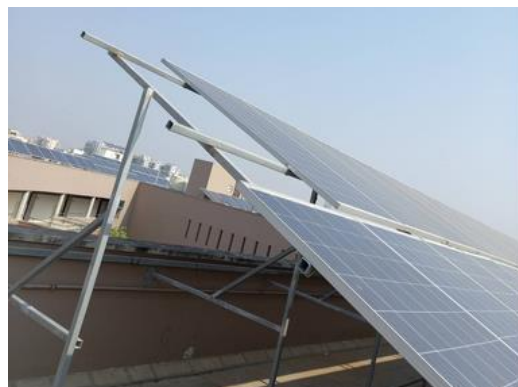
Figure 250: Missing module.

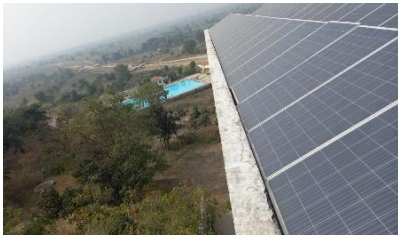
Figure 251: No access to modules

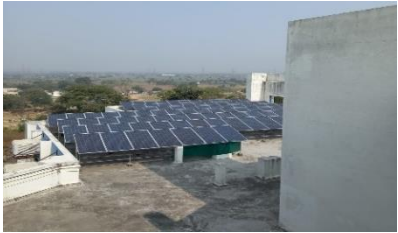
Figure 252: Near shading

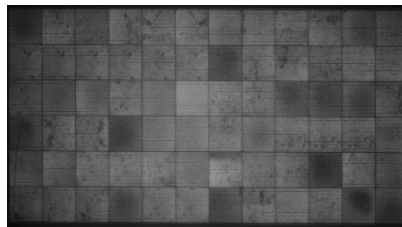
Figure 253: Module with manufacturing defect in the ARC layer

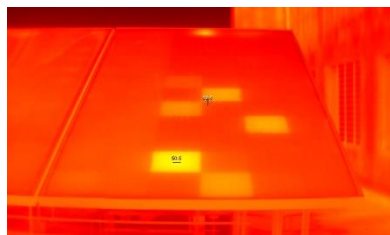
Figure 254: PID evidence in IR picture

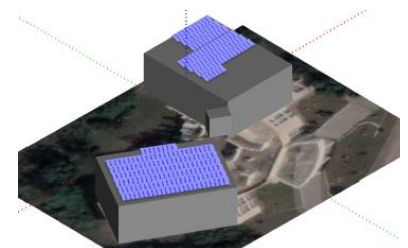
Figure 256: 3D model constructed in PVsyst

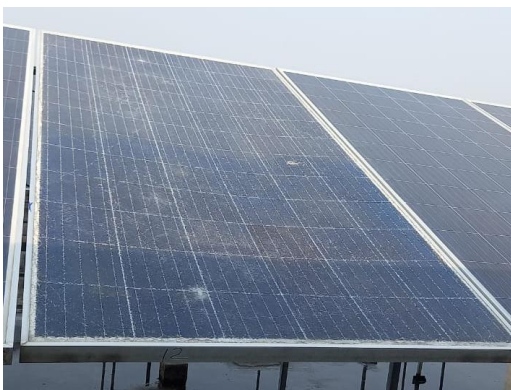
Figure 263: Broken module.

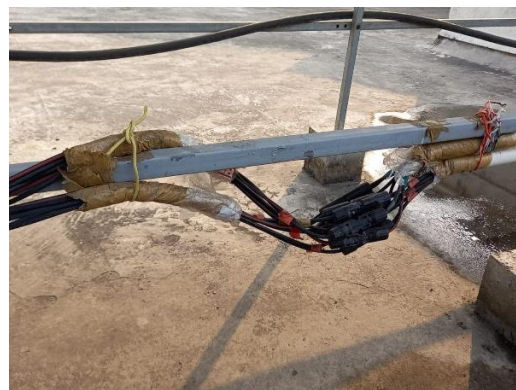
Figure 264: Poor cable management.

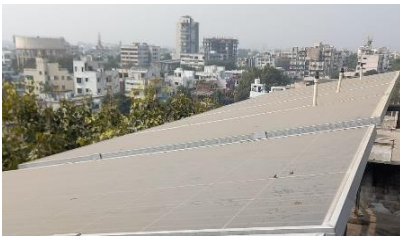
Figure 265: Heavy soiling and bird drops on panels

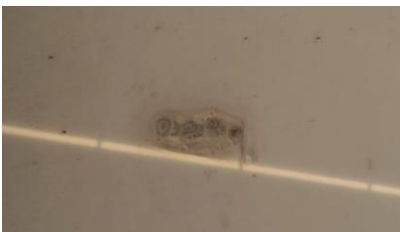
Figure 266: Back-sheet damaged

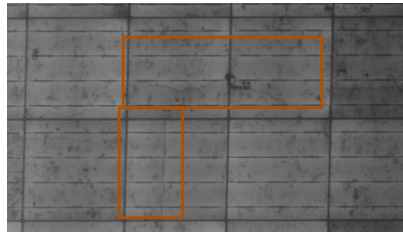
Figure 267: Microcracks on modules

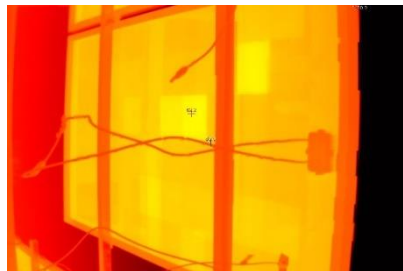
Figure 268: IR picture of a defective cell on module

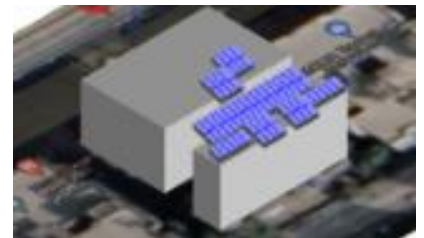
Figure 269: 3D model constructed in PVsyst.
