Evaluation of Underperforming Rooftop PV Plants in India – Moving from kW to kWh Part II

Phase I: Evaluation of 65 Rooftop PV Plants in India
(Jammu, Uttar Pradesh, Gujarat, Maharashtra, West
Bengal, Himachal Pradesh, Punjab and Kerala)

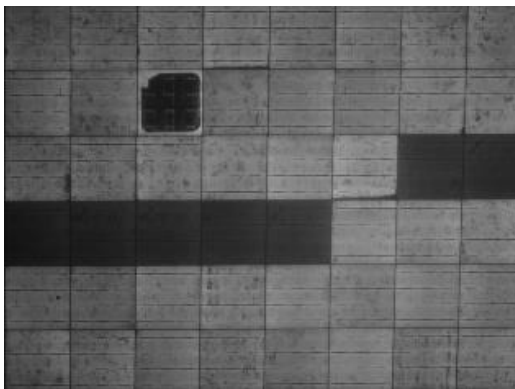
Figure 274: EL image of defective manufacturing

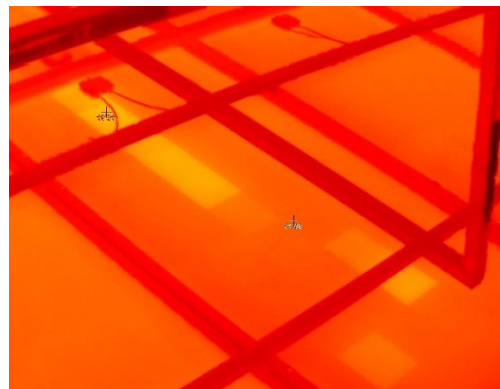
Figure 275: IR image of a defective manufacturing

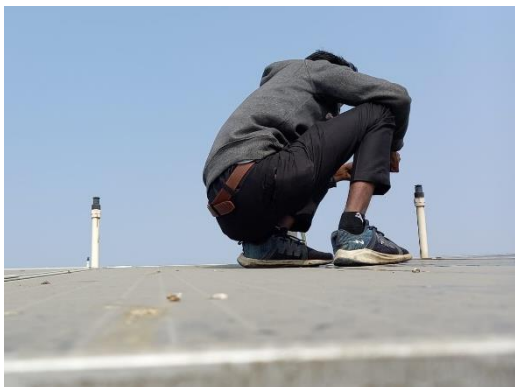
Figure 276: Bad O&M practices

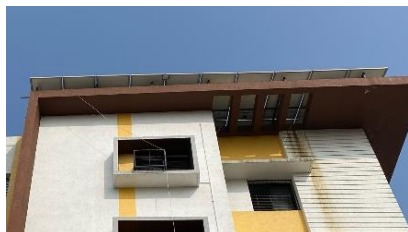
Figure 278: Panels beyond construction area

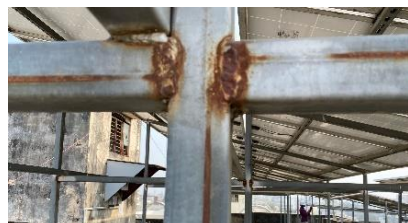
Figure 279: Rust in mounting structure

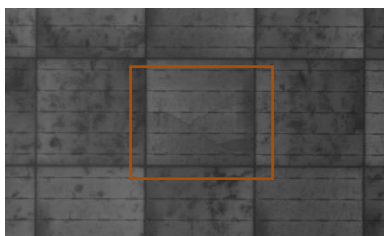
Figure 280: EL imaging

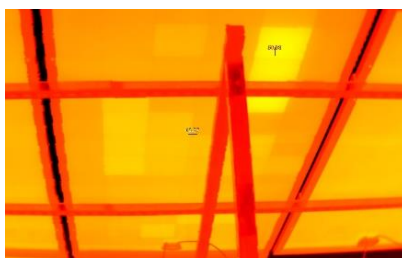
Figure 281: Modules with manufacturing defect

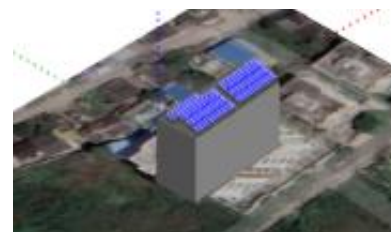
Figure 282: 3D model constructed in PVsyst

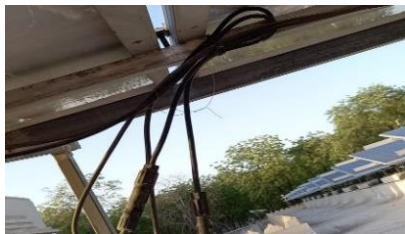
Figure 291: Poor cable management.

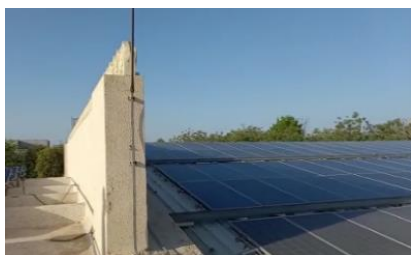
Figure 292: Shading on installations by boundary wall.

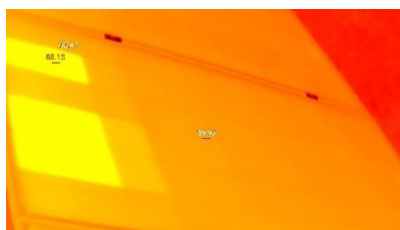
Figure 293: Hot cells from soiling.

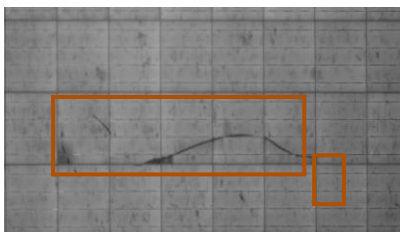
Figure 294: Defects from EL imaging.

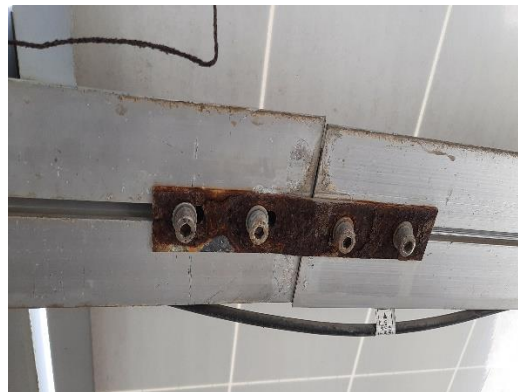
Figure 298: Corroded joints.

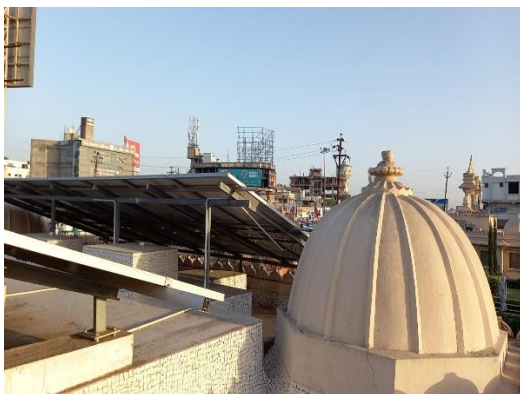
Figure 299: 1.5m tall shading object.

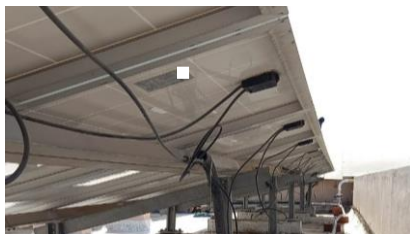
Figure 305: Cable layout.

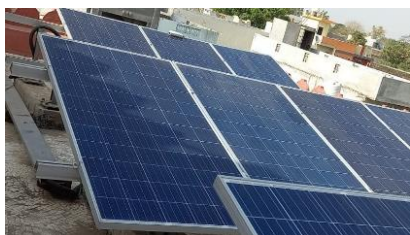
Figure 306: Shading by taller room on the modules.

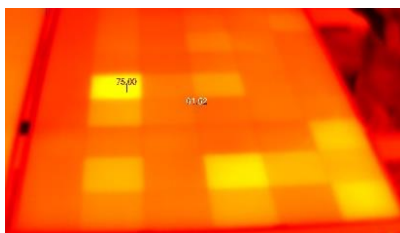
Figure 307: Hot cells from IR imaging.

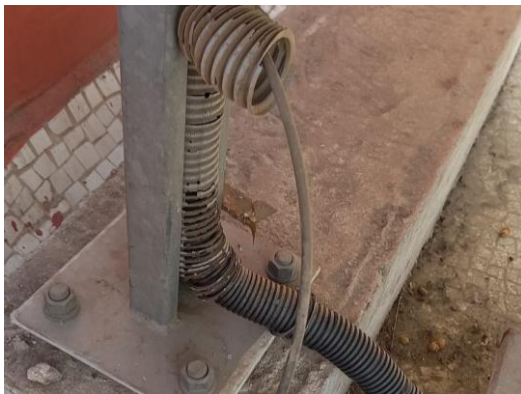
Figure 311: Degraded conduit.

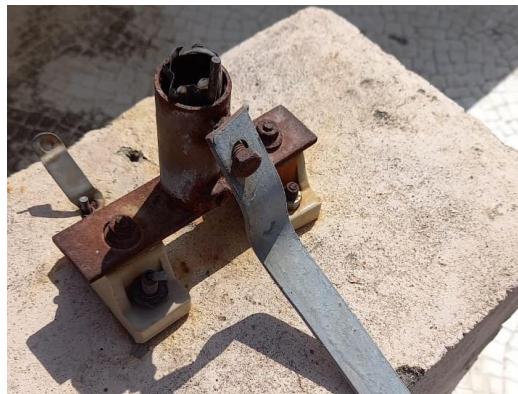
Figure 312: Broken LA on site.

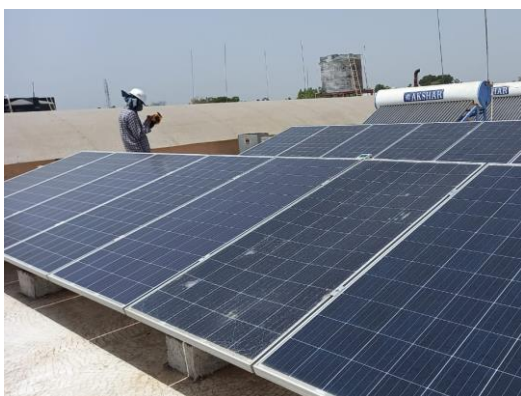
Figure 313: Module with cell breakage.

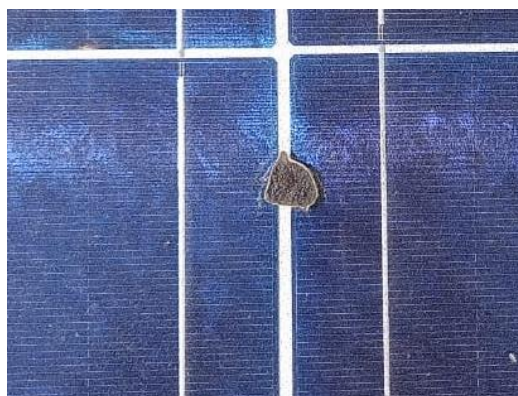
Figure 314: Module with burn on the cell.

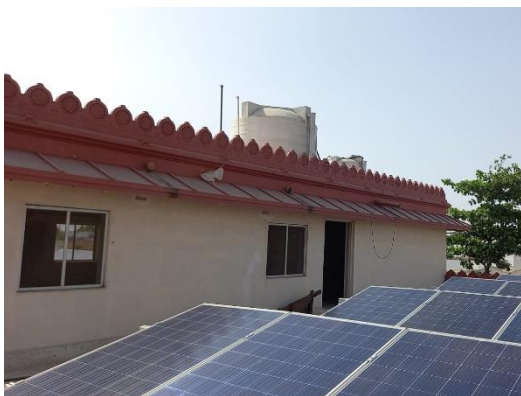
Figure 315: Taller building cast module shading.

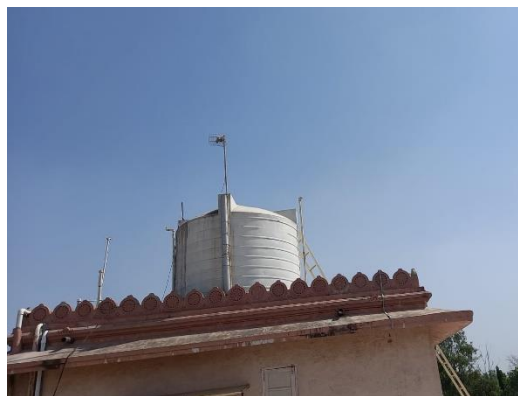
Figure 316: Broken LA on site.

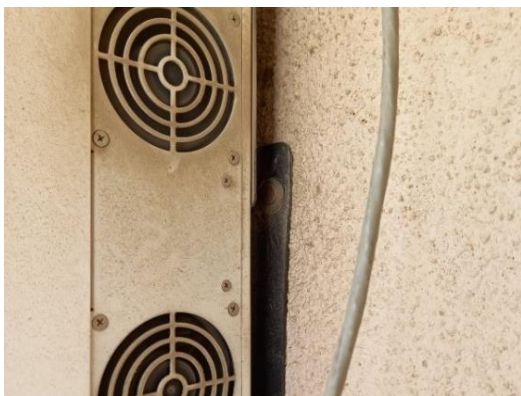
Figure 317: Soiled inverter fans.

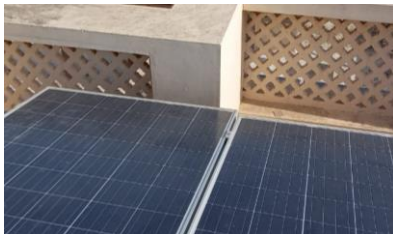
Figure 319: Shifted modules.

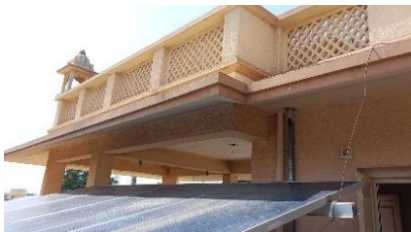
Figure 320: Shading on installations.

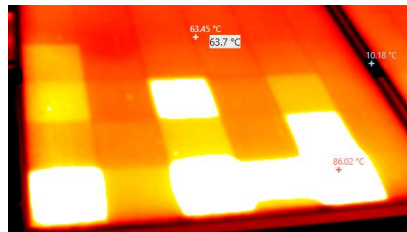
Figure 321: Hot cells

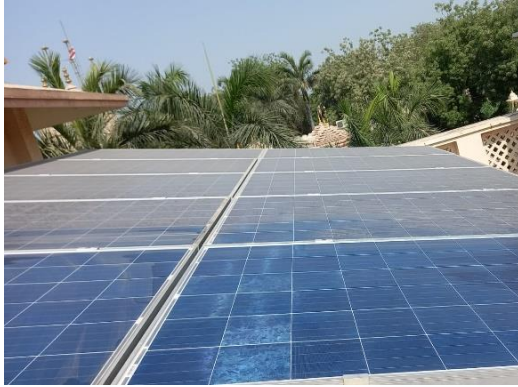
Figure 325: Soiling condition.

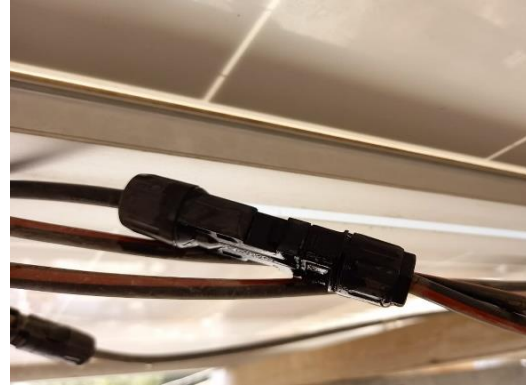
Figure 326: Burned connector.

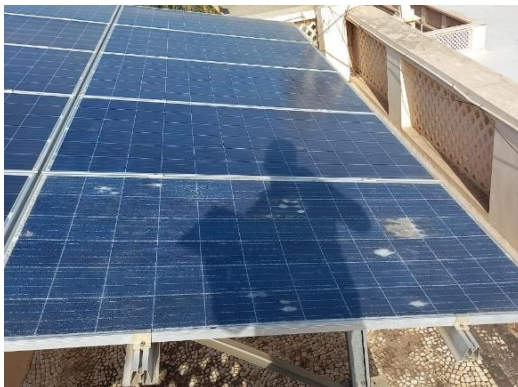
Figure 327: Broken modules.

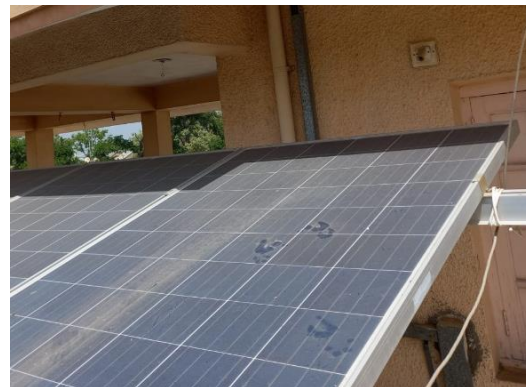
Figure 328: Footprints on the modules.

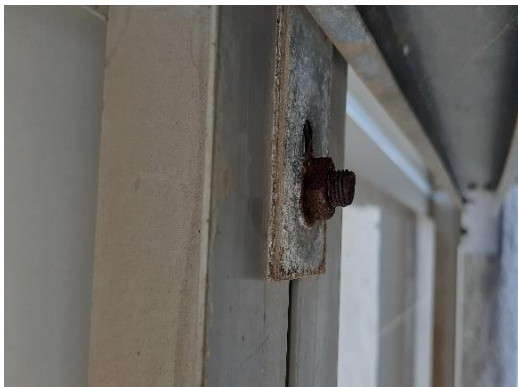
Figure 331: Rusty screws.

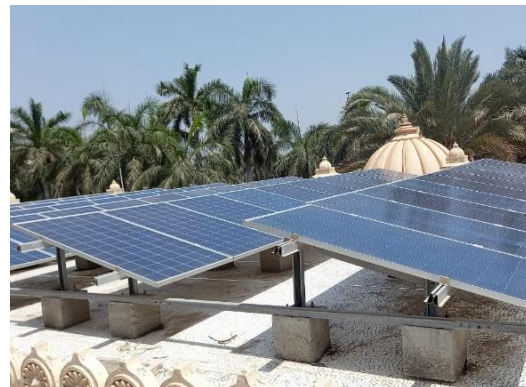
Figure 332: Site overview.

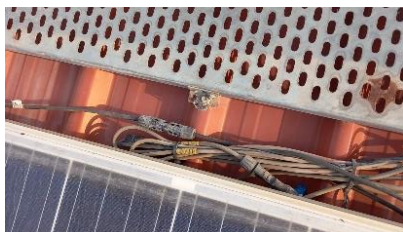
Figure 333: Cable layout.

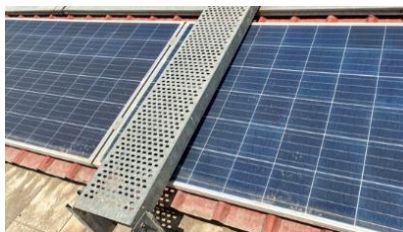
Figure 334: Module shading from walkway.

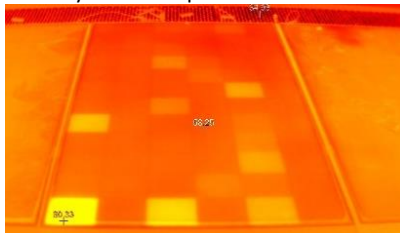
Figure 335: Hot cells from IR imaging.

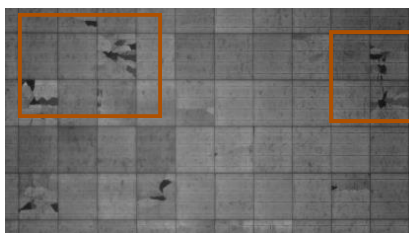
Figure 336: Defects from EL imaging.

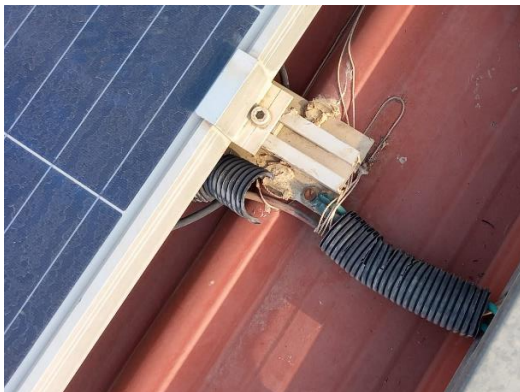
Figure 345: Degraded conduit.

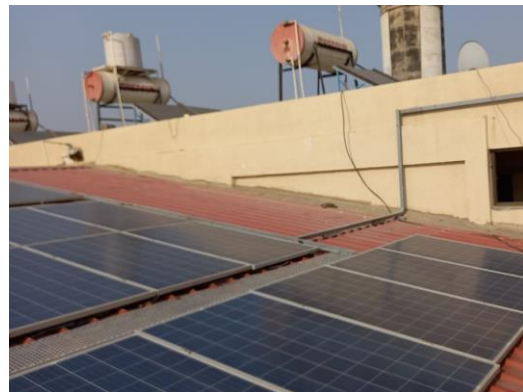
Figure 346: Shading from taller section of building.

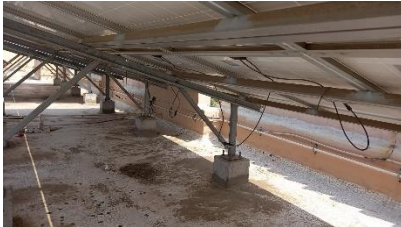
Figure 347: Loosely hanging cables and low bending radius.

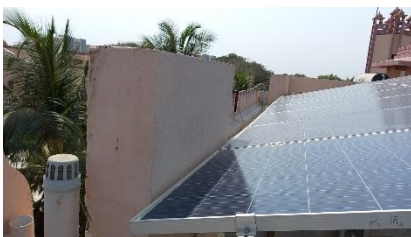
Figure 348: Shading on installations by boundary wall.

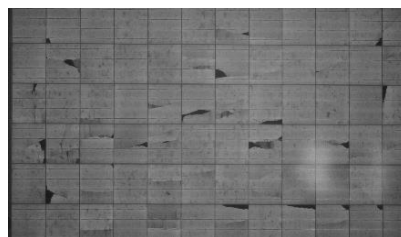
Figure 350: Defects from EL imaging.

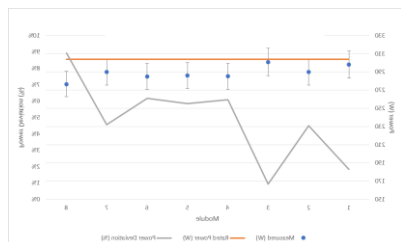
Figure 351: IV curve measurement results.

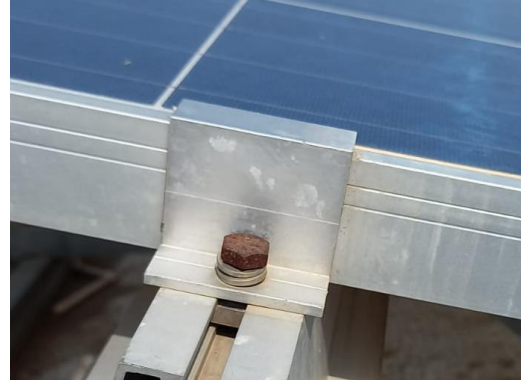
Figure 354: Rusted screws.

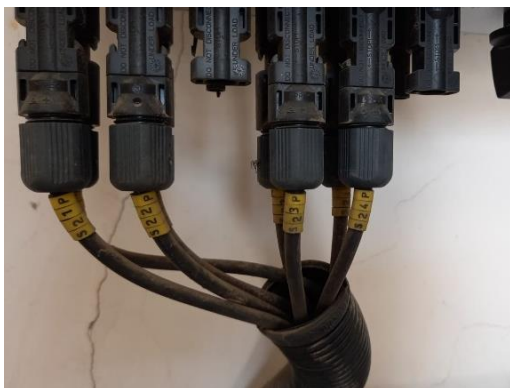
Figure 355: Open inverter connectors.

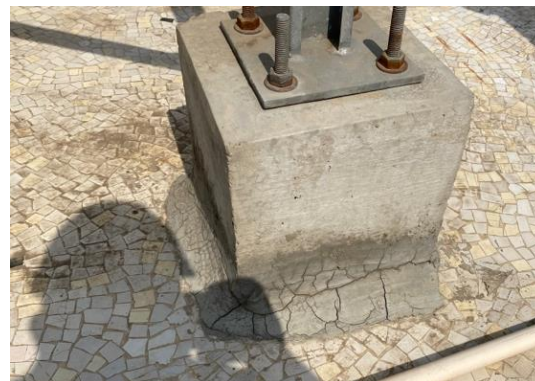
Figure 358: Broken ballast blocks fixation.

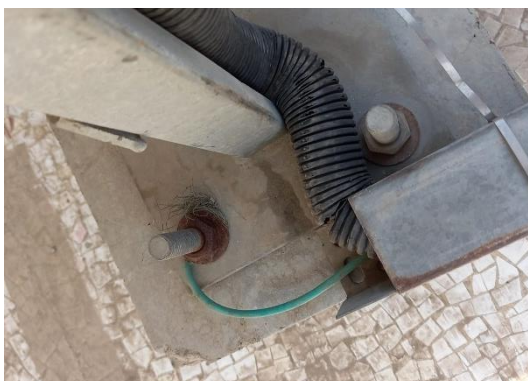
Figure 359: Degraded conduit.

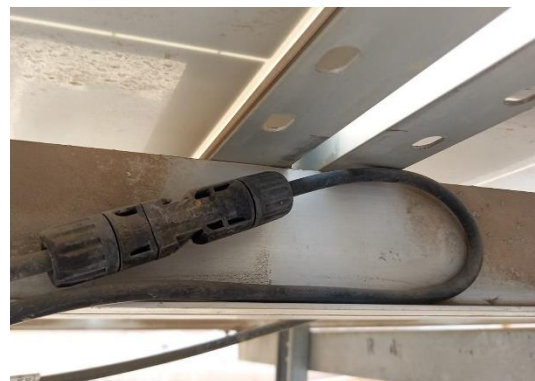
Figure 360: Bending radius of the cables is too low.

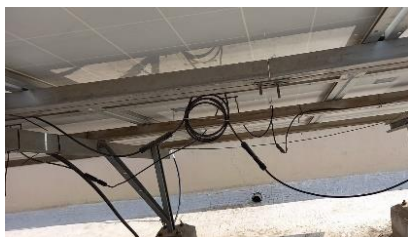
Figure 361: Cable layout.

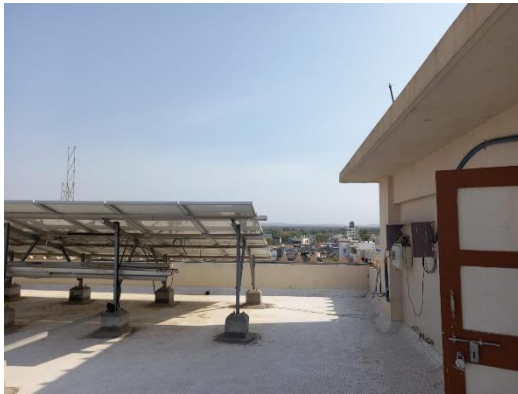
Figure 367: Taller room that cause shading.

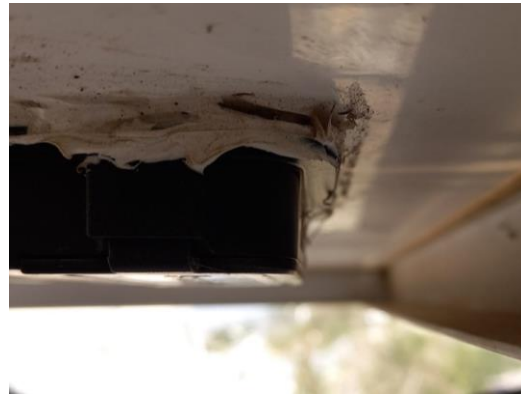
Figure 368: Sealant gap around junction box.

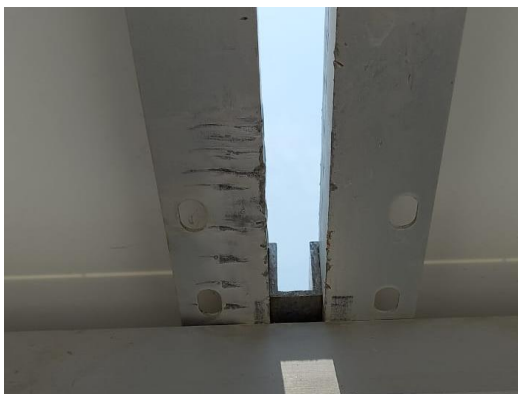
Figure 369: Damaged module frame.

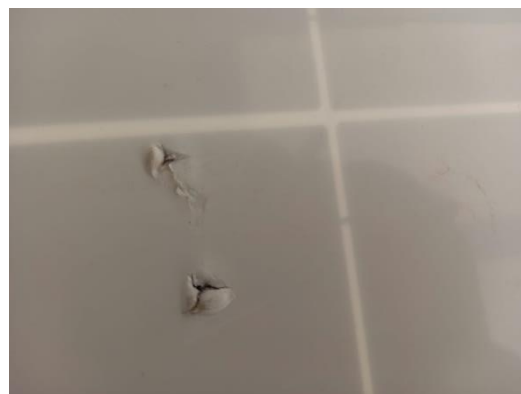
Figure 370: Broken back-sheet.

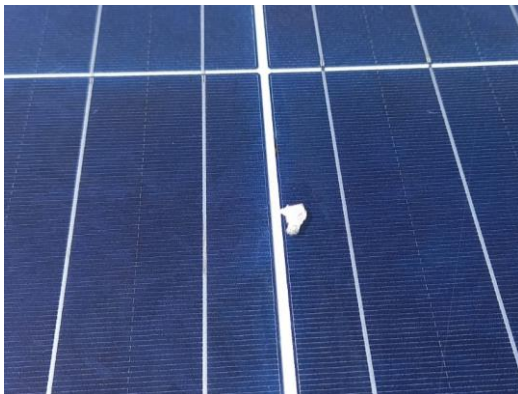
Figure 371: Sealant on cell.

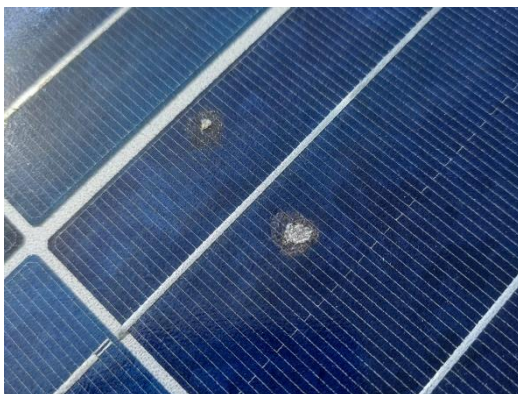
Figure 373: Moisture ingress.

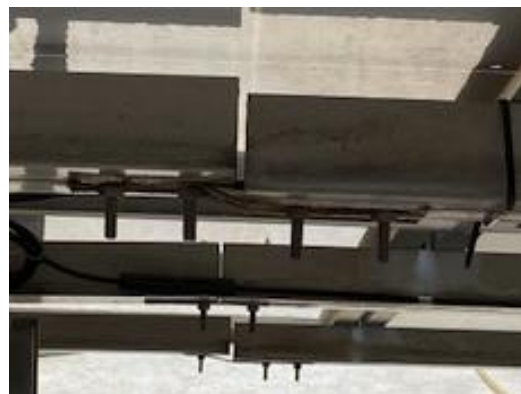
Figure 374: Damaged and corroded connecting plates.

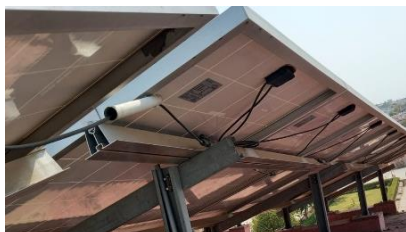
Figure 375: Loosely hanging cables and low bending radius.

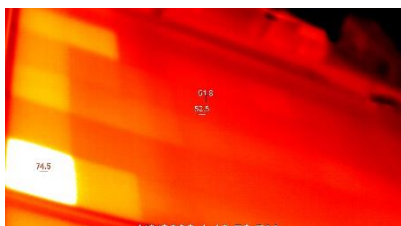
Figure 377: Hotspot from soiling.

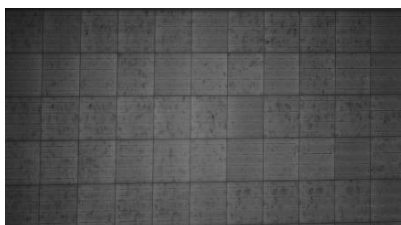
Figure 378: Defects from EL imaging.

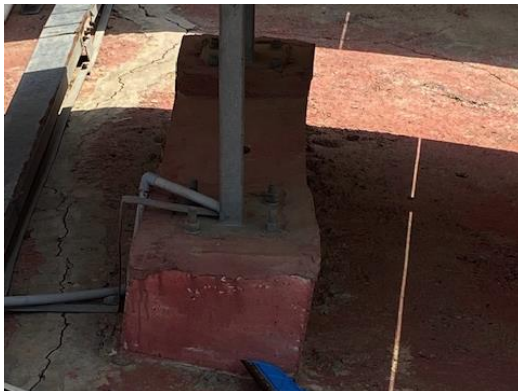
Figure 383: Improperly cast ballast blocks.

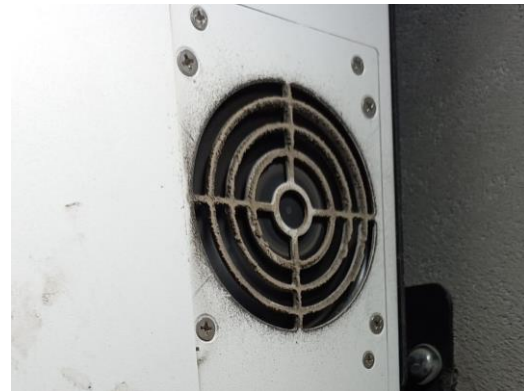
Figure 384: Inverter fans soiled.

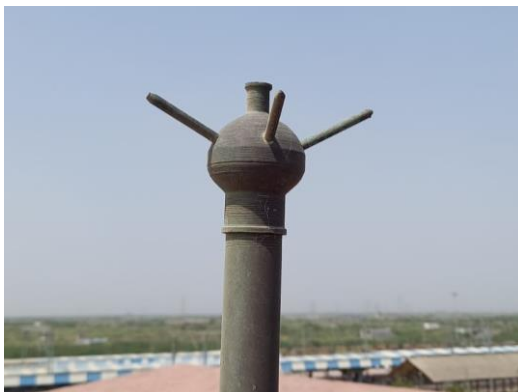
Figure 387: Spikes of lightning arrester damaged.

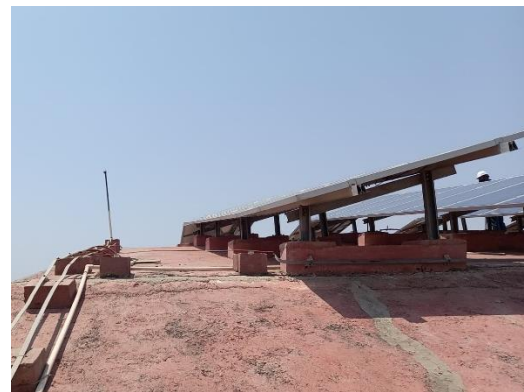
Figure 388: LA casting shading.

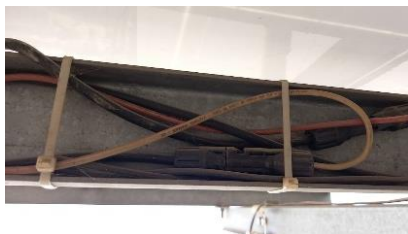
Figure 389: Cable layout.

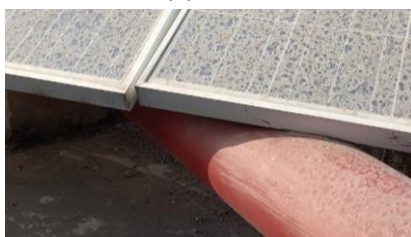
Figure 390: Module frame bent from installation over pipeline.

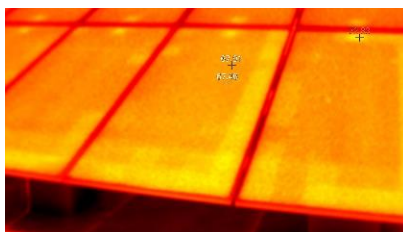
Figure 391: IR analysis indicating PID.

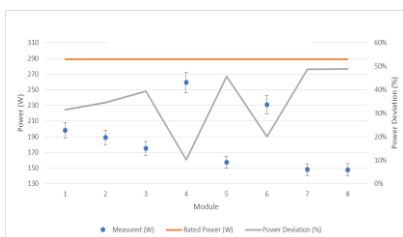
Figure 393: IV curve measurement results.

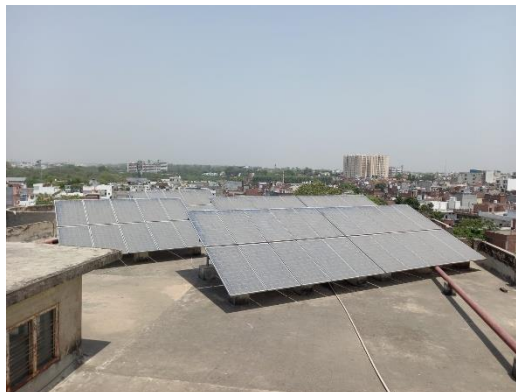
Figure 396: Soiling condition of modules.

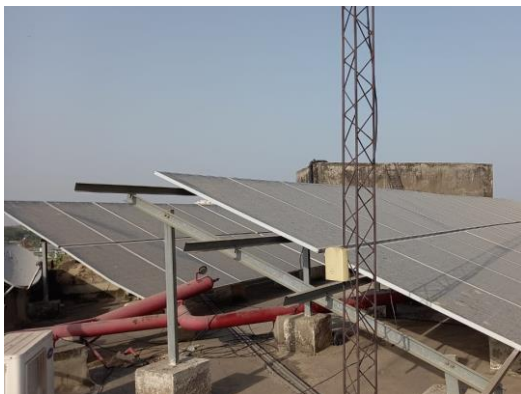
Figure 397: Overview showing pipeline through installation and tower causing shading.

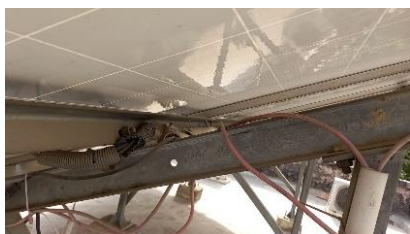
Figure 403: Loosely hanging cables and low bending radius.

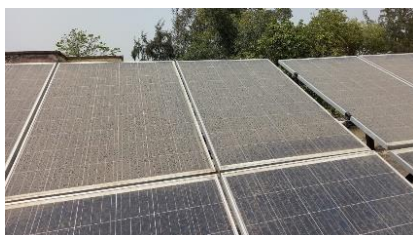
Figure 404: Modules with heavy soiling.

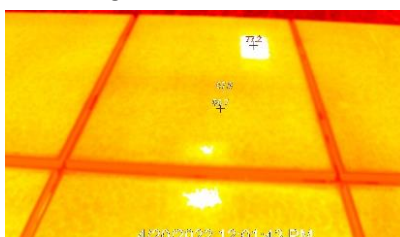
Figure 405: Hotspot from soiling.

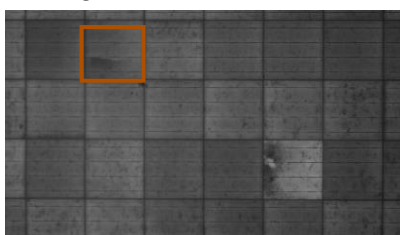
Figure 406: Defects from EL imaging.

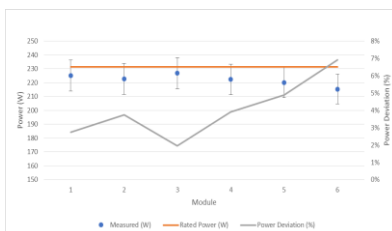
Figure 407: IV curve measurement results.

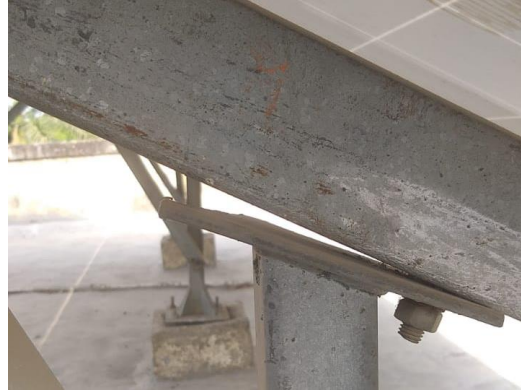
Figure 410: Improper bolting.

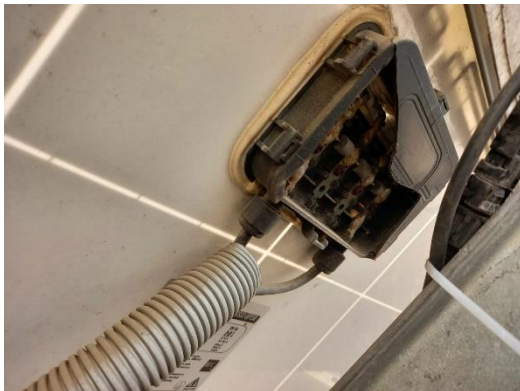
Figure 411: Broken J-box with corroded contacts.

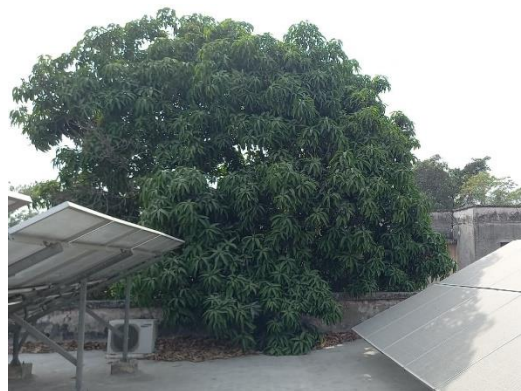
Figure 412: Shading from tree.

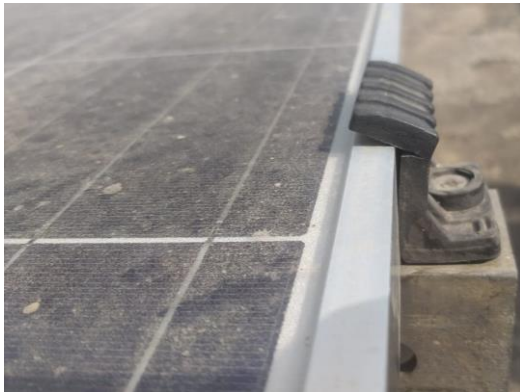
Figure 413: Broken polymer clamps casting shadow.

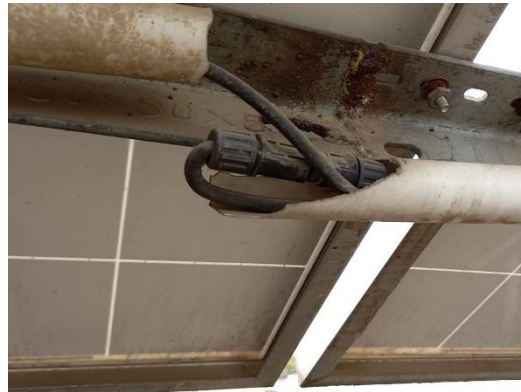
Figure 414: Cables with low bending radius.

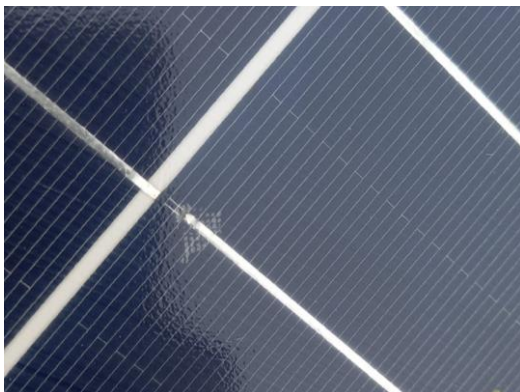
Figure 415: Air bubbles from improper lamination.

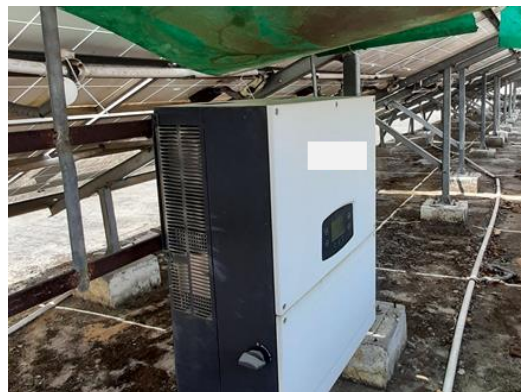
Figure 416: Inverter soiled due to ambient exposure.

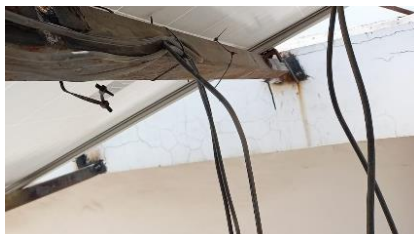
Figure 417: Loosely hanging cables and low bending radius.

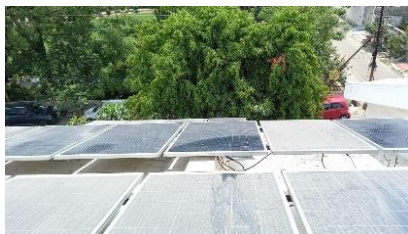
Figure 418: Severely soiled modules.

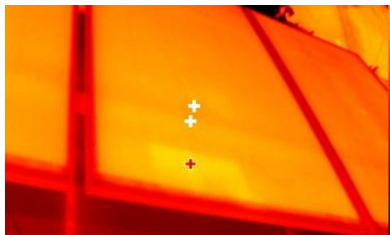
Figure 419: Hotspot from soiling.

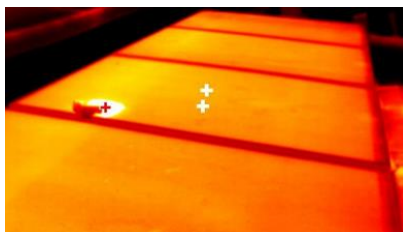
Figure 420: Hotspot from stray object on module.

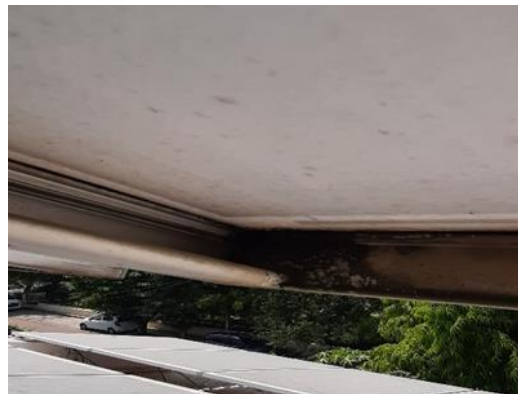
Figure 424: Corroded module frame.

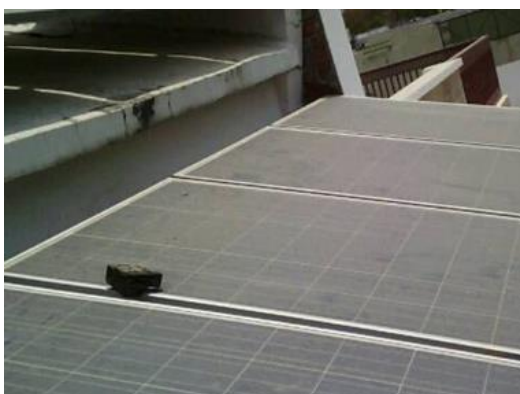
Figure 425: Stray object on module.

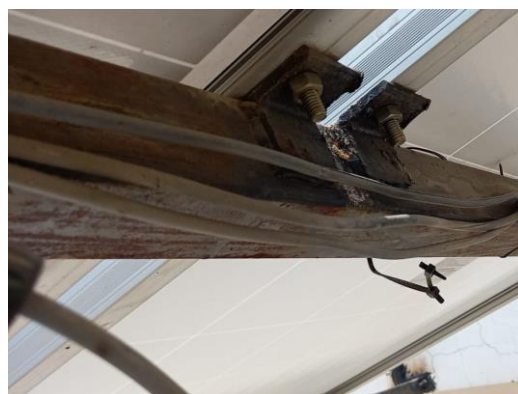
Figure 426: Severely rusted joints.

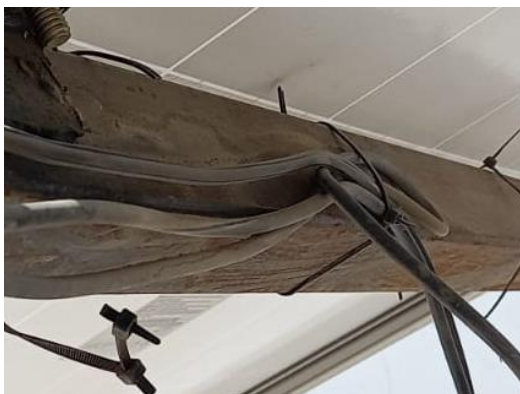
Figure 427: Cable layout with low bending radius.

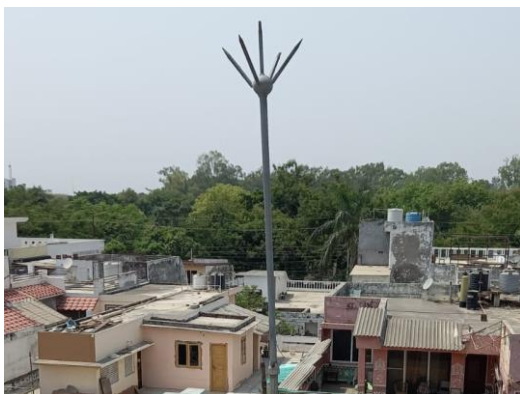
Figure 429: LA found on site.

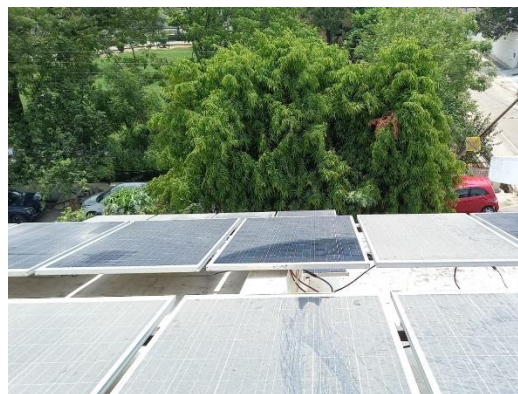
Figure 430: Soiled modules.

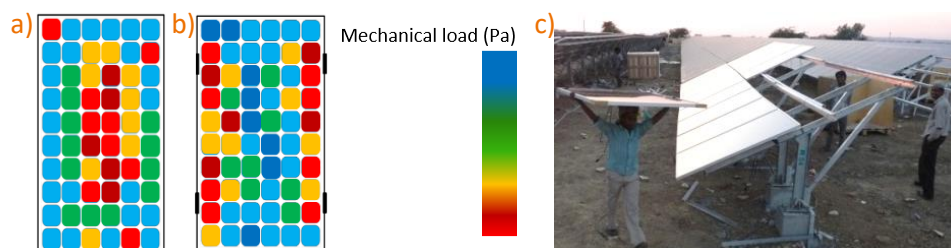
Figure 431: statistical distribution of cracks, a) transportation, b) installation, c) example of both

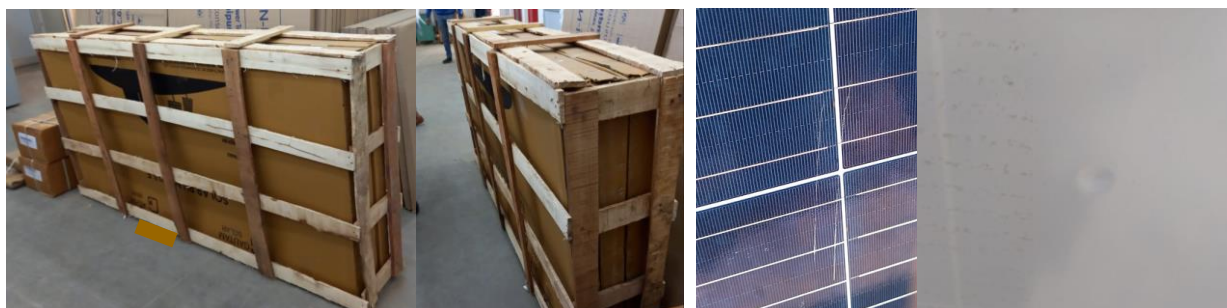
Figure 432: Modules inspected at warehouse. Left, packaging solution; right, mechanical damages discovered (scratches on glass, cell dents)

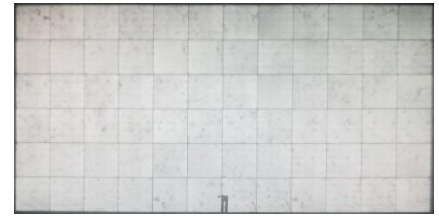
*Pictures submitted by module manufacturer. After multiple reviews, because of the low image quality and the lack of response from the manufacturer, it is highly likely that these EL pictures taken during production don't actually belong to the modules under scope. Similarly to lack of documentation available by plant owners (and in several cases, EPCs), the absence of after sales support from domestic module manufacturers limits development and confidence in local industry, creating a vicious circle.

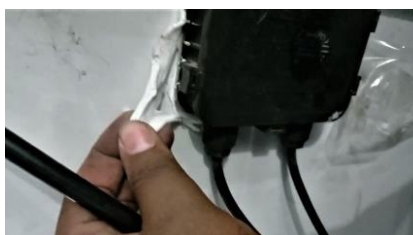
Figure 435: Degrading sealant around junction box.

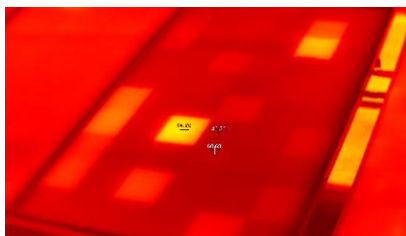
Figure 436: Hot cells from IR imaging.

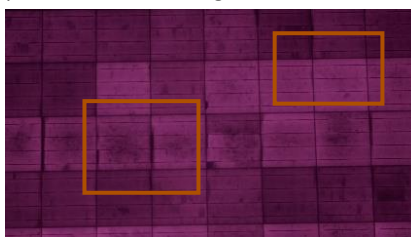
Figure 437: Defects from EL imaging.

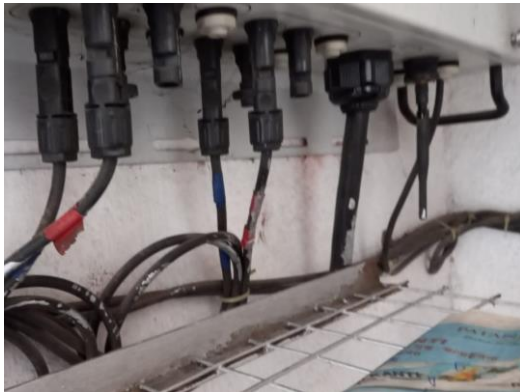
Figure 440: Degraded labelling used in cables.

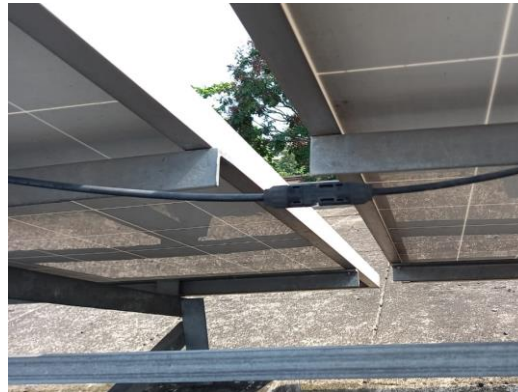
Figure 441: Connector exposed to ambient.

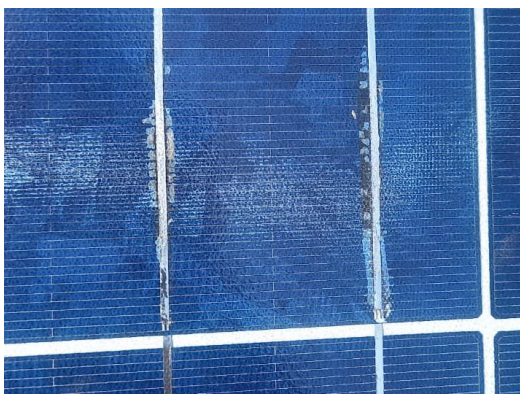
Figure 442: Broken J-box with corroded contacts.

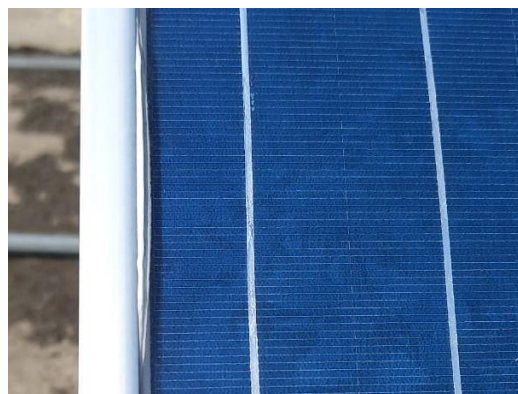
Figure 443: Sealant over cell.

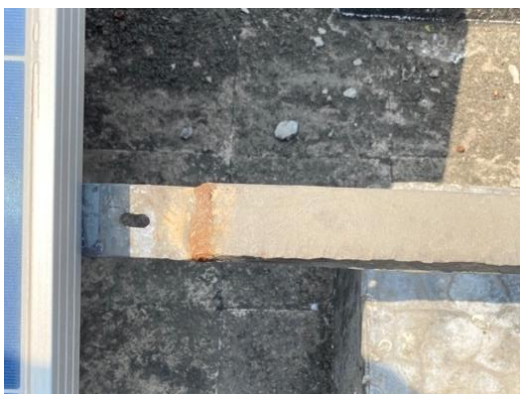
Figure 446: Structure purlin rusted at joint.

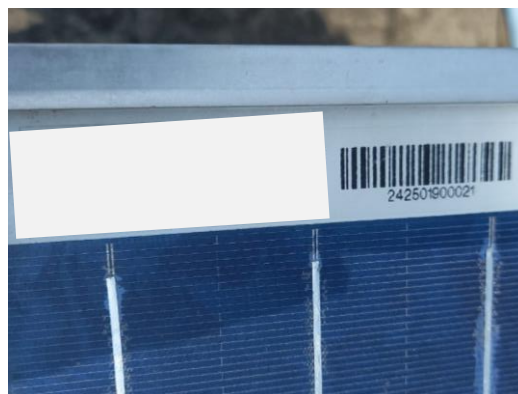
Figure 447: Module with different power rating and manufacture year used.

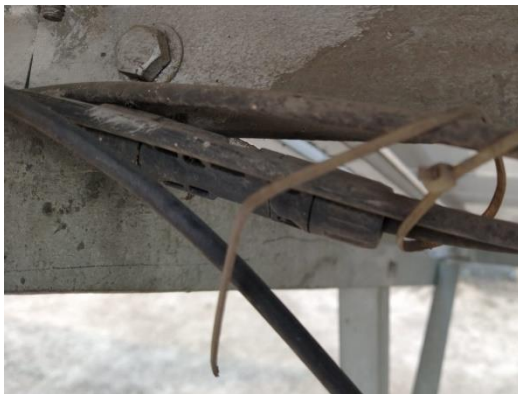
Figure 454: Degraded cables and connectors.

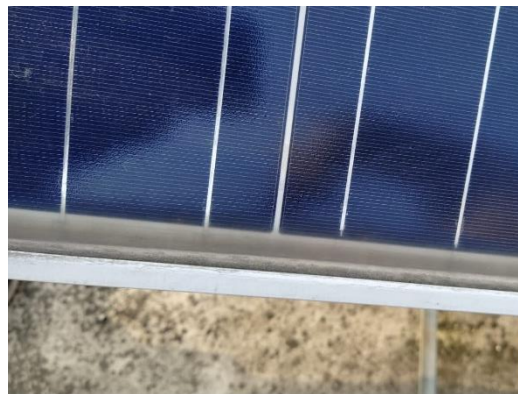
Figure 455: Module cementing.

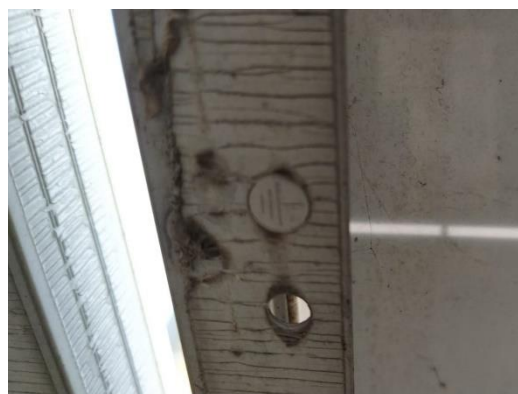
Figure 457: Missing module to module equipotential bonding.

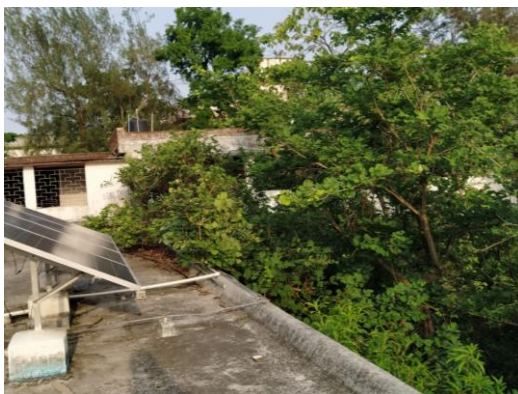
Figure 458: Tree and tree debris in plant vicinity.

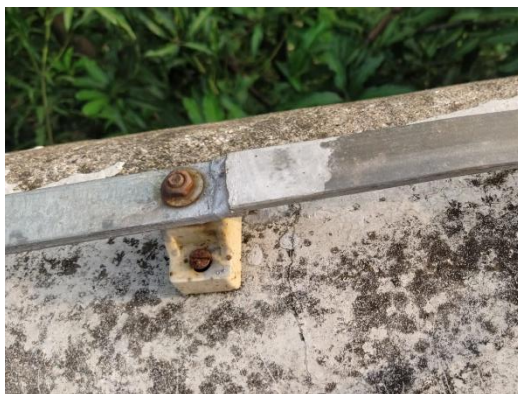
Figure 460: Rusty bolt in earthing strip.

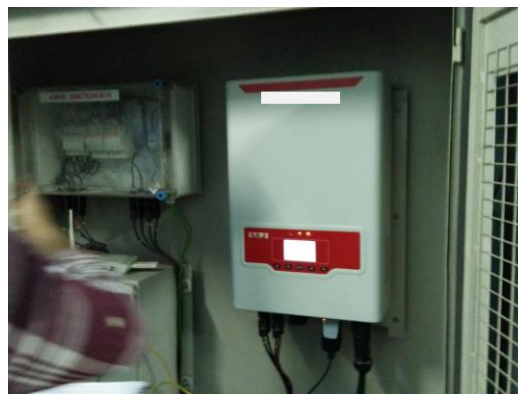
Figure 461: Inverter overview.

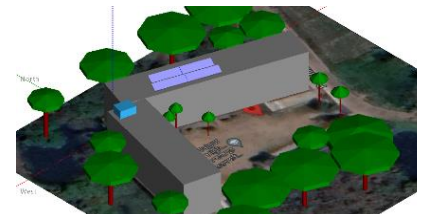
Figure 467: 3D model constructed in PVsyst.

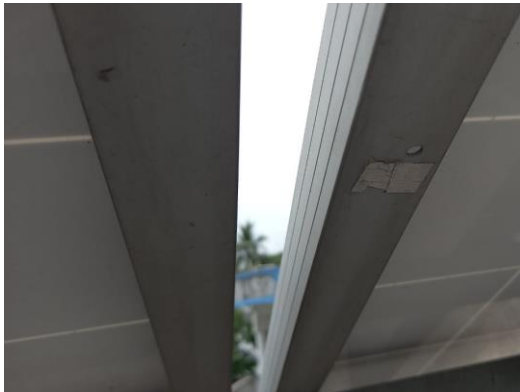
Figure 468: Module to module bonding missing.

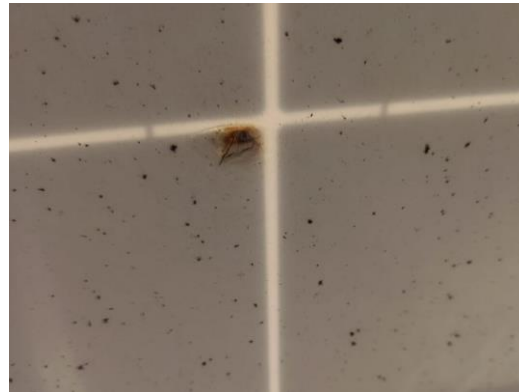
Figure 469: Back sheet burn and chalking.

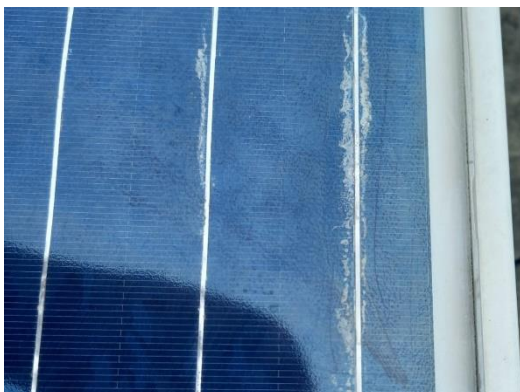
Figure 470: Cell delamination.

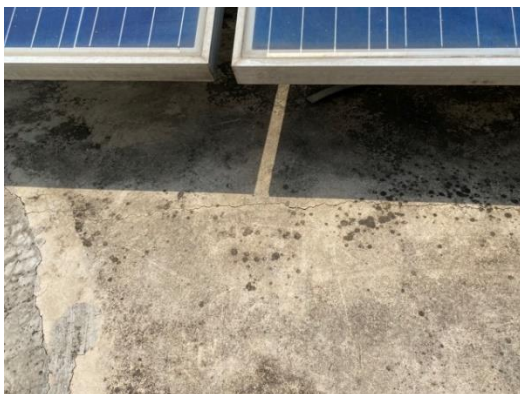
Figure 472: Module cementing and surface cracking.

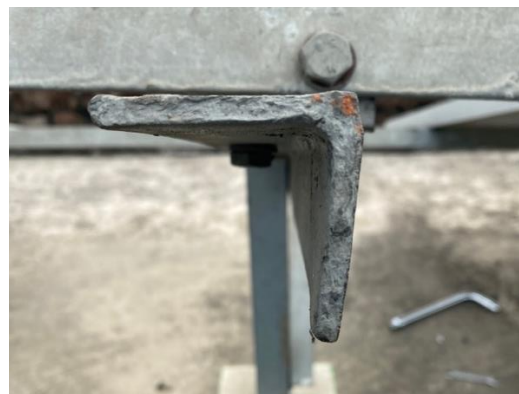
Figure 473: Deformed L channel purlins.

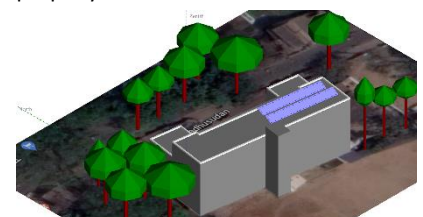
Figure 481: 3D model constructed in PVsyst.

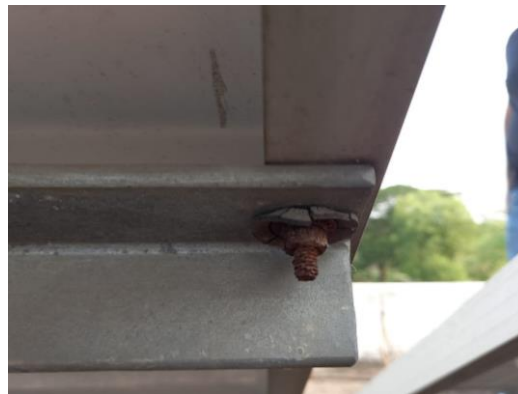
Figure 483: Rusted bolts.

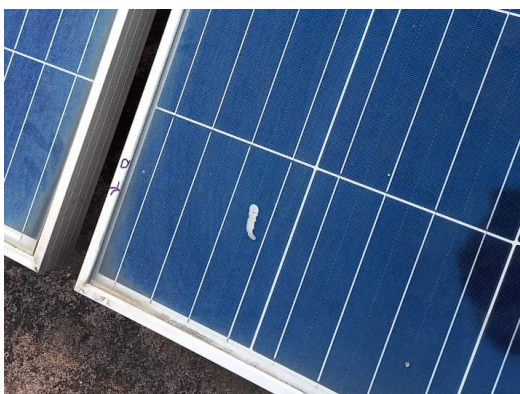
Figure 484: Cement stuck on module glass and module cementing.

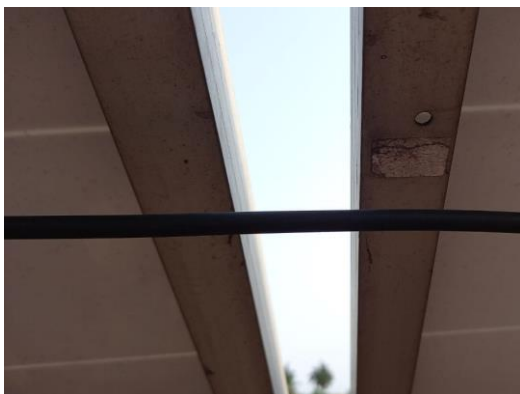
Figure 486: Missing module-to-module bonding.

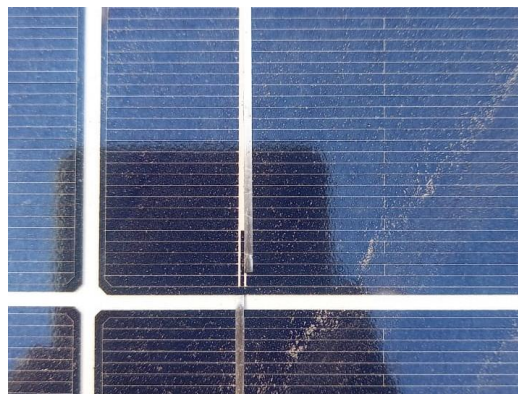
Figure 487: Busbar misalignment.

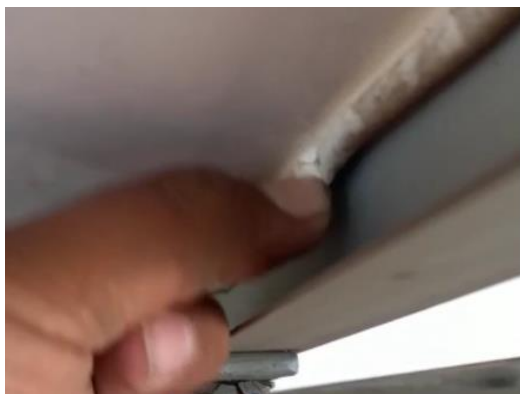
Figure 488: Improper sealant.

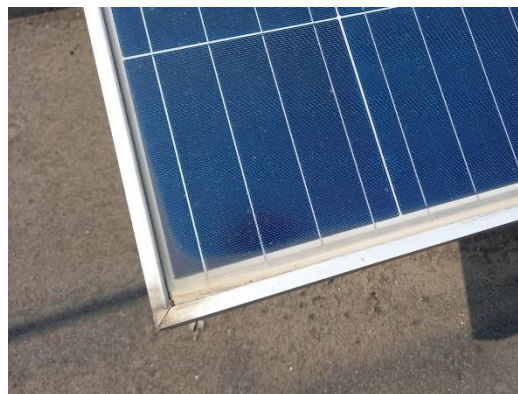
Figure 489: Cementing of module.

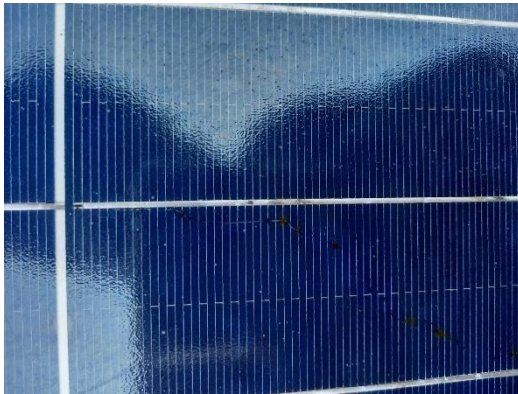
Figure 496: Burn marks on fingers.

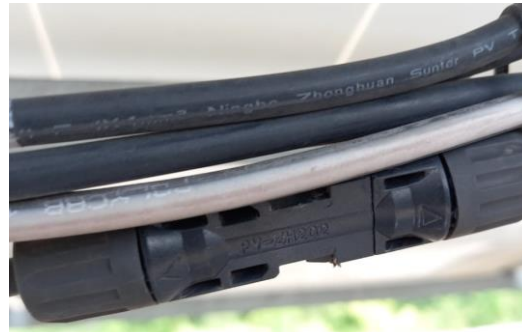
Figure 497: Degraded connectors.

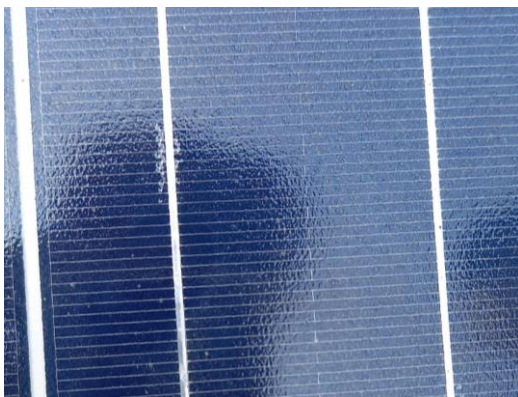
Figure 498: Cell delamination.

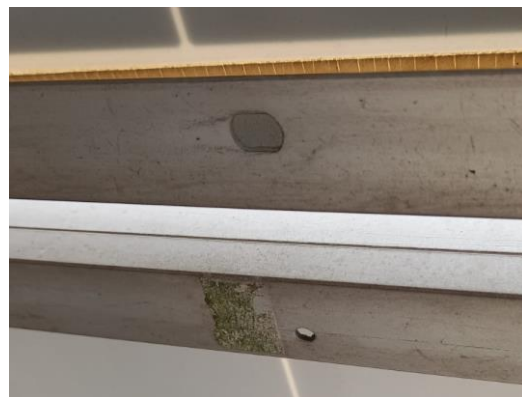
Figure 499: Missing module to module bonding.

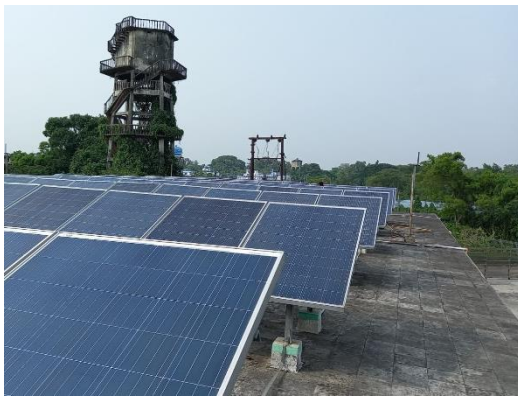
Figure 500: Site overview.

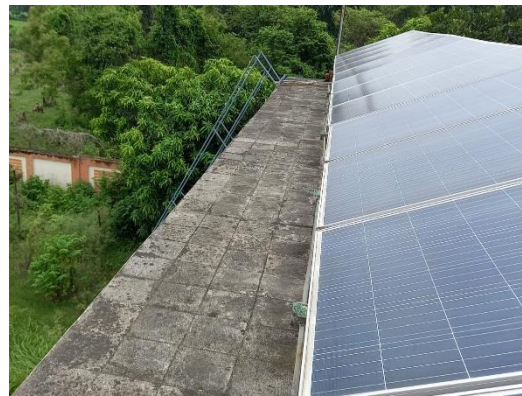
Figure 501: Missing safety railings.

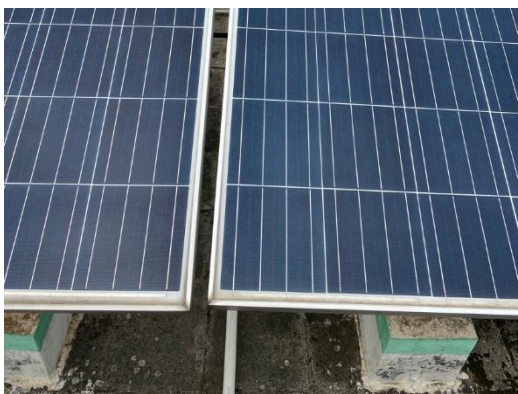
Figure 502: Module misalignment.
