Evaluation of Underperforming Rooftop PV Plants in India – Moving from kW to kWh Part II

Phase I: Evaluation of 65 Rooftop PV Plants in India
(Jammu, Uttar Pradesh, Gujarat, Maharashtra, West
Bengal, Himachal Pradesh, Punjab and Kerala)

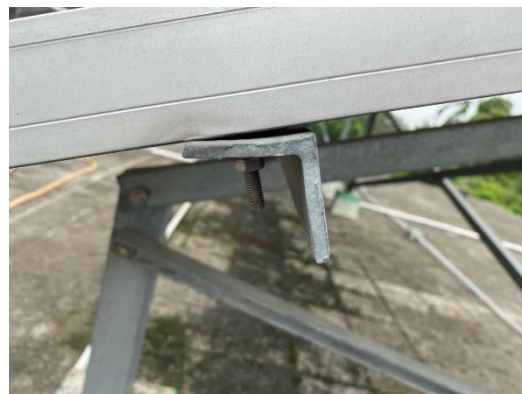
Figure 503: Rusted screw and purlin not parallel.

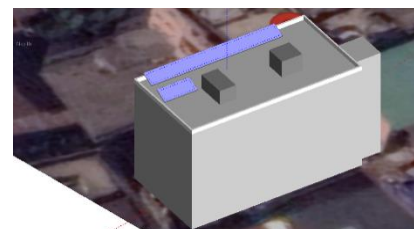
Figure 509: 3D model constructed in PVsyst.

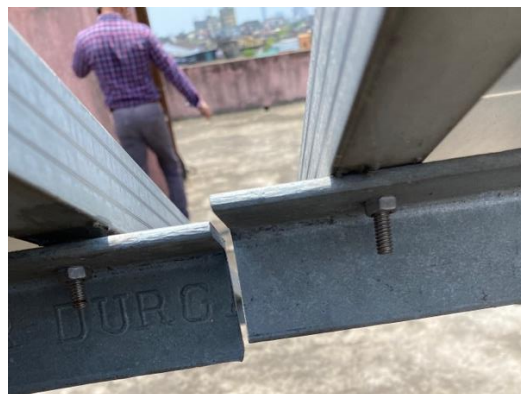
Figure 515: Module misalignment from improper L bracket fixation.

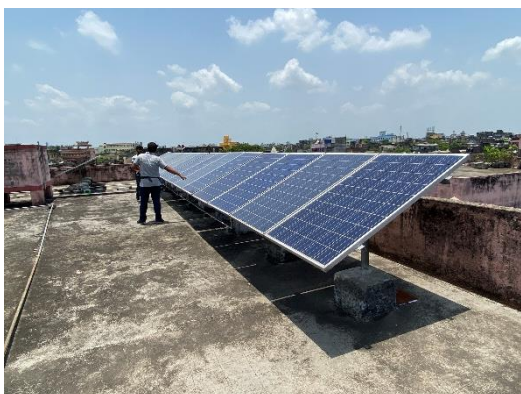
Figure 516: Uneasy access to table rear-side.

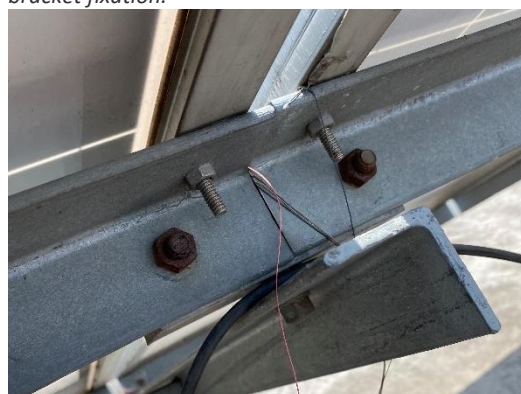
Figure 517: Rusty screws and nuts.

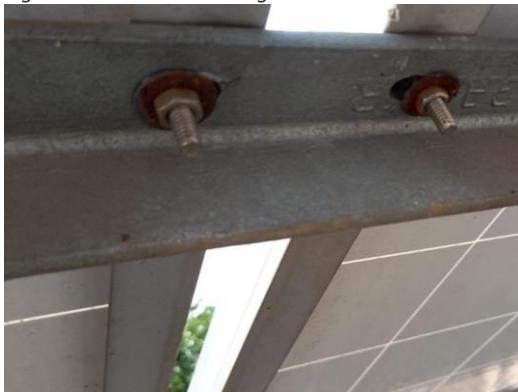
Figure 526: Rusted screws.

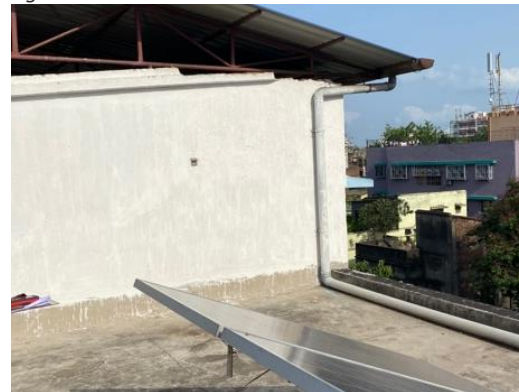
Figure 527: Shading by shed roof.

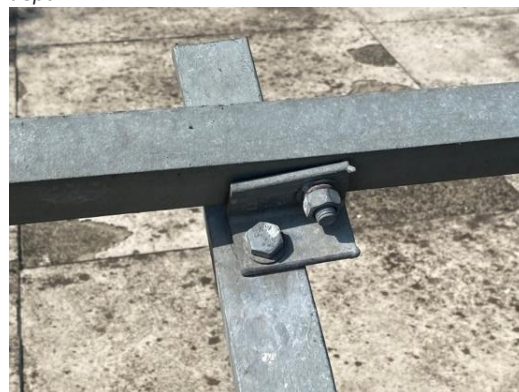
Figure 531: Improperly fixed purlin.

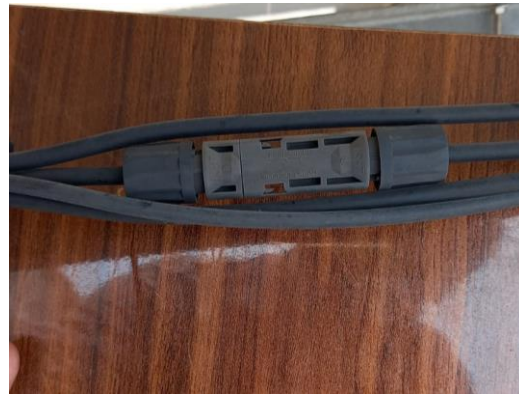
Figure 539: Degraded connectors.

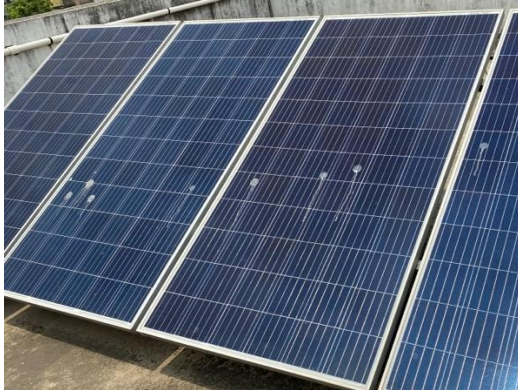
Figure 540: Bird dropping.

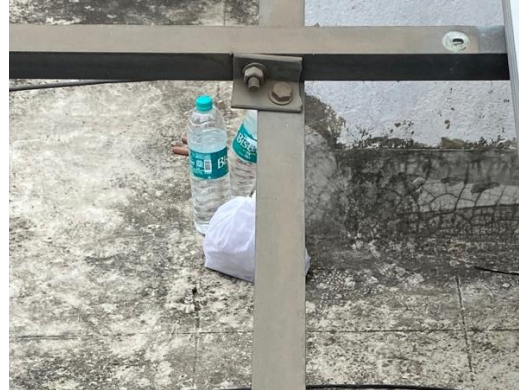
Figure 541: Improperly mounted L plate.

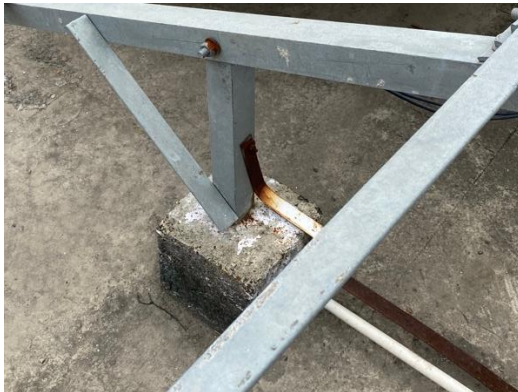
Figure 542: Rusty bolts and earthing strips.

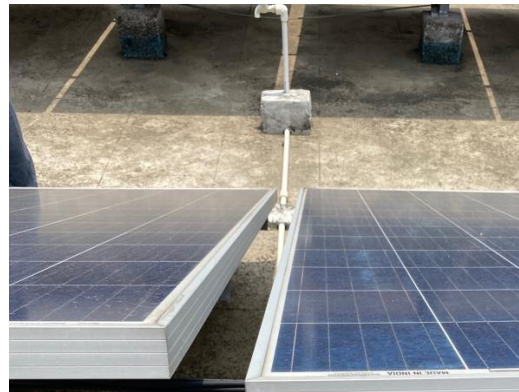
Figure 543: Module misalignment.

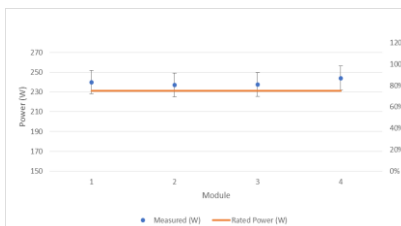
Figure 550: IV curve measurement results.

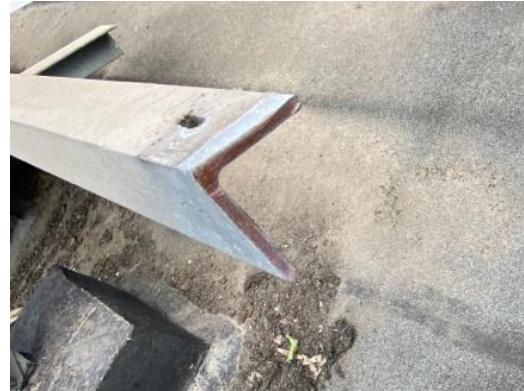
Figure 553: Purlin ends rusted from saw cutting.

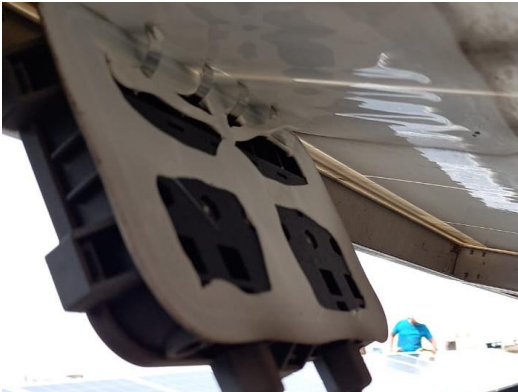
Figure 554: Detached J-box.

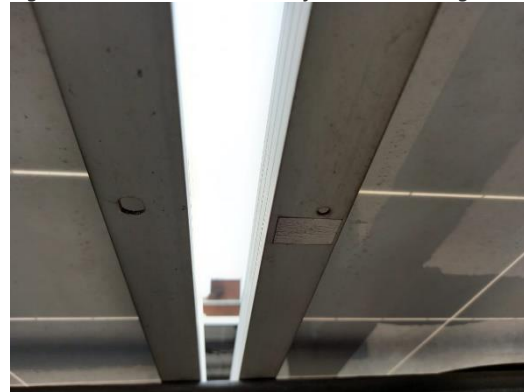
Figure 555: Missing module to module bonding.

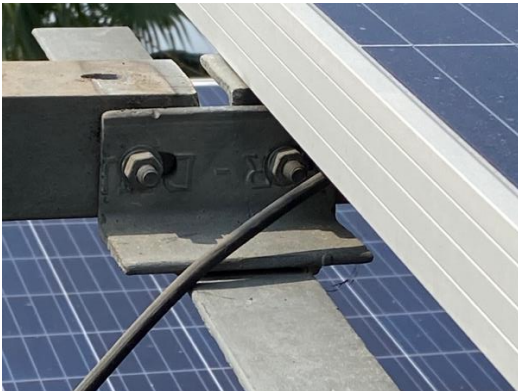
Figure 556: Gap between purlins.

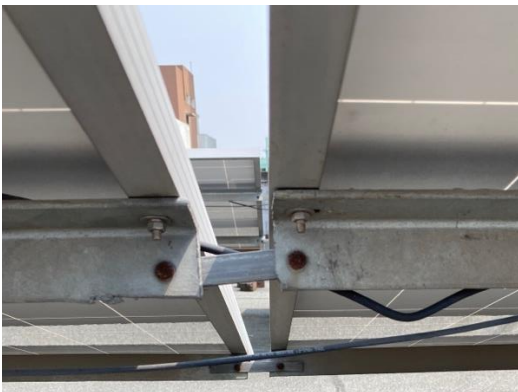
Figure 558: Module misalignment due to improper purlin fixation.

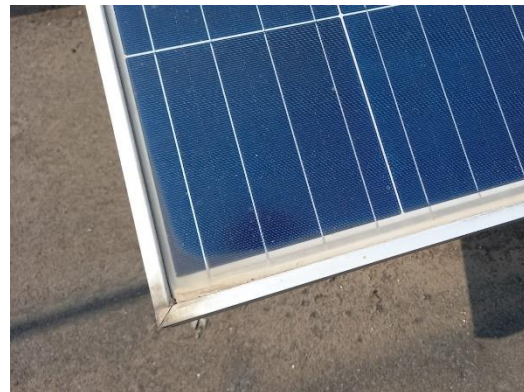
Figure 559: Cementing of module.

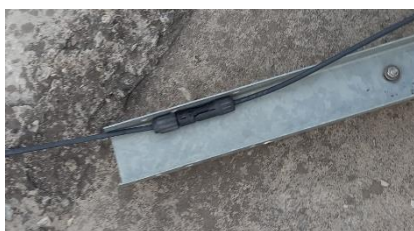
Figure 560: PV cable exposed to ambient and sharp edge

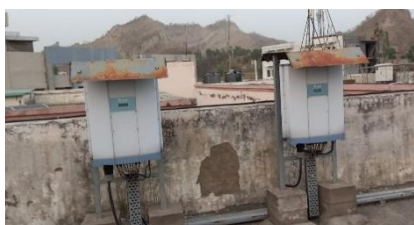
Figure 561: Inverters exposed to ambient

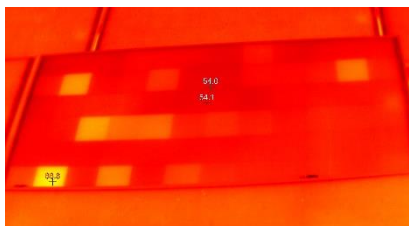
Figure 562: Hot cells on shaded module

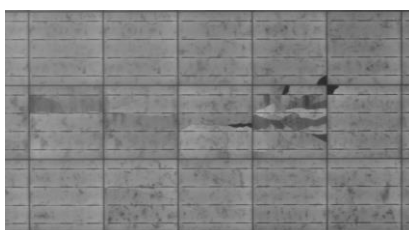
Figure 563: Broken cells from EL imaging

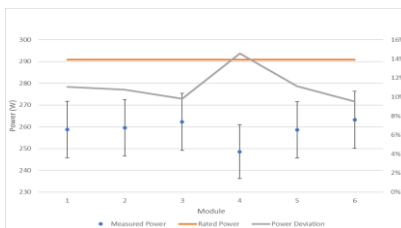
Figure 564: IV curve measurement results

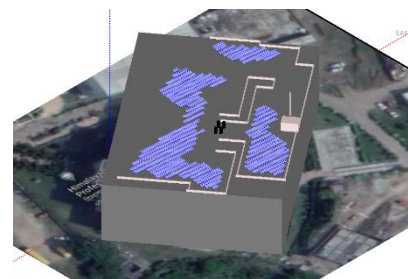
Figure 565: 3D model constructed in PVsyst

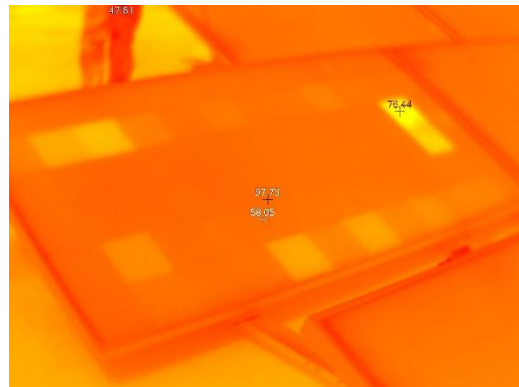
Figure 569: Hot cell caused by paint traces

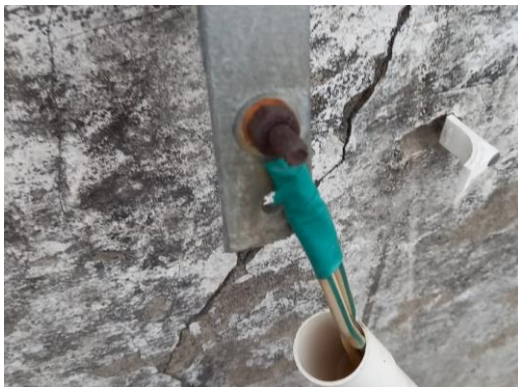
Figure 570: Rusty contacts of earthing system

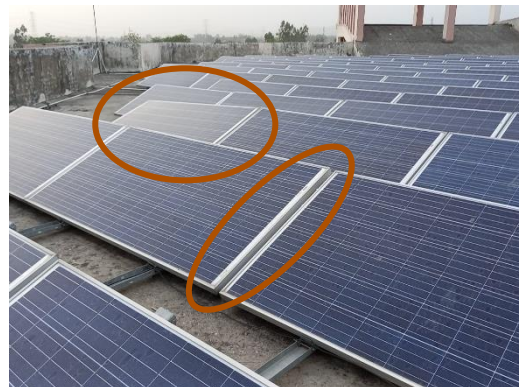
Figure 571: Misaligned modules

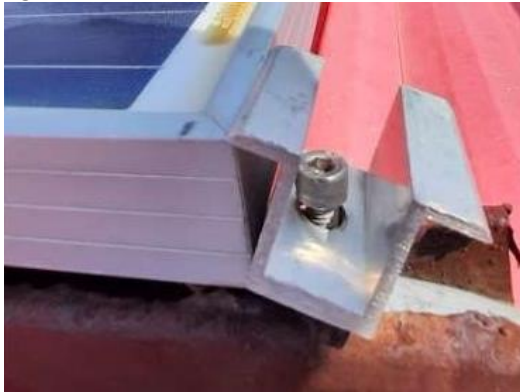
Figure 582: Damaged clamps.

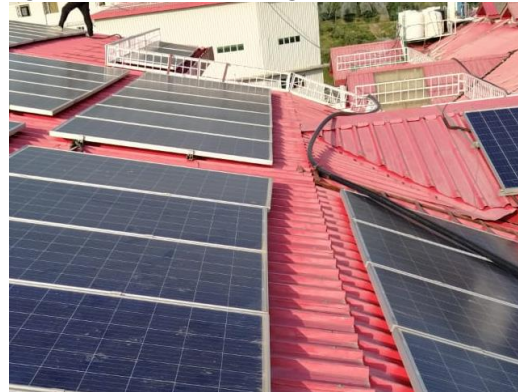
Figure 583: Multiple orientations on site.

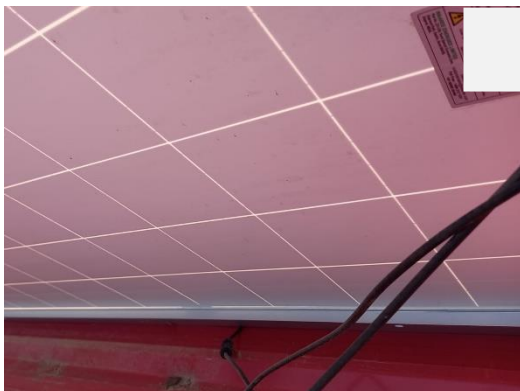
Figure 586: Missing module to module bonding.

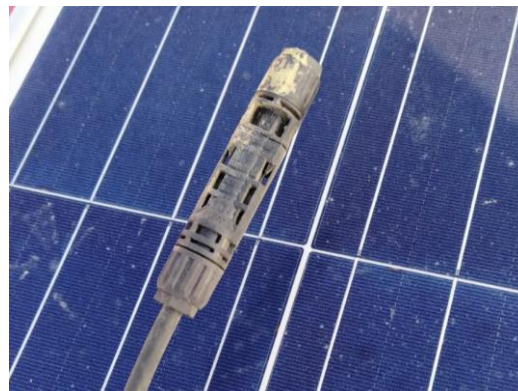
Figure 587: Disconnected connector due to poor crimping.

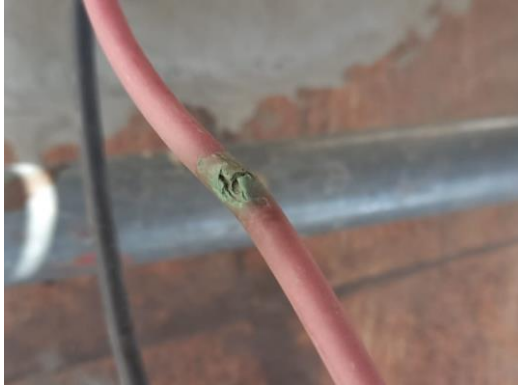
Figure 594: Cut and burn mark on string cable.

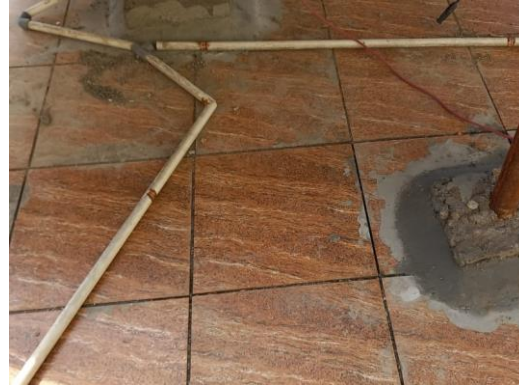
Figure 595: Broken cable conduits.

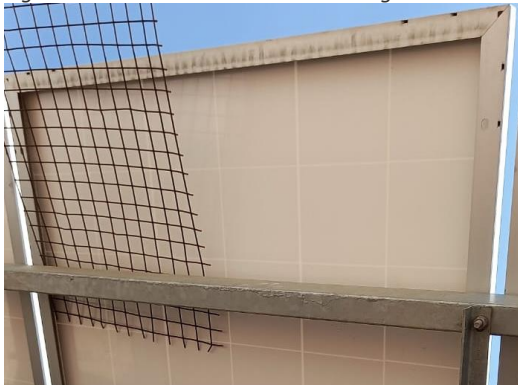
Figure 596: Foreign objects under module.

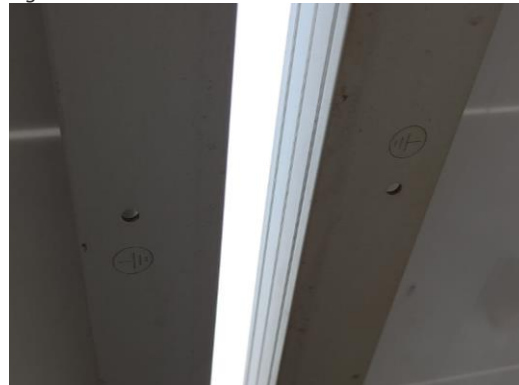
Figure 597: Missing module to module bonding.

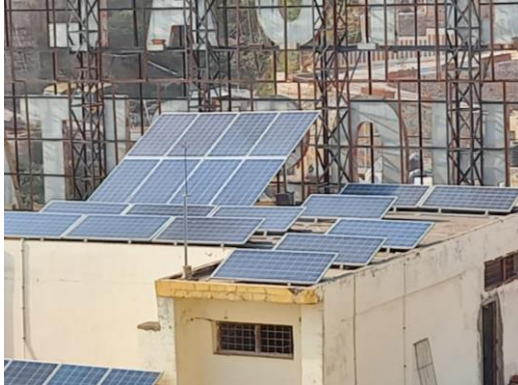
Figure 598: Modules installed in high wind zones.

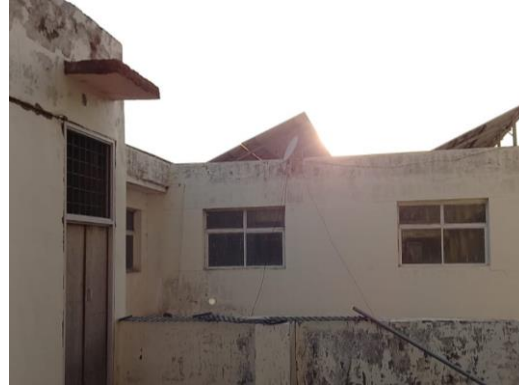
Figure 599: Improper roof access.

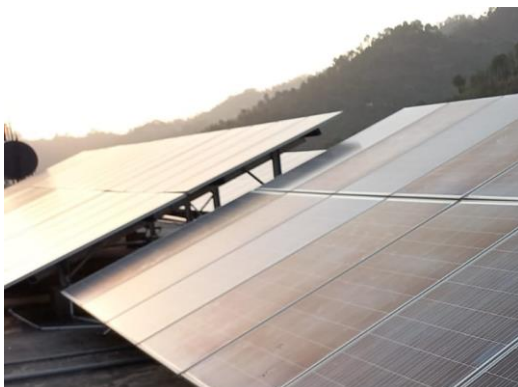
Figure 600: Shading by adjacent table.

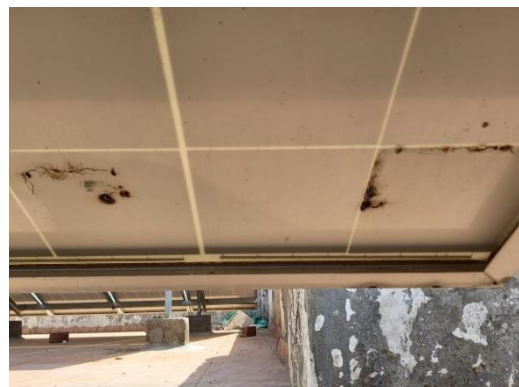
Figure 601: Backsheet burn.

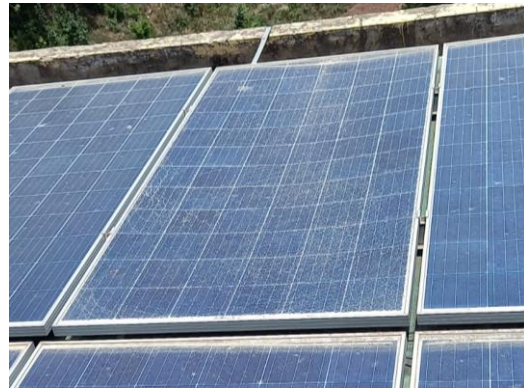
Figure 609: Module with broken glass.

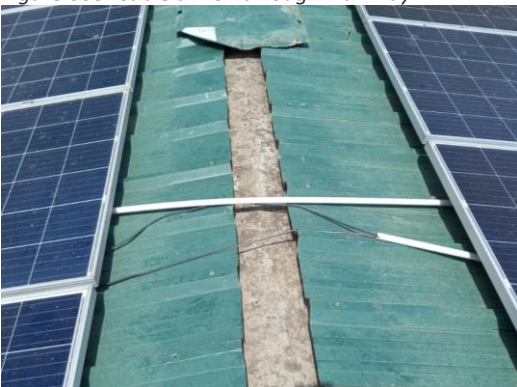
Figure 610: North and south module orientations connected to the same string.

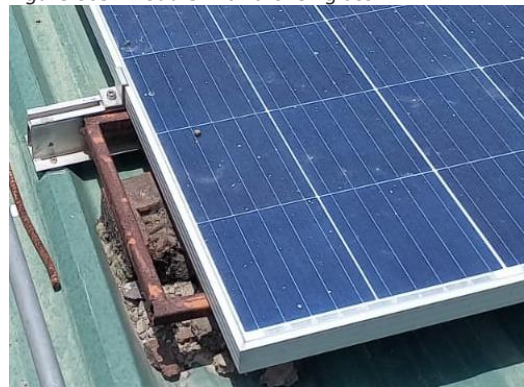
Figure 611: Rusted structure components.

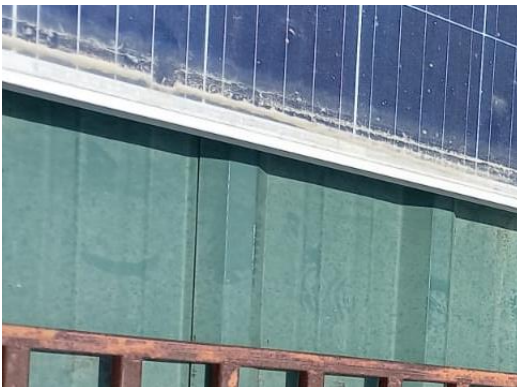
Figure 612: Module cementing.

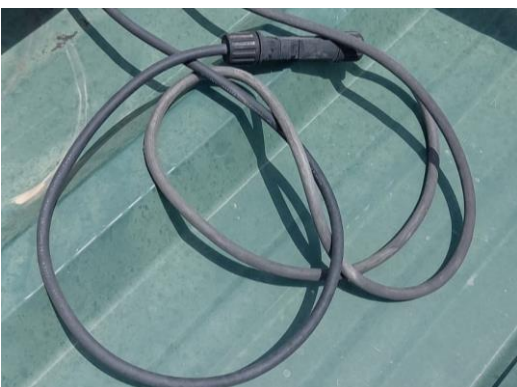
Figure 614: Degraded cable from ambient conditions.

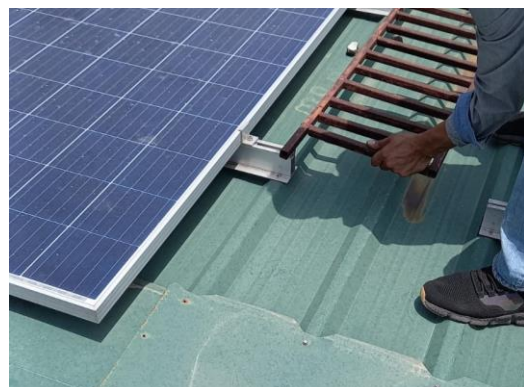
Figure 615: Walkways not properly anchored.

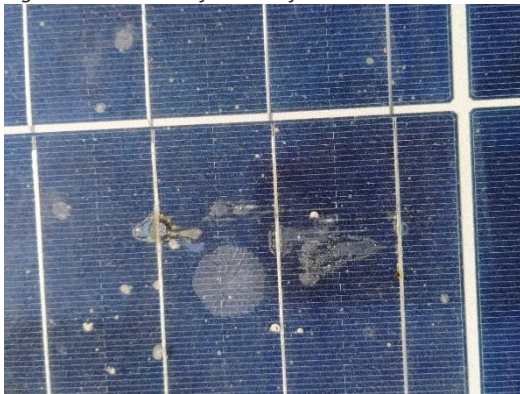
Figure 624: Cell corrosion.

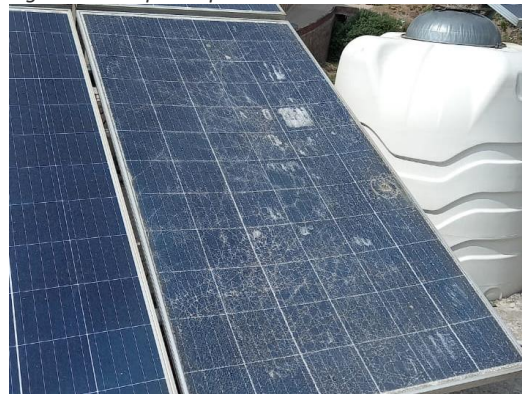
Figure 625: Broken module connected to the system.

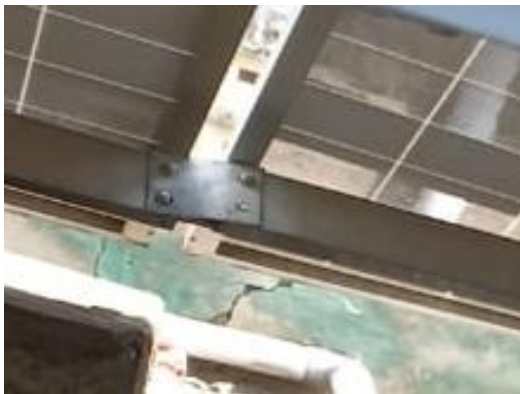
Figure 626: Improper bolting in structure.

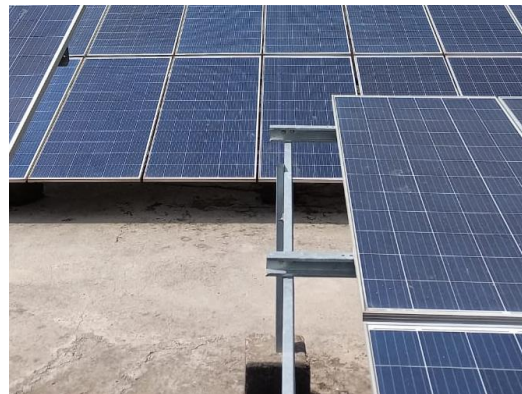
Figure 627: Excess length in table structure.

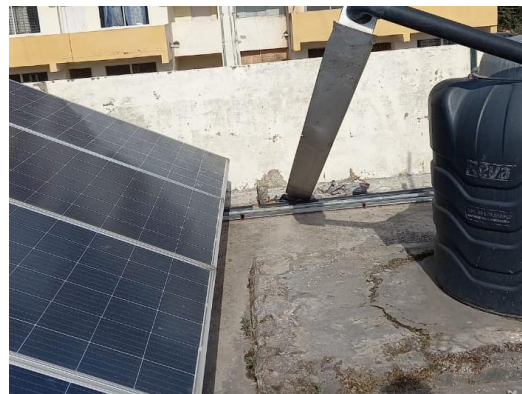
Figure 629: Cell burn marks due to hotspots from shading.

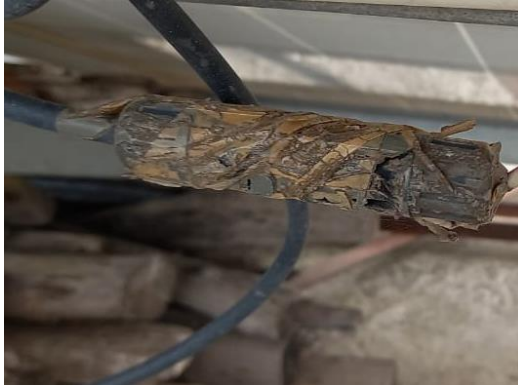
Figure 636: Damaged connector.

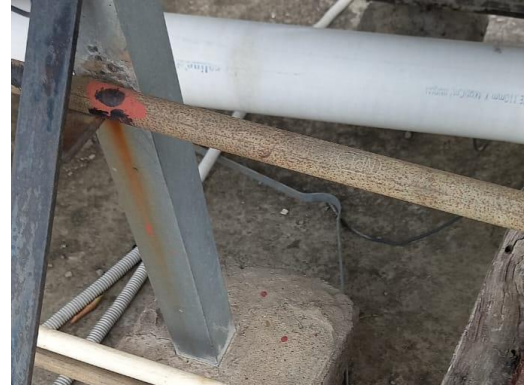
Figure 637: Disconnected earthing strip.

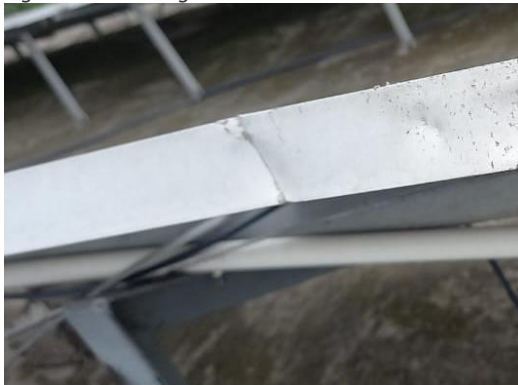
Figure 638: Damaged frame.

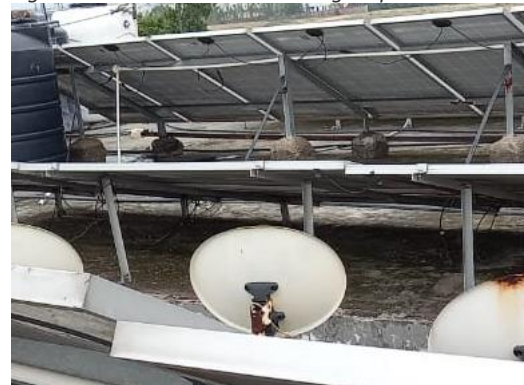
Figure 639: Misaligned vertical posts.

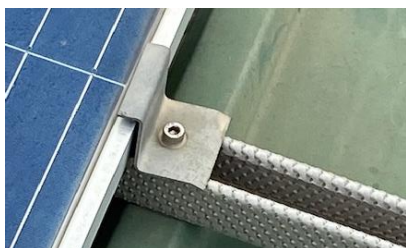
Figure 644: Improper clamping method of the modules

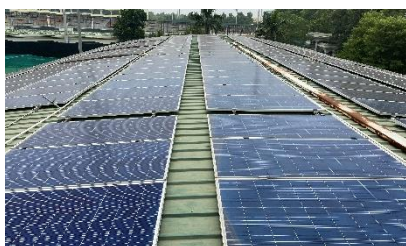
Figure 645: Insufficient ventilation.

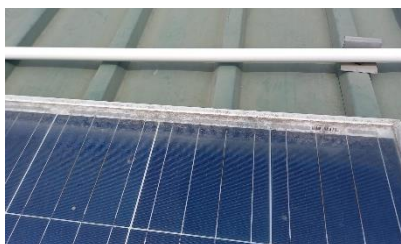
Figure 646: Soiling on the modules

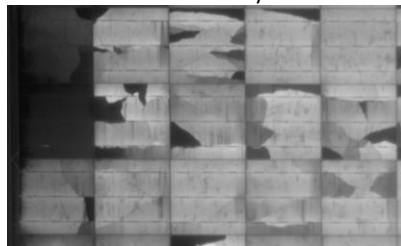
Figure 647: Isolated parts and micro-cracks

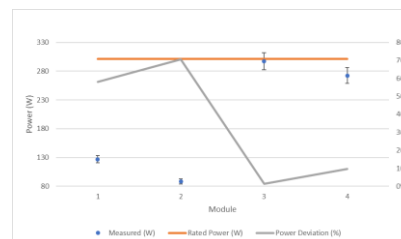
Figure 648: IV curve measurement results

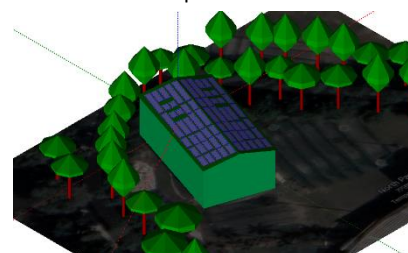
Figure 649: 3D model constructed in PVsyst

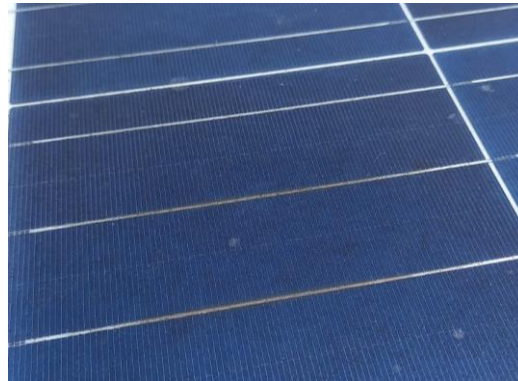
Figure 651: Busbar corrosion on some modules

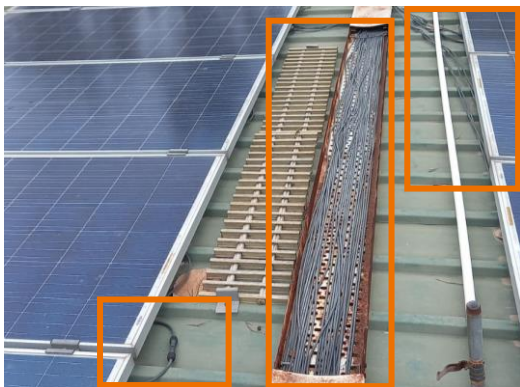
Figure 652: Cables and connectors exposed to weather

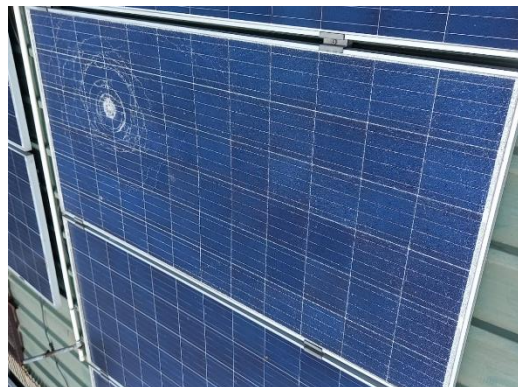
Figure 655: Connected damaged module

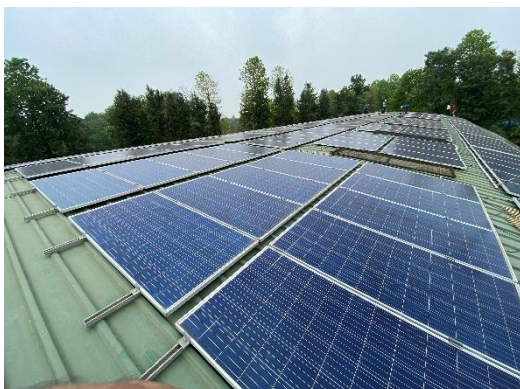
Figure 656: Modules with different tilt due to curved rooftop

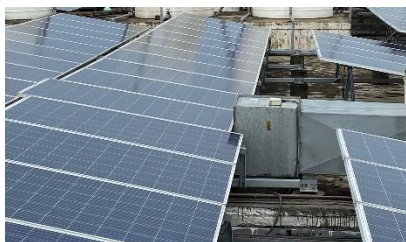
Figure 658: Exhaust ventilation towards a module

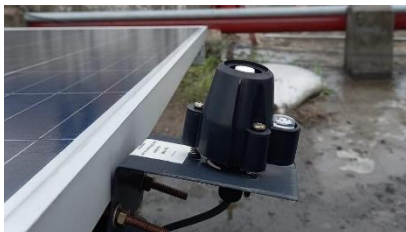
- Figure 659: Irradiance sensor not aligned to array.
- An inverter presents evidence of water leakage inside the room.

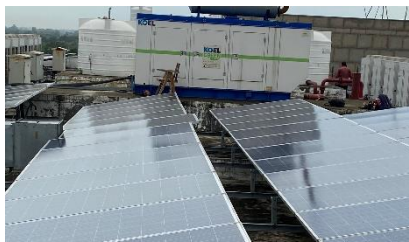
Figure 660: System shaded by several objects

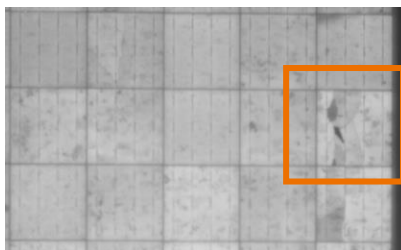
Figure 661: Isolated parts and micro-cracks

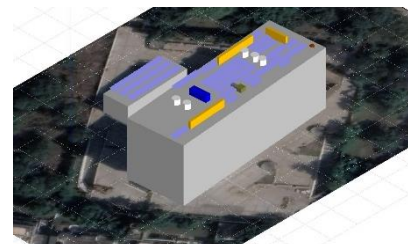
Figure 663: 3D model constructed in PVsyst

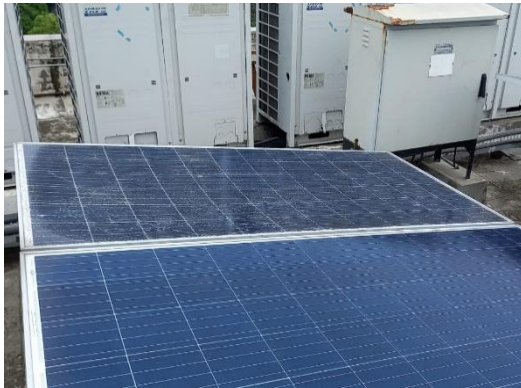
Figure 664: Damaged module

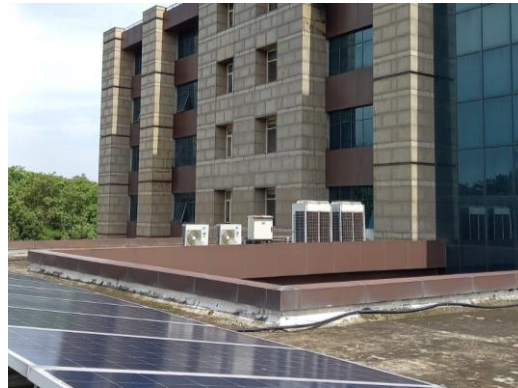
Figure 665: The 20 kWp system is shaded by a building

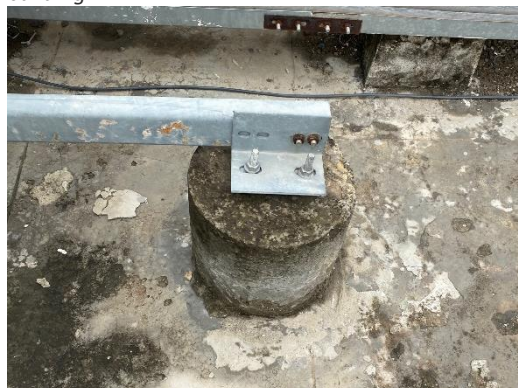
Figure 667: Rusted elements of the foundation

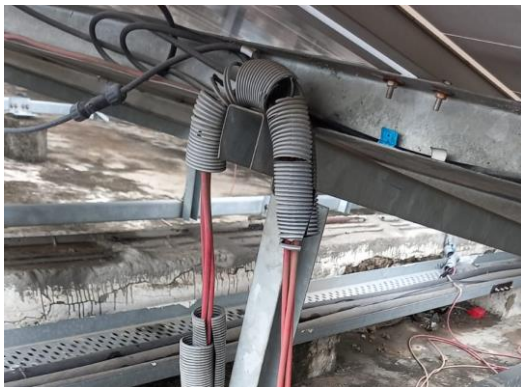
Figure 668: PV cable conduit degraded

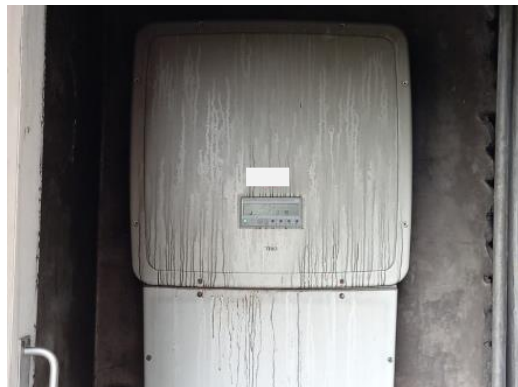
Figure 669: Inverter with evidence of water leakage

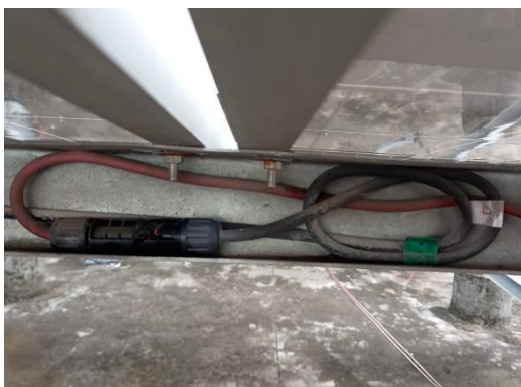
Figure 670: Minimum bending radius not considered

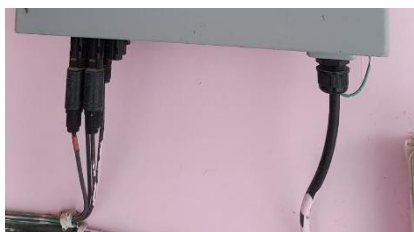
Figure 672: No string labelling

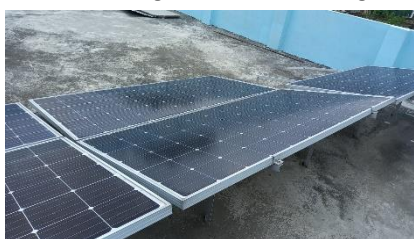
Figure 673: Different tilted modules due to bent structure

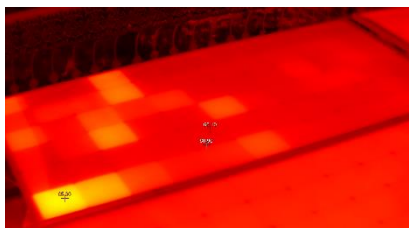
Figure 674: Hot cells on shaded module

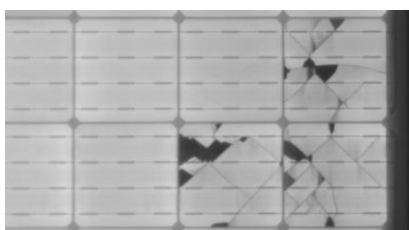
Figure 675: Broken cells from EL imaging

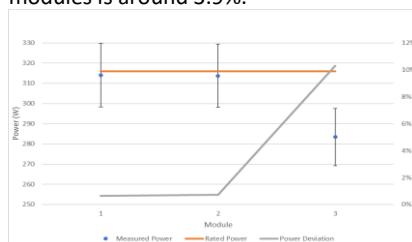
Figure 676: IV curve measurement results

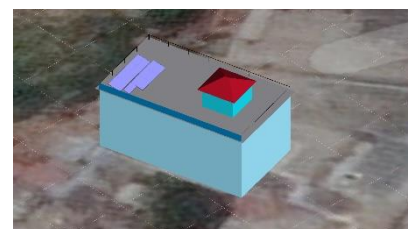
Figure 677: 3D model constructed in PVsyst

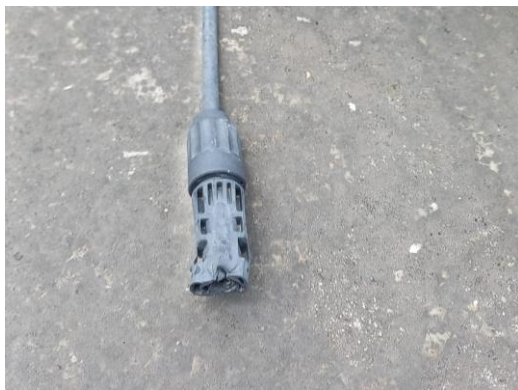
Figure 680: Burnt cable connector

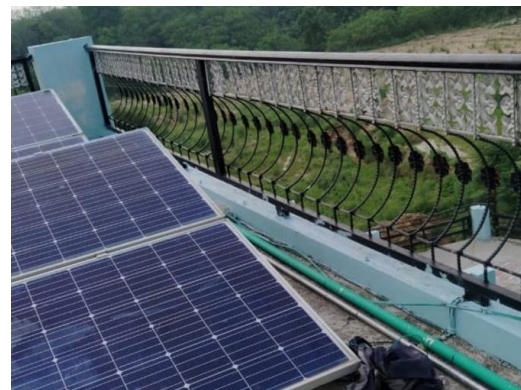
Figure 681: Shaded module by side rail

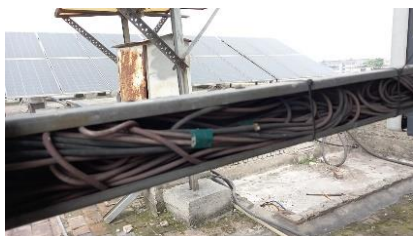
Figure 686: Cable layout.

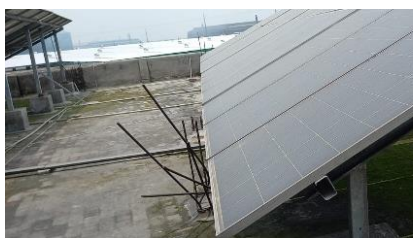
Figure 687: Shading by iron rods.

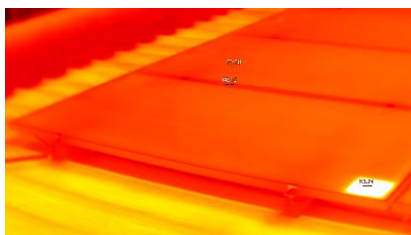
Figure 688: Hot cells from IR imaging.

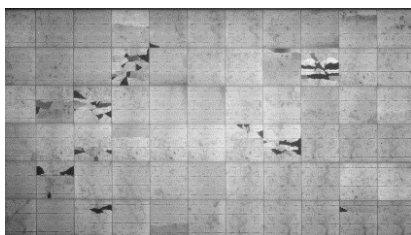
Figure 689: Defects from EL imaging.

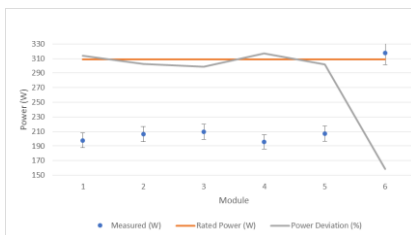
Figure 690: IV curve measurement results.

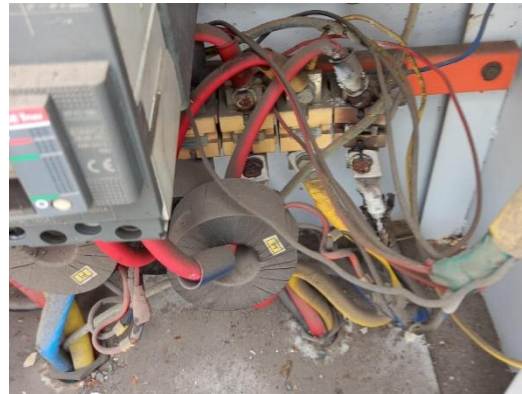
Figure 693: Burnt wire in mains.

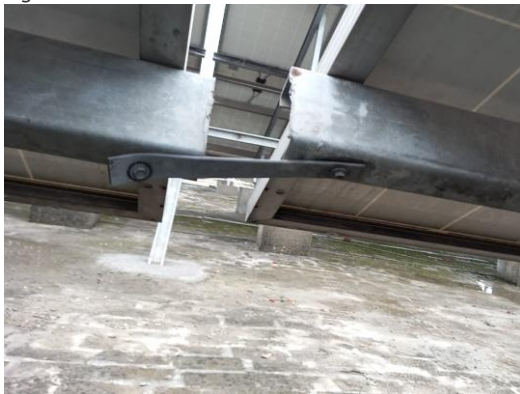
Figure 694: Loose earthing strips and misaligned structure purlins.

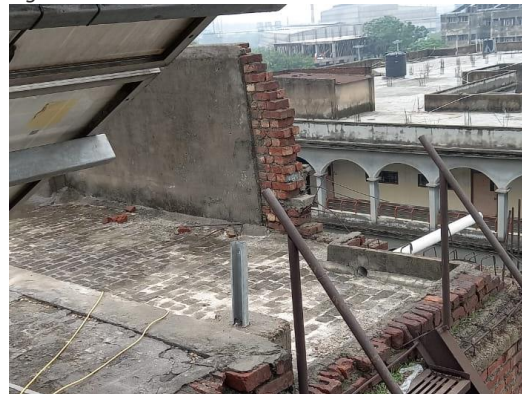
Figure 695: Missing safety railings.

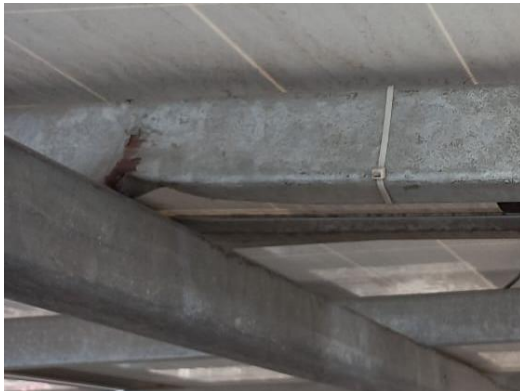
Figure 696: Bent and damaged structure.

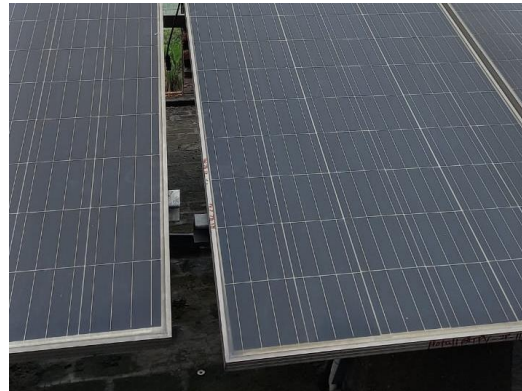
Figure 697: Module and structure misalignment.

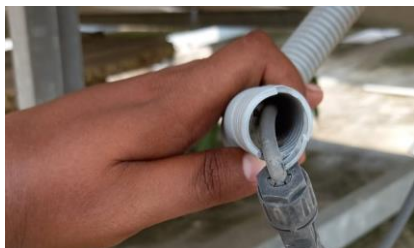
Figure 700: Cable conduit without foam

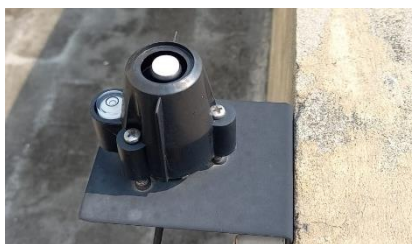
Figure 701: Irradiance sensor not aligned to plane of array

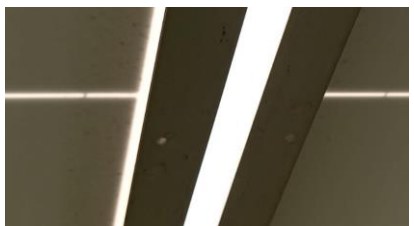
Figure 702: No EPB between modules

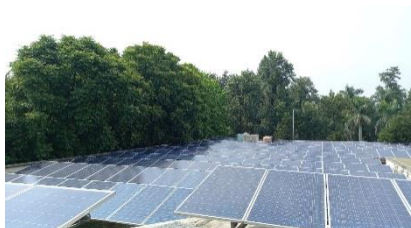
Figure 703: System shaded by trees

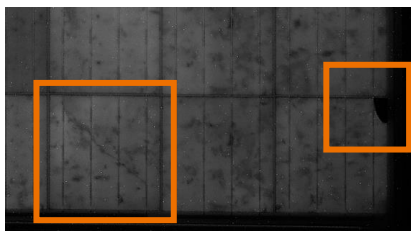
Figure 704: Isolated parts and micro-crack

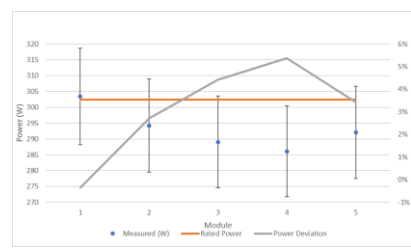
Figure 705: IV curve measurement results

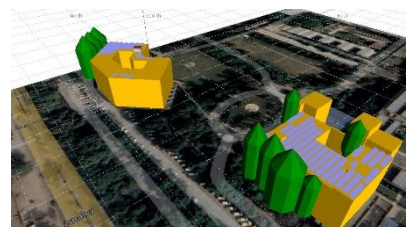
Figure 706: 3D model constructed in PVsyst

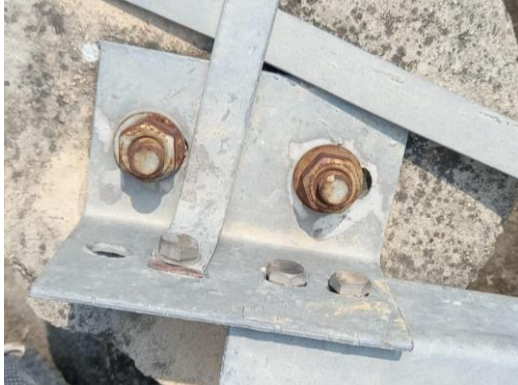
Figure 707: Rusted elements of the earth stripe

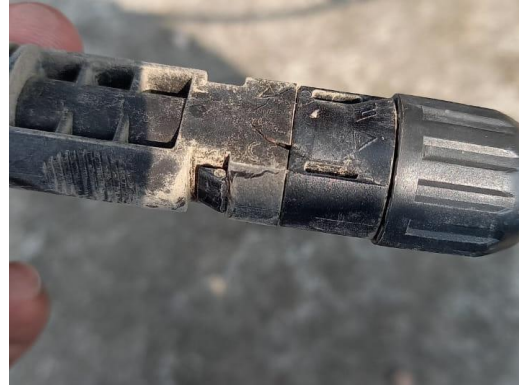
Figure 708: Broken MC4 connector

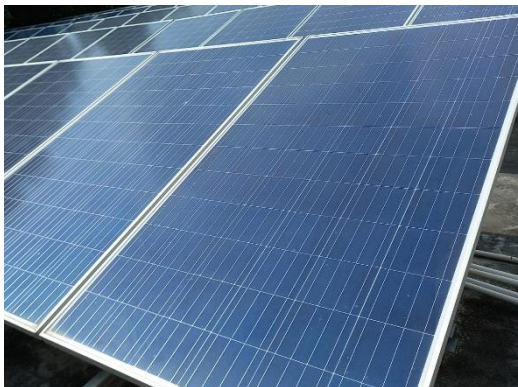
Figure 709: Cleanliness of modules

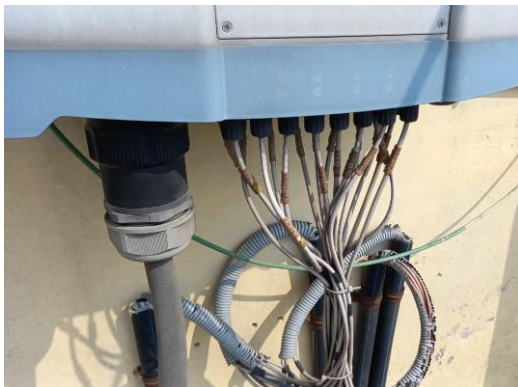
Figure 711: PV cable conduit degraded

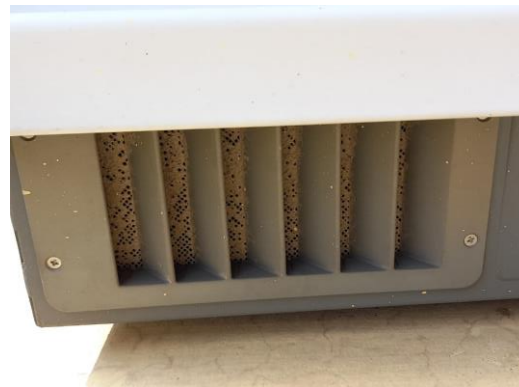
Figure 712: Soiled filters of inverter

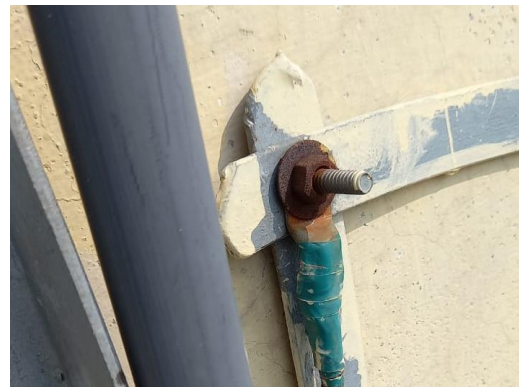
Figure 714: Earthing contacts corroded

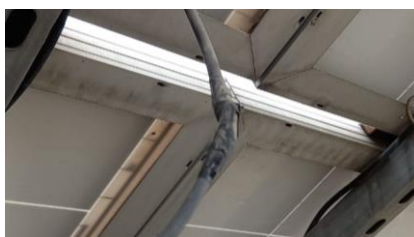
Figure 715: Cable layout.

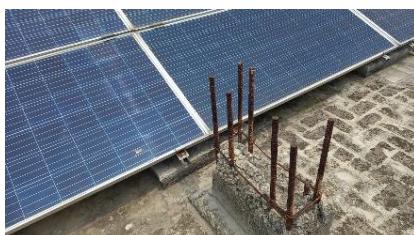
Figure 716: Shading by iron rods.

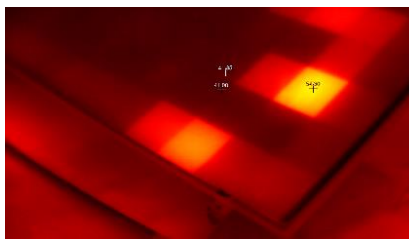
Figure 717: Hot cells from IR imaging.

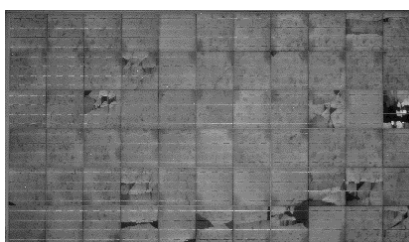
Figure 718: Defects from EL imaging.

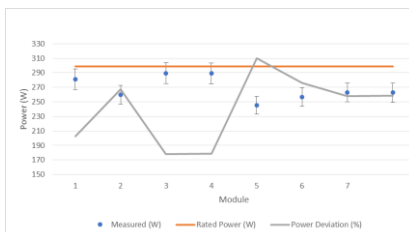
Figure 719: IV curve measurement results.

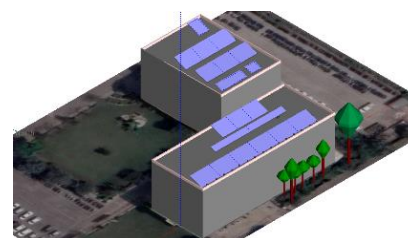
Figure 720: 3D model constructed in PVsyst.

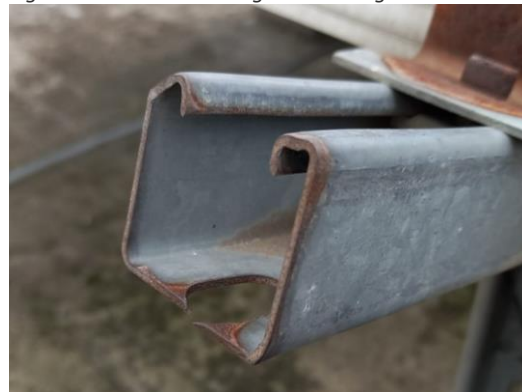
Figure 724: Sharp and rusted purlin edge.

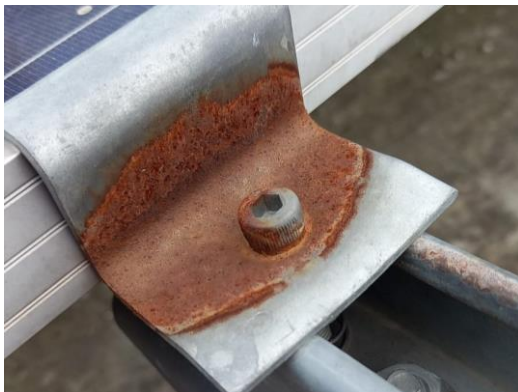
Figure 725: Rusty clamps.

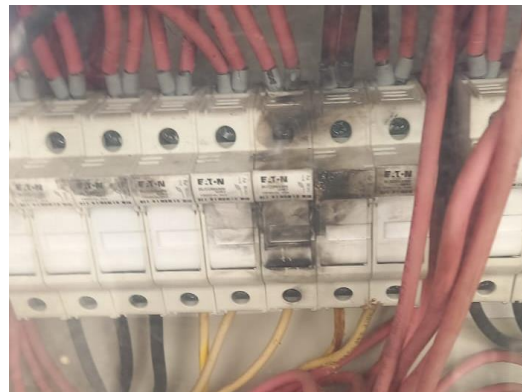
Figure 726: Burned fuse.

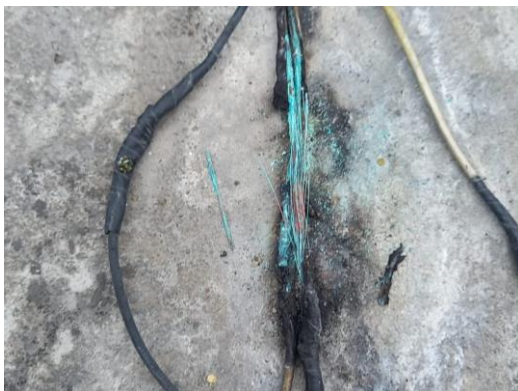
Figure 727: Broken cables and exposed wires.

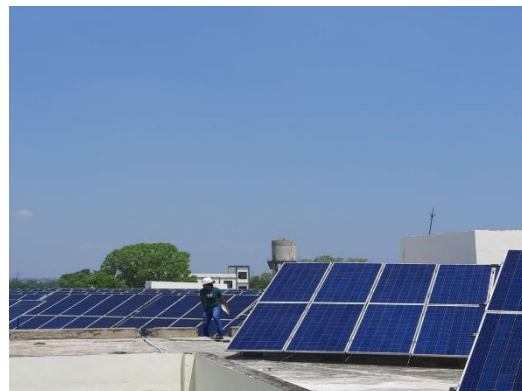
Figure 728: Orientations overview.

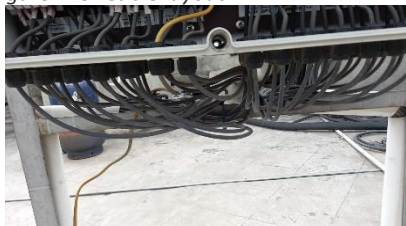
Figure 730: Missing string labelling at inverter end.

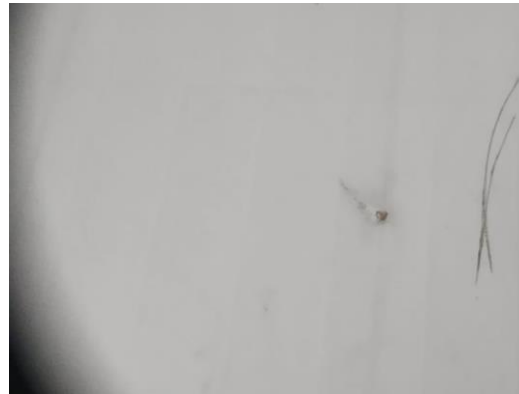
Figure 737: Module with backsheet damage.

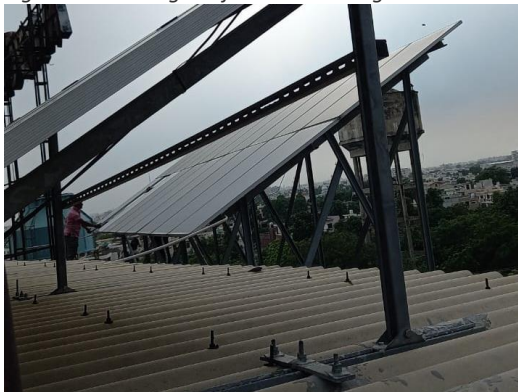
Figure 738: Table structure bolted through asbestos.

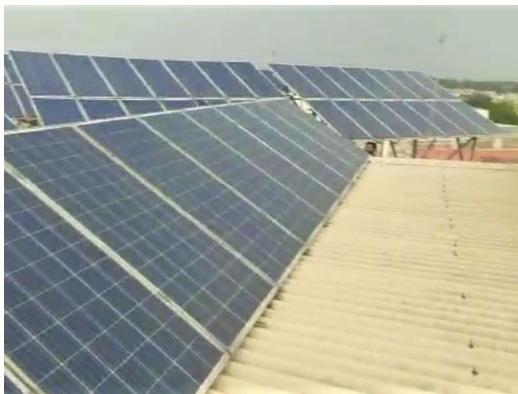
Figure 740: Multiple orientations found on site.

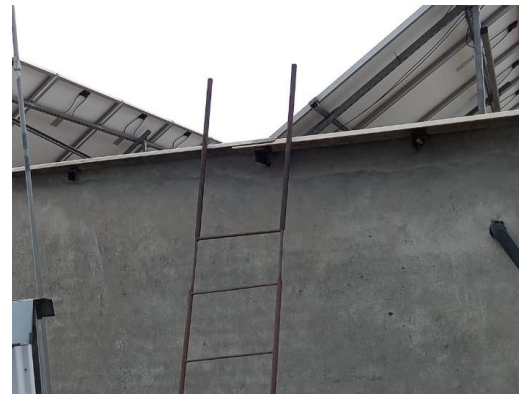
Figure 741: Improper roof access.

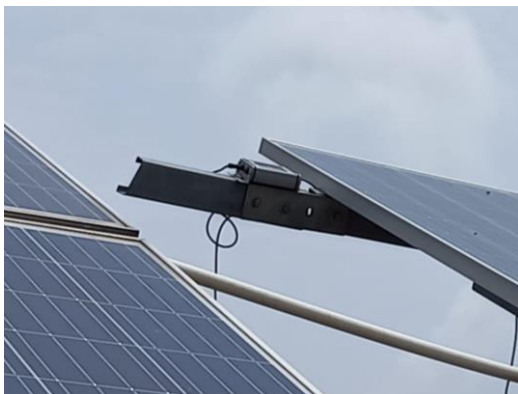
Figure 742: Irradiance sensor.

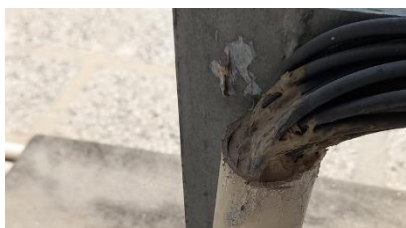
Figure 745: Cable conduit with foam.

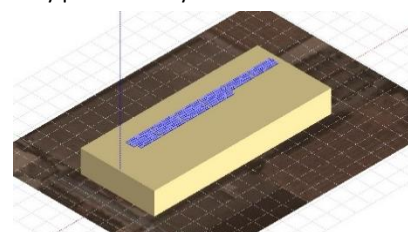
Figure 751: 3D model constructed in PVsyst.

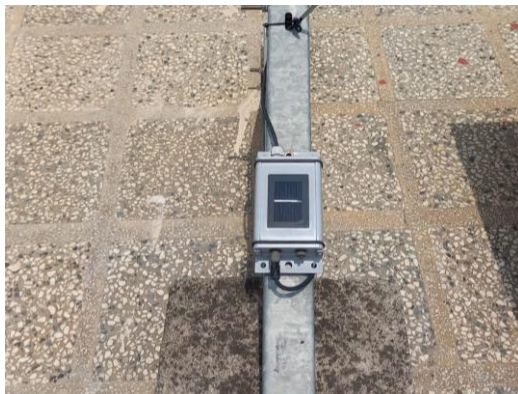
Figure 756: Irradiance sensor found on site.

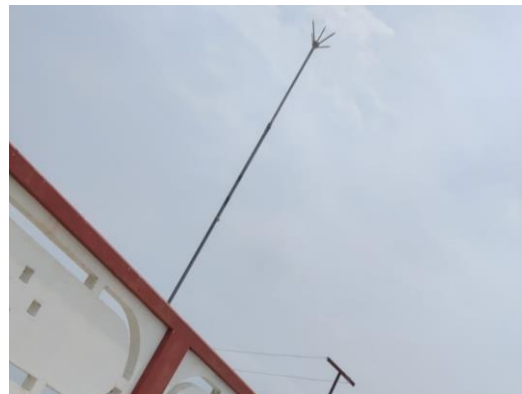
Figure 757: LA found on site.

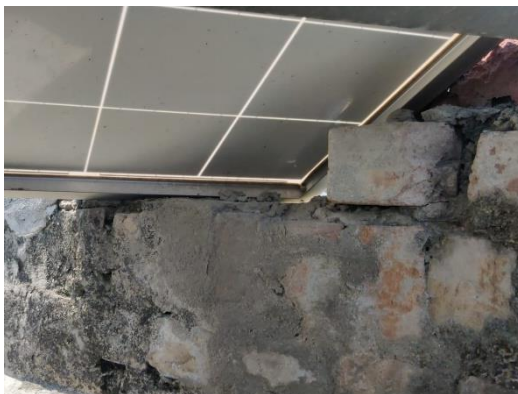
Figure 758: Module placed on parapet wall.

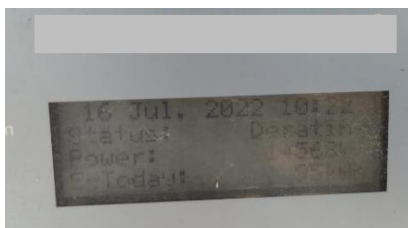
Figure 761: Inverter running in derating mode.
