Evaluation of Underperforming Rooftop PV Plants in India – Moving from kW to kWh Part II

Phase I: Evaluation of 65 Rooftop PV Plants in India
(Jammu, Uttar Pradesh, Gujarat, Maharashtra, West
Bengal, Himachal Pradesh, Punjab and Kerala)

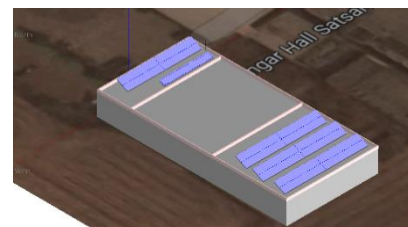
Figure 766: 3D model constructed in PVsyst.

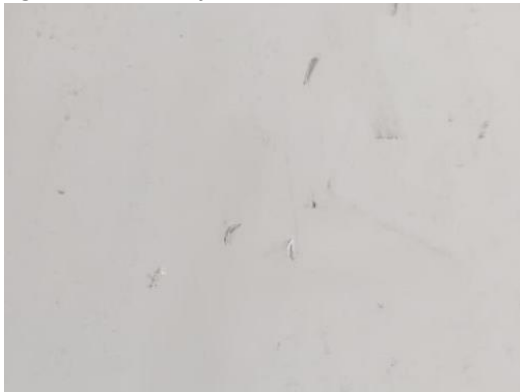
Figure 769: Backsheet damage.

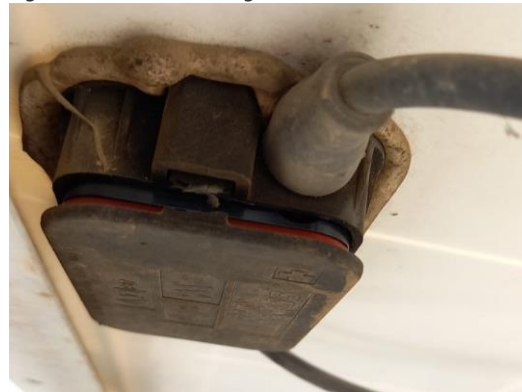
Figure 770: Damaged J-box cover.

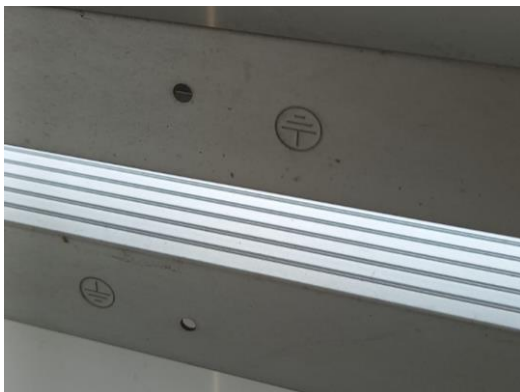
Figure 771: Missing module to module bonding.

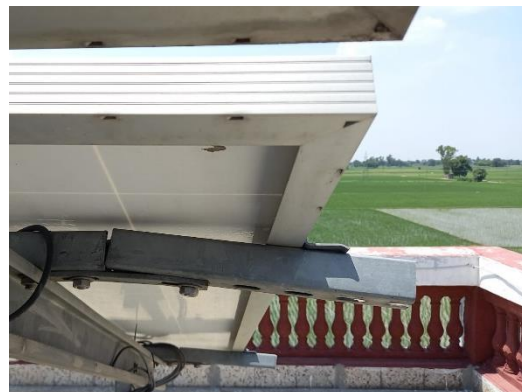
Figure 772: Bent structure.

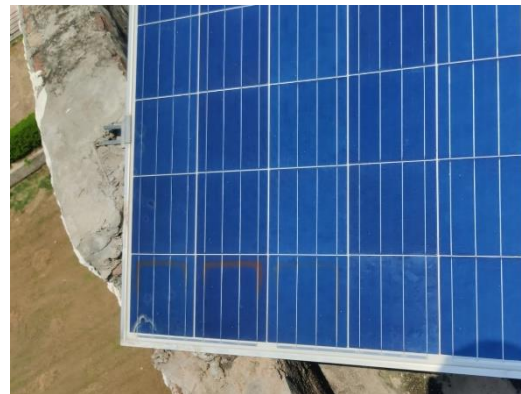
Figure 786: Cell damage from reduced heat dissipation.

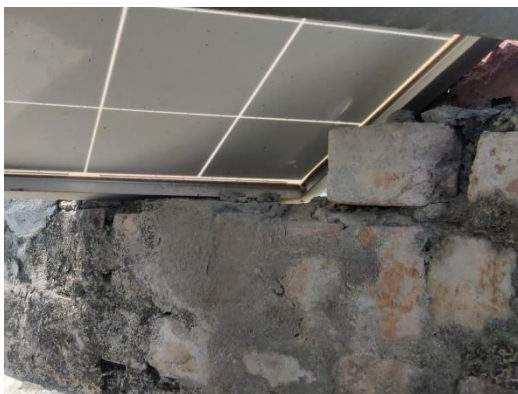
Figure 787: Module placed on parapet wall.

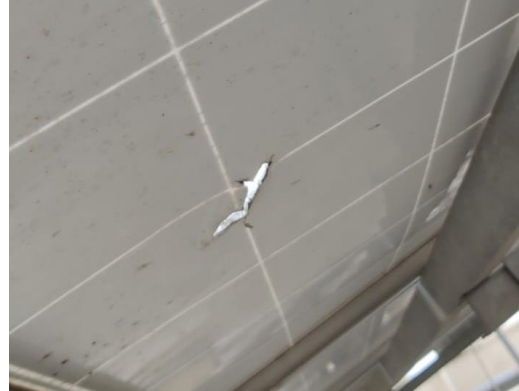
Figure 796: Damaged backsheet.

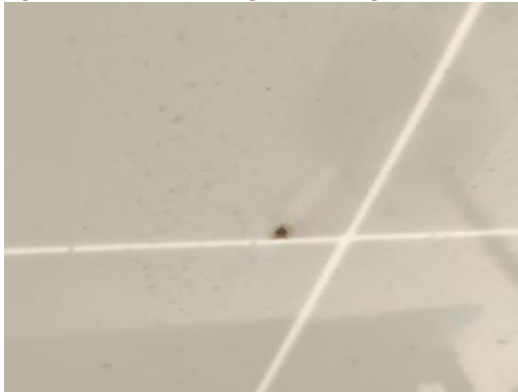
Figure 797: Burned backsheet.

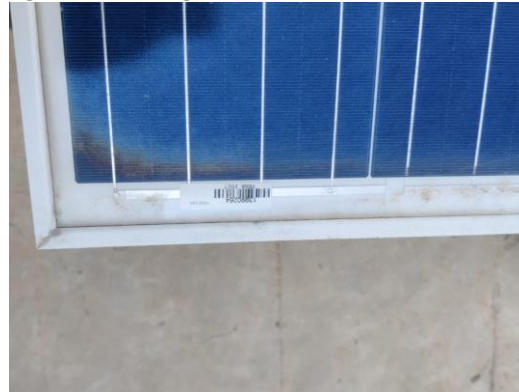
Figure 798: Module cementing.

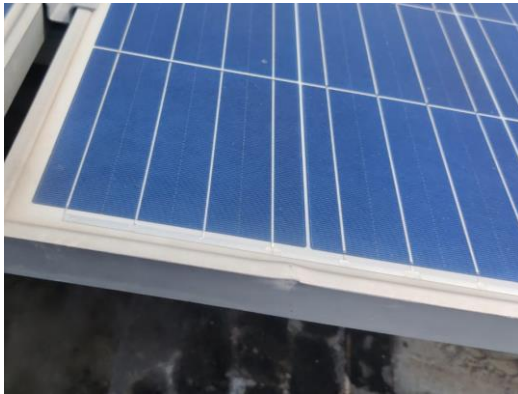
Figure 809: Module with damaged frame.

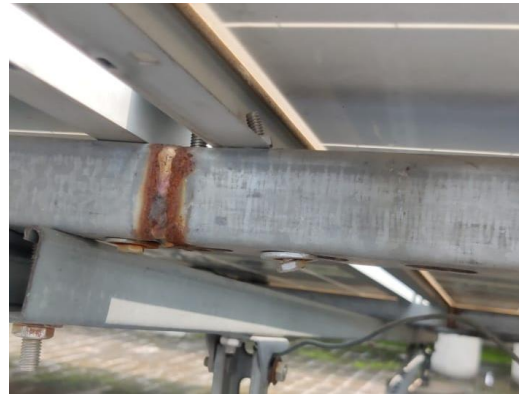
Figure 810: Rusty purlin.

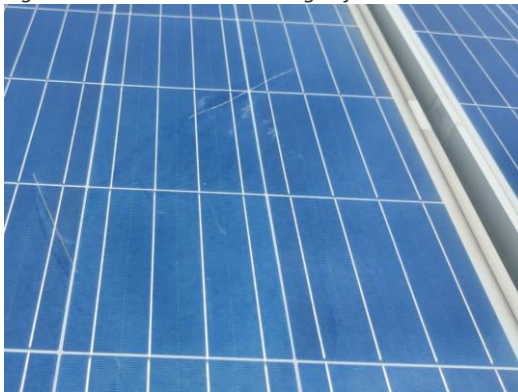
Figure 811: Module glass scratch.

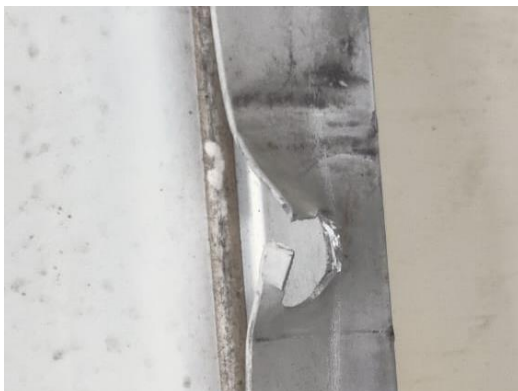
Figure 815: Damaged frame.

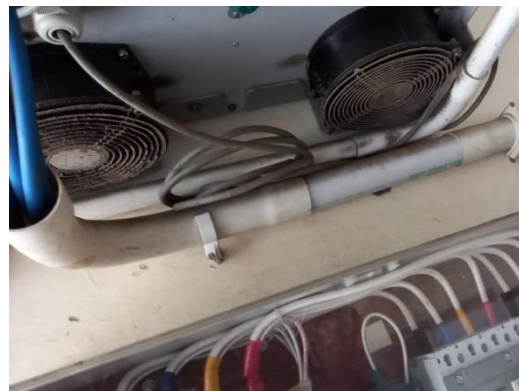
Figure 816: Soiled inverter fans.

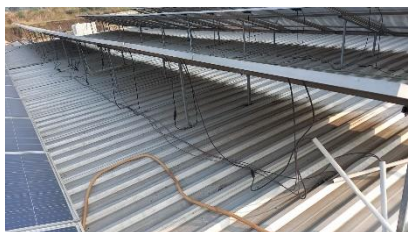
Figure 817: Cables hanging under the tables.

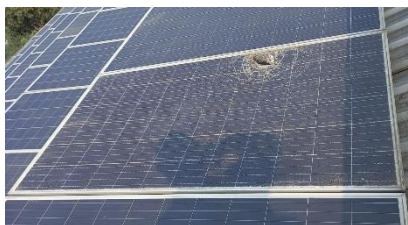
Figure 818: Broken module

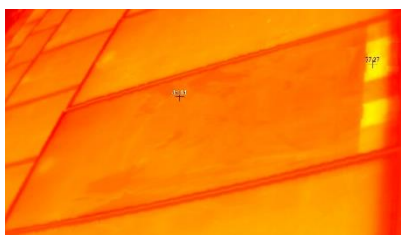
Figure 819: Hot cells due to reduced inter-row distance.

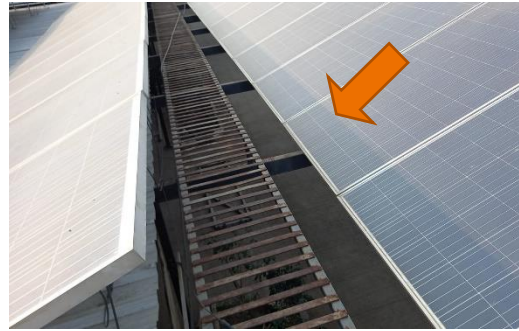
Figure 824: Interrow shading and corroded walkway

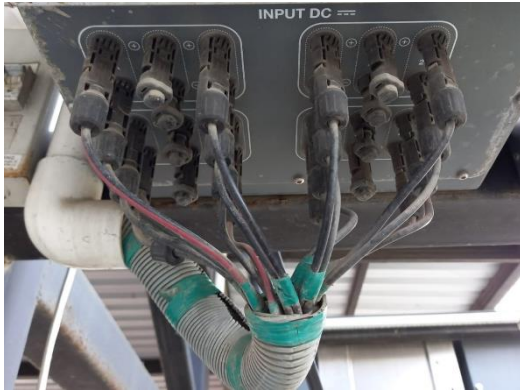
Figure 825: No string labelling at inverter end

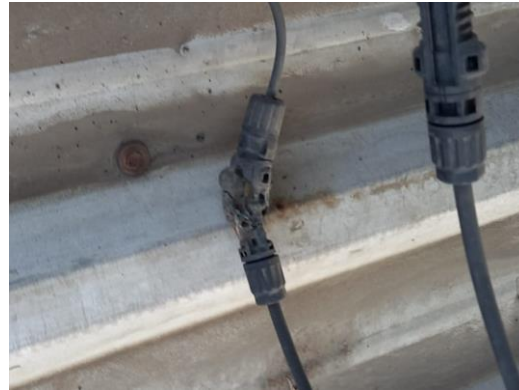
Figure 826: Burnt connector

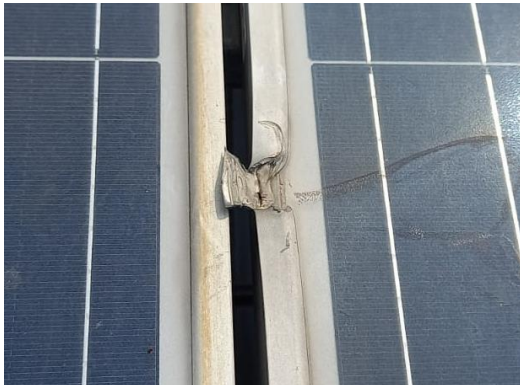
Figure 827: Mechanical damage of the frame

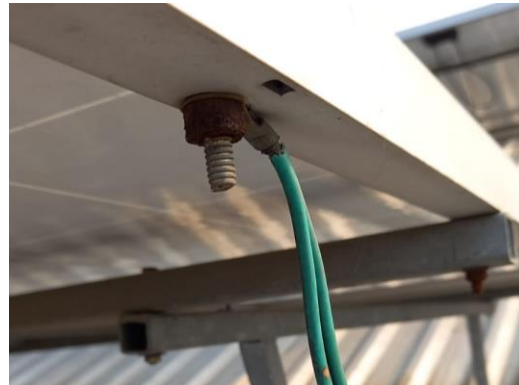
Figure 828: Rusty contact of structural earthing.

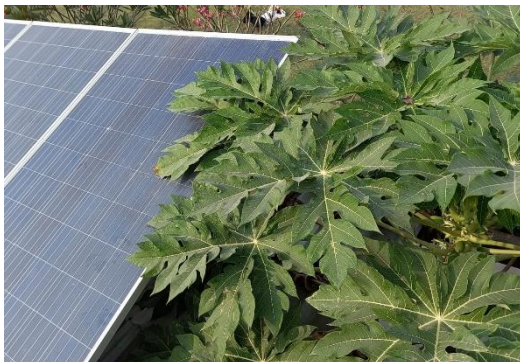
Figure 829: Edge module shaded by nearby tree.

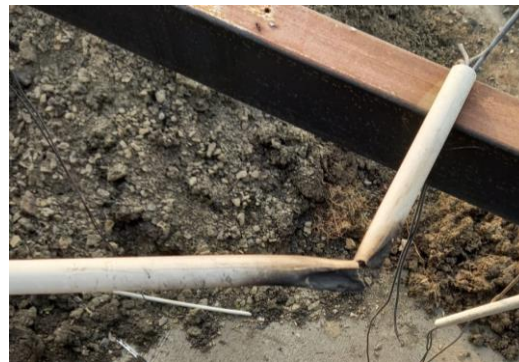
Figure 830: Degraded cable conduit.

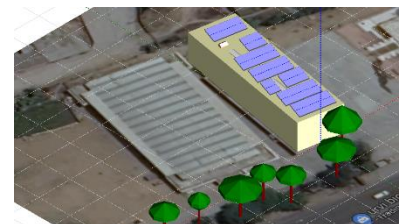
Figure 836: 3D model constructed in PVsyst.

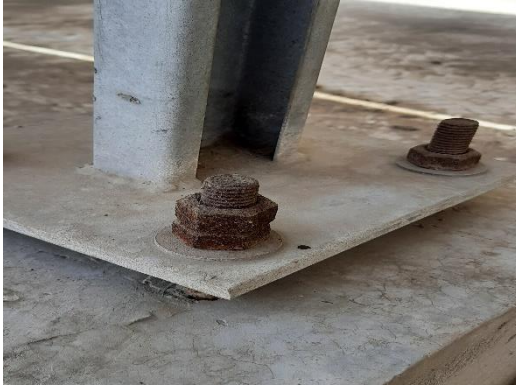
Figure 837: Rusted structure bolts.

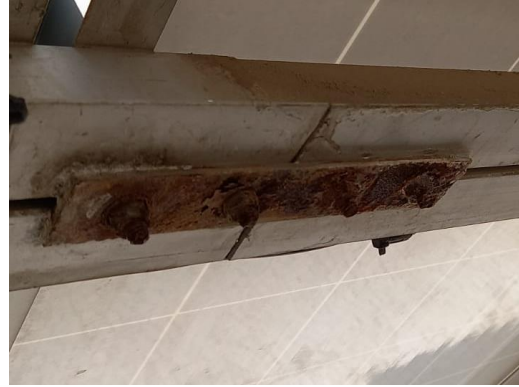
Figure 838: Rusted bolts and joints.

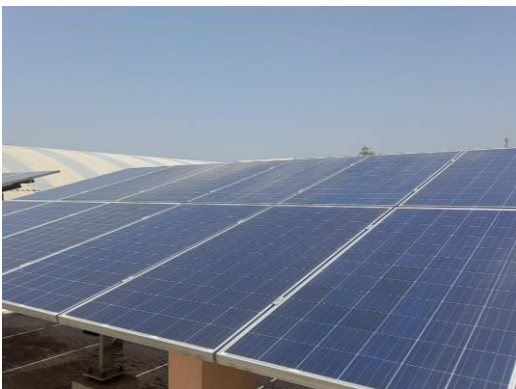
Figure 839: Soiling condition of modules.

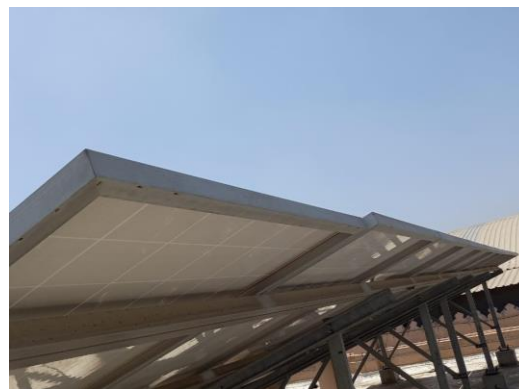
Figure 840: Module misalignment.

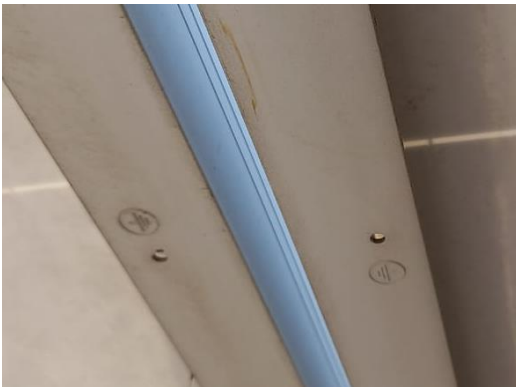
Figure 841: Missing module-to-module bonding.

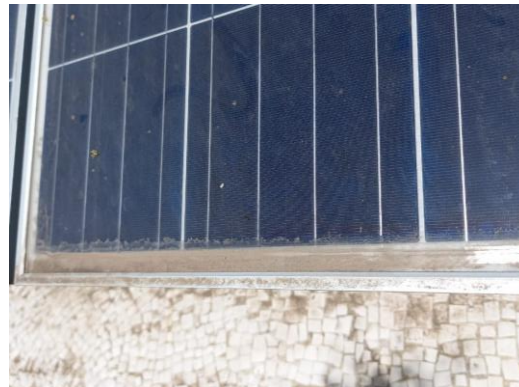
Figure 842: Module cementing.

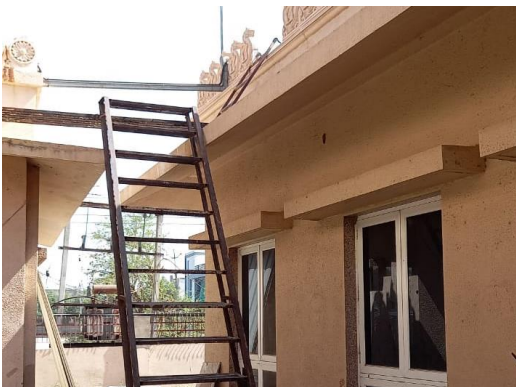
Figure 843: Improper roof access.

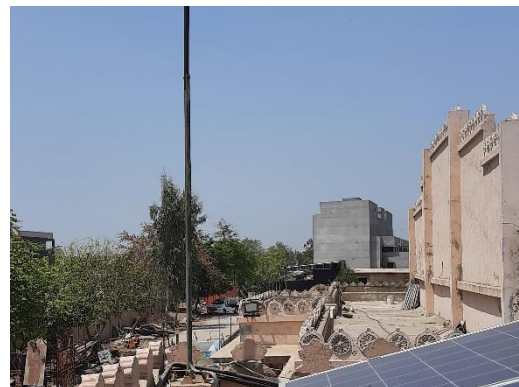
Figure 844: Shading by LA.

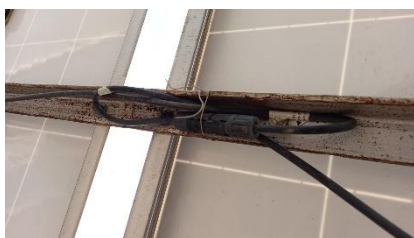
Figure 845: Bending radius not considered

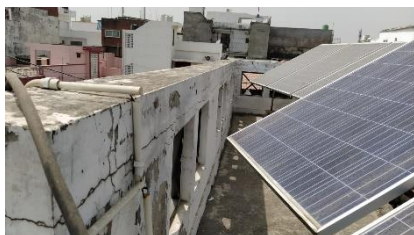
Figure 846: Design disregards building's parapet

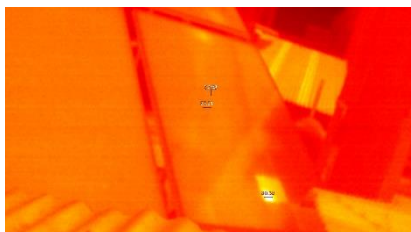
Figure 847: Hot spot in shaded module

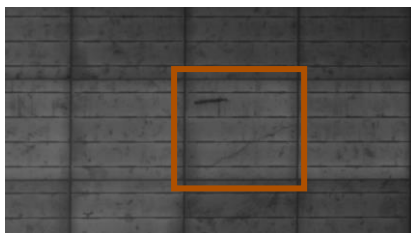
Figure 848: Scratch and microcrack on cell

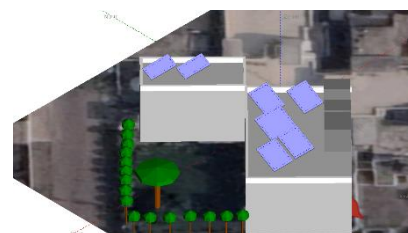
Figure 850: 3D model constructed in PVsyst

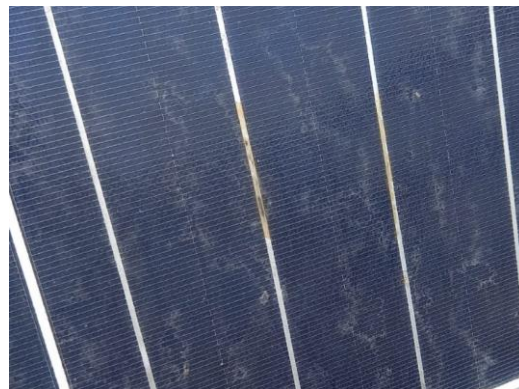
Figure 854: Burnt busbar

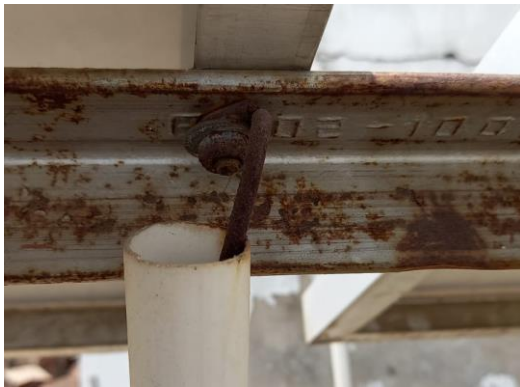
Figure 855: Non-conventional structural earthing

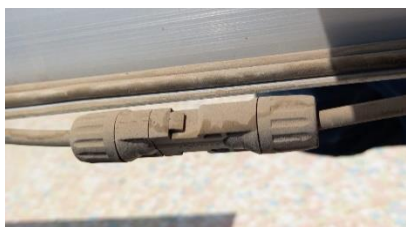
Figure 859: Cable layout.

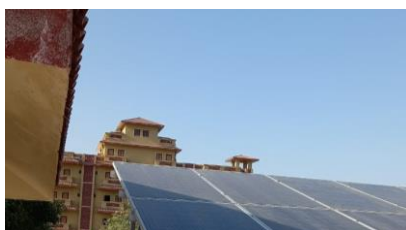
Figure 860: Module shading by taller roof.

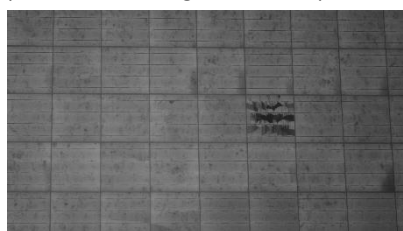
Figure 862: Defects from EL imaging.

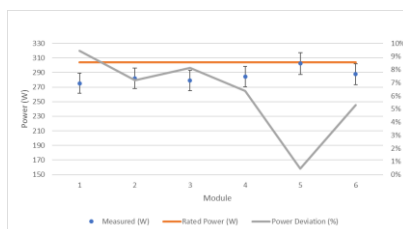
Figure 863: IV curve measurement results.

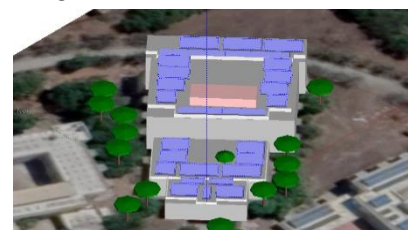
Figure 864: 3D model constructed in PVsyst.

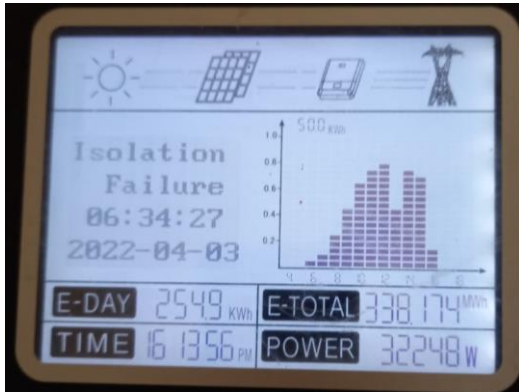
Figure 865: Isolation failure in an inverter.

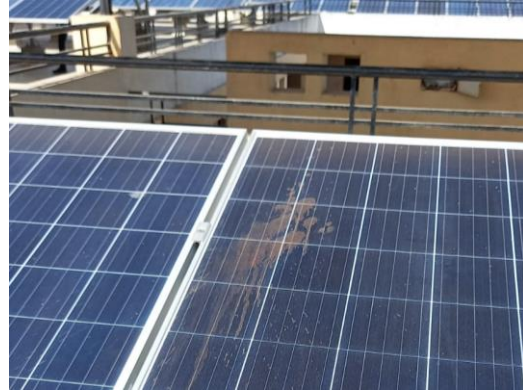
Figure 866: Paint remains stuck on glass.

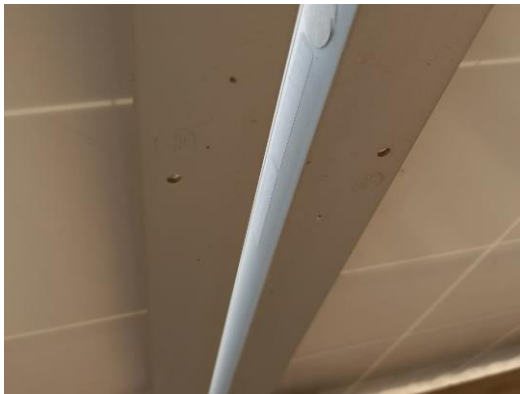
Figure 867: Missing module to module bonding.

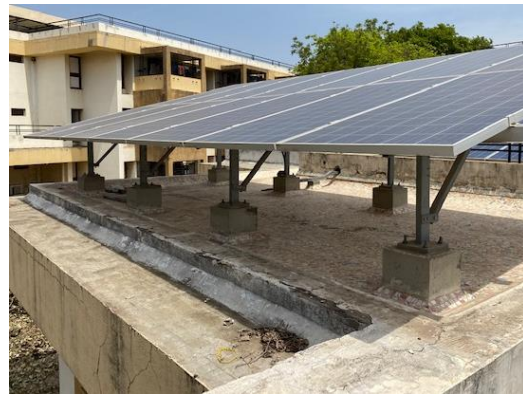
Figure 868: Tables in high wind zones.

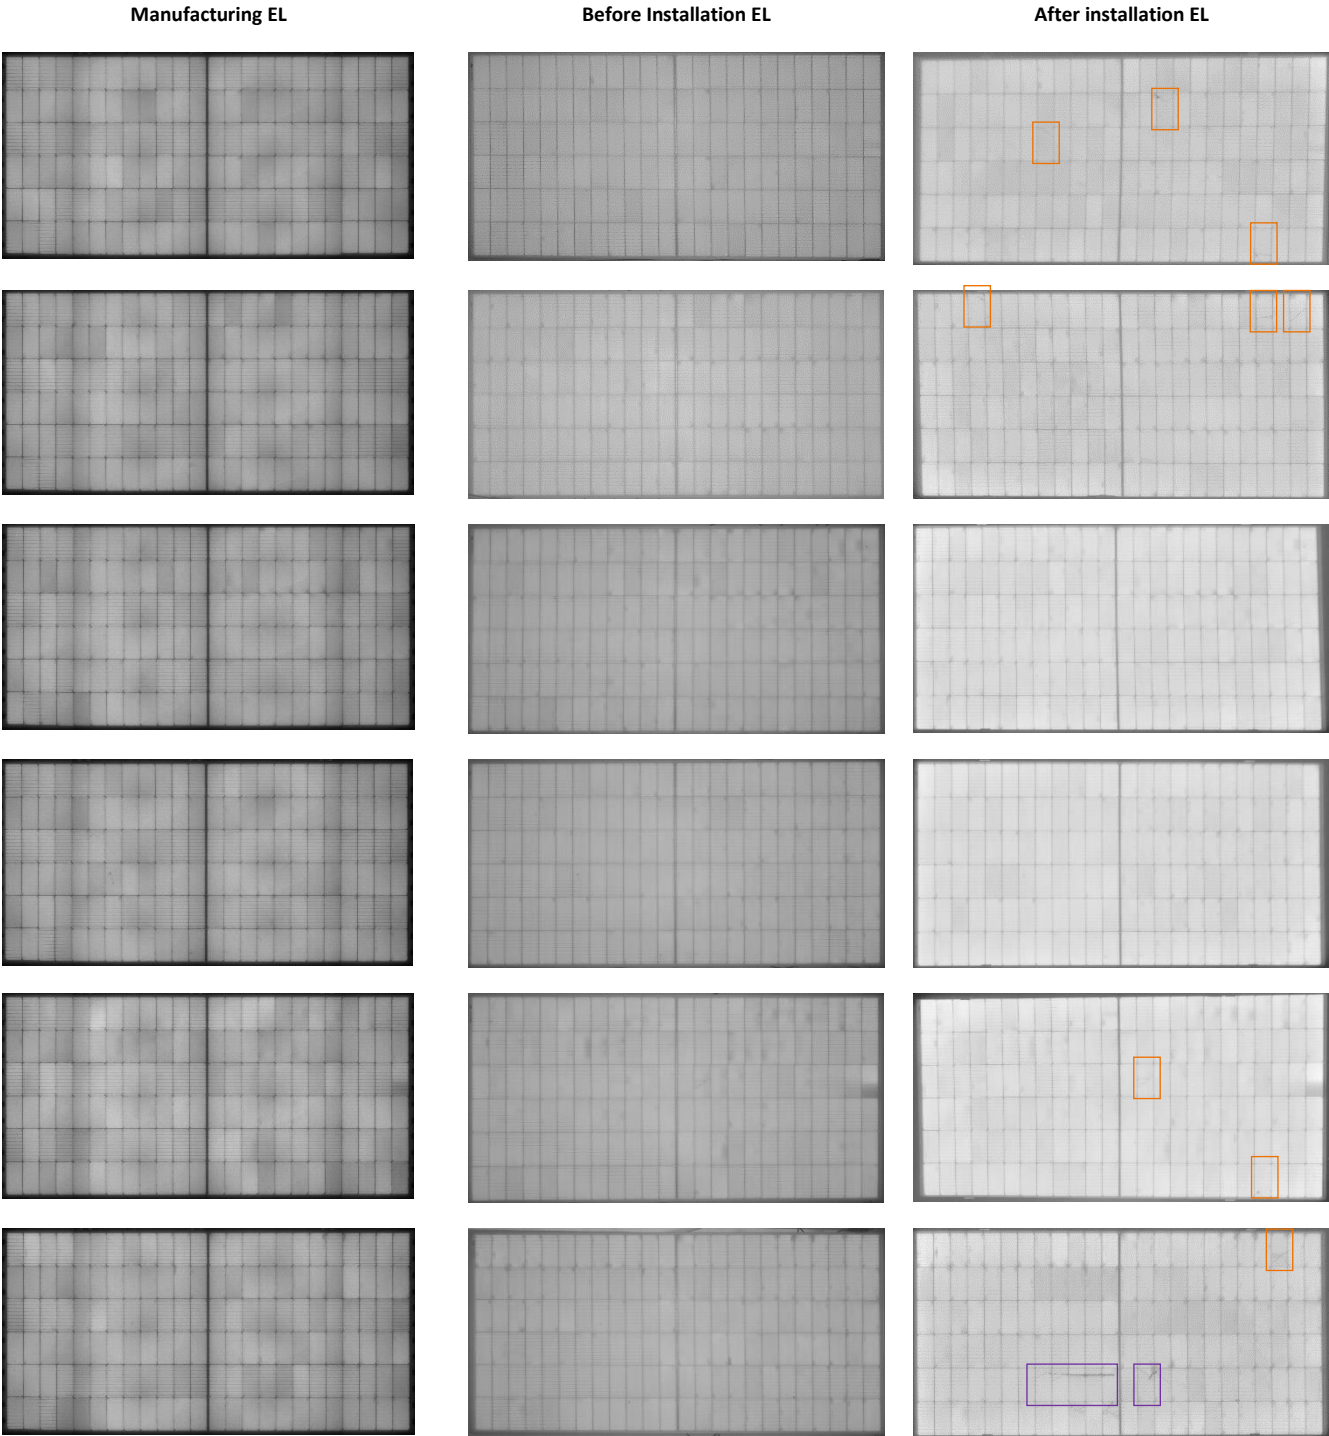
Abstract: The purpose was the evaluation of crack evolution from manufacturing until installation. PV Module damages are often a result of shipping on fragile wood pallets and boxes with partial loads. Similarly, module handling, transport and installation are important sources of module damages. Furthermore, new technologies (i.e., Half-cut cells, Tiling Ribbon Technology, M10, M12 cell sizes, etc.) have also brought new sources of cracking.

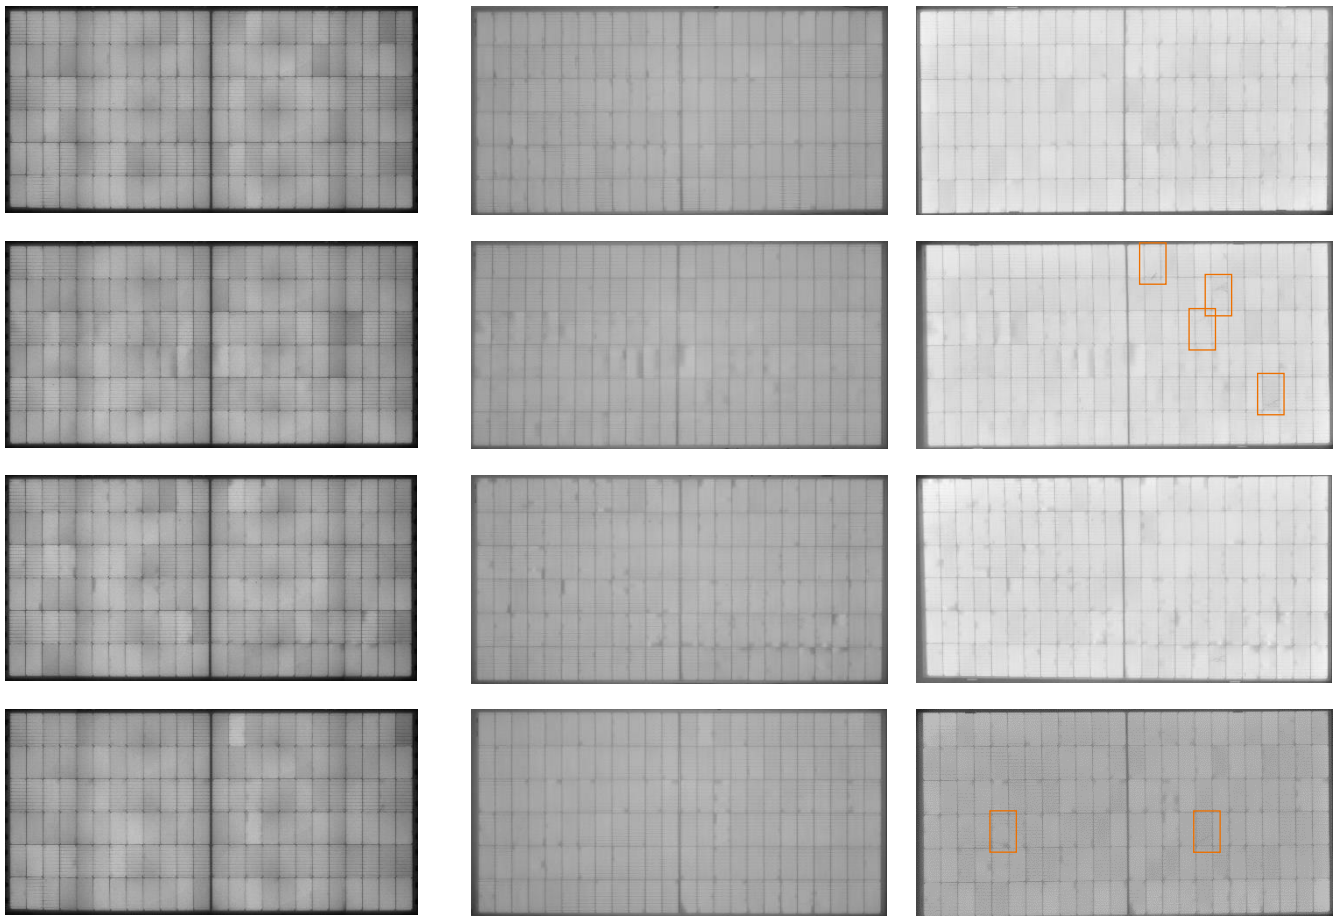
PV Module damages are often due to shipping on fragile wood pallets and boxes with partial loads. Similarly, module handling, transport and installation are important sources of module damages. Hence, the purpose was the evaluation of crack evolution from manufacturing until installation. As common practice, the installers/EPC should always follow PV Module manufacturing guidelines for transportation, installation and handling, as well as PV industry best practices.

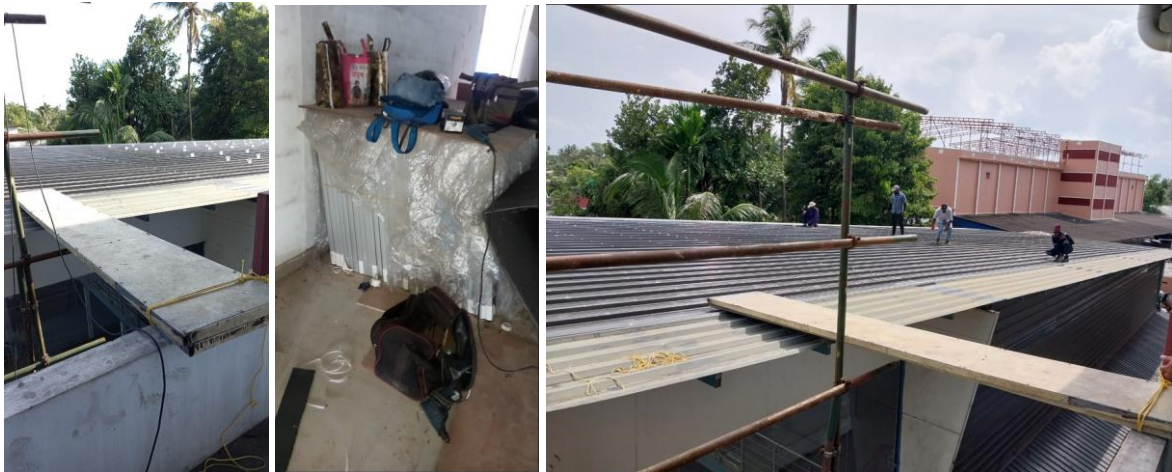
Onsite site conditions for access and module handling

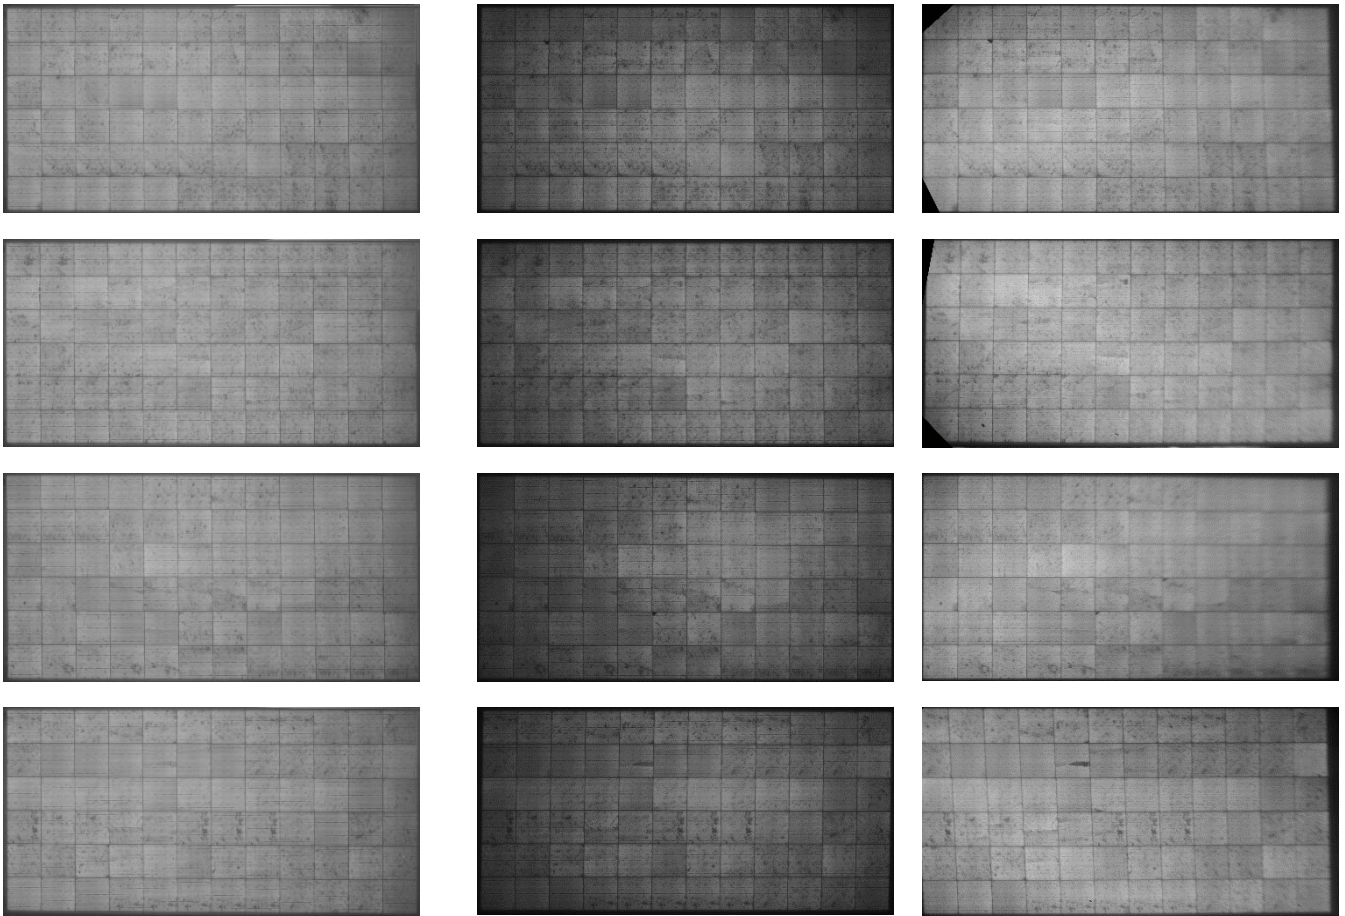
Even though transportation issues are known within the industry (cracks, scratches, broken glass), they are still a nuisance in project development, particularly during transportation

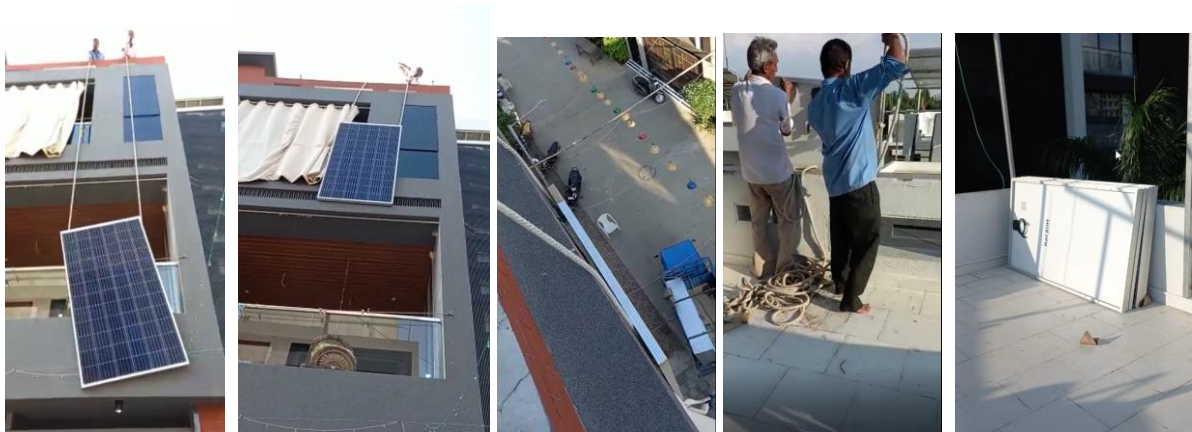
Onsite site conditions for access and module handling. Furthermore, PPE and H&S practices disregarded.

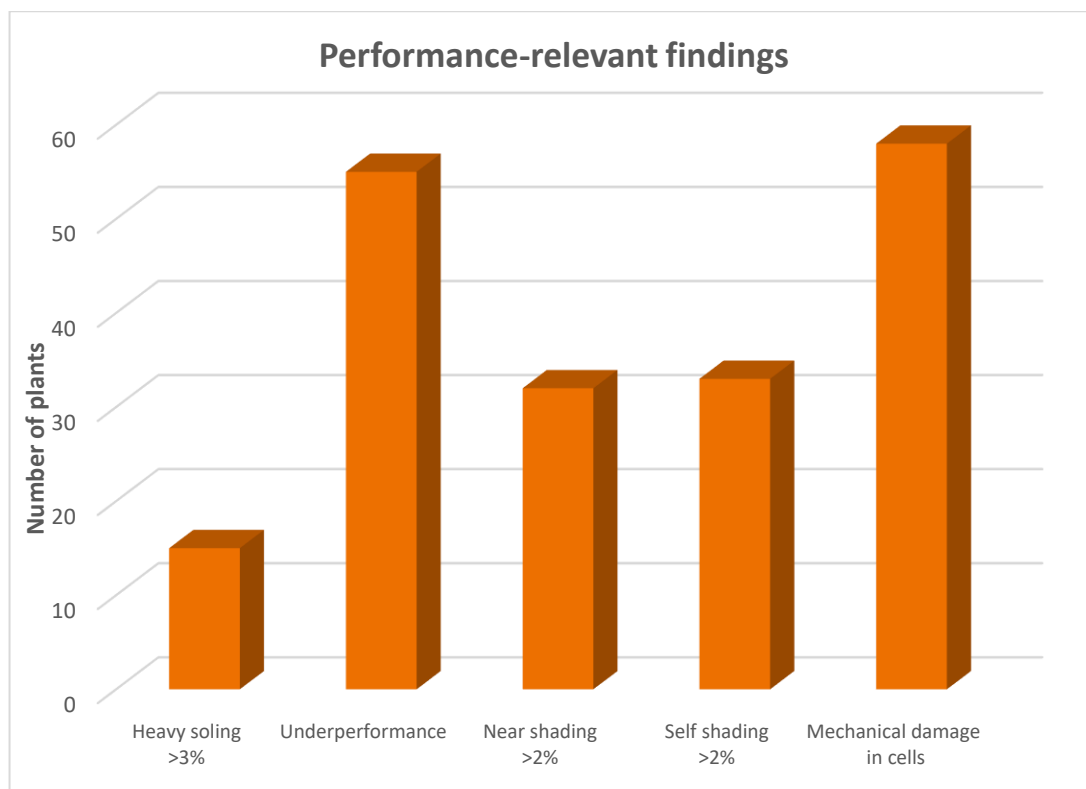
Figure 873: Chart showing occurrence of relevant findings across inspected plants.

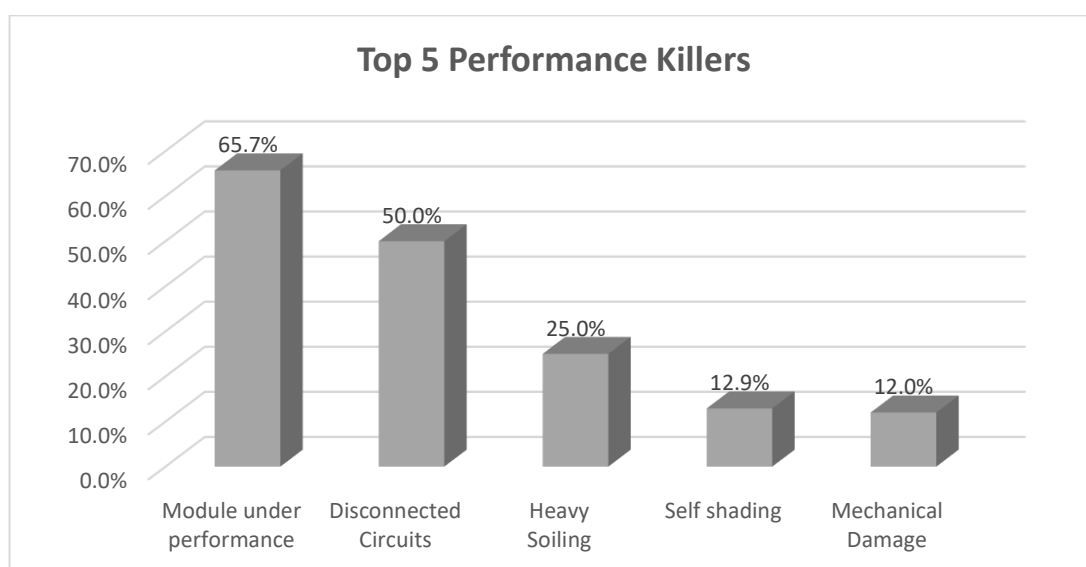
Figure 874: Top 5 findings with the highest performance impact on the inspected PV plants

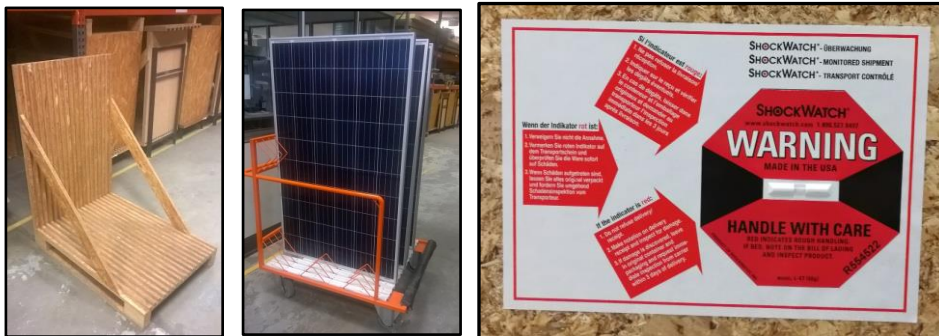
Examples of best practices to improve logistic activities

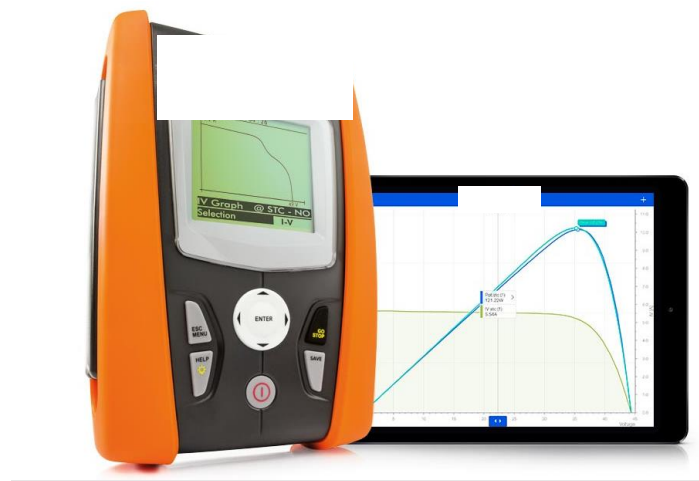
■■■■■ is a peak power measuring device and IV curve tracer that provides the measurement of the IV curve of photovoltaic modules and strings on site. Measurements of PV array IV characteristics under actual on-site conditions and their extrapolation to Standard Test Conditions (STC) can provide data on power rating, verification of installed array power performance relative to design specification, detection of possible differences between on-site module characteristics and laboratory or factory measurements, and detection of a possible performance degradation of module and arrays with respect to on-site initial data.

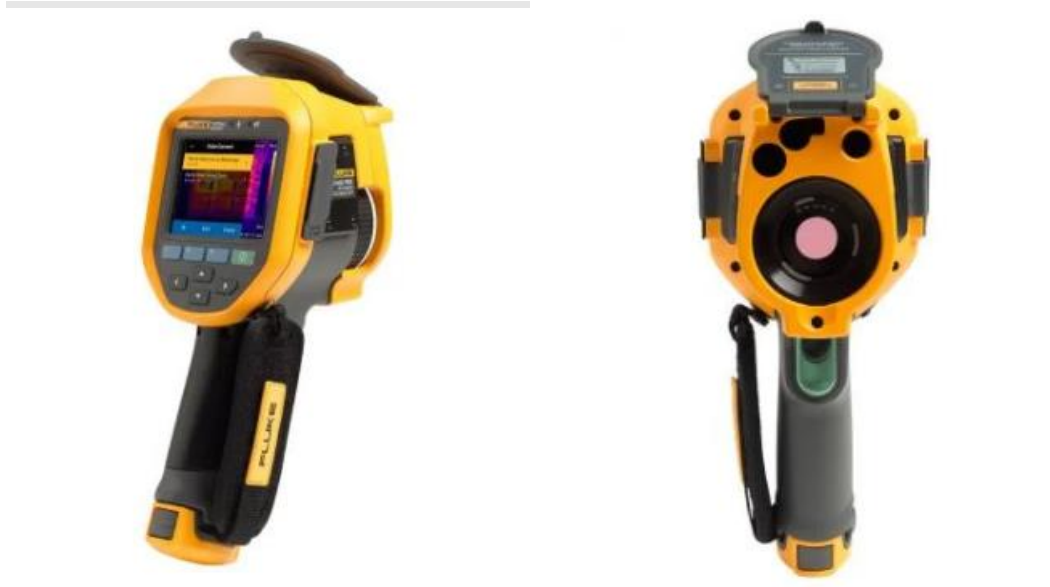
Figure 138: Infrared camera [source:

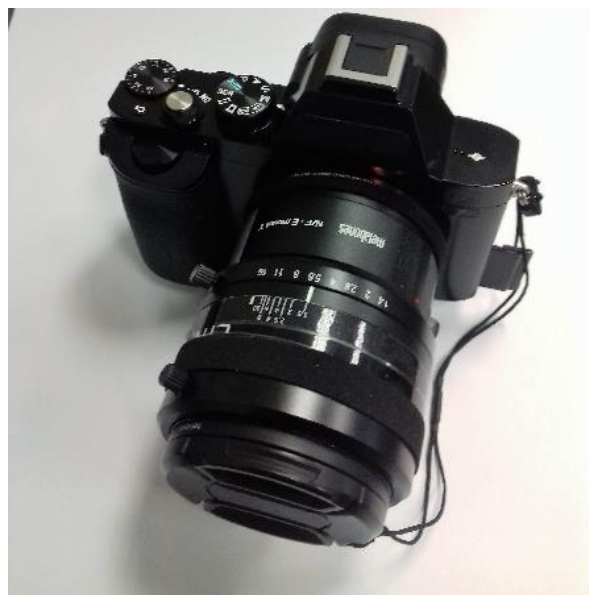
Figure 139: with CCD high pass edge filter [source: PI Berlin]
