Evaluation of Underperforming Rooftop PV Plants in India – Moving from kW to kWh

Part II: Evaluation of 10 Rooftop PV Plants in Delhi & Andaman and Nicobar Islands

Report Number: 201802070_II_V2
Berlin, 09.07.2019

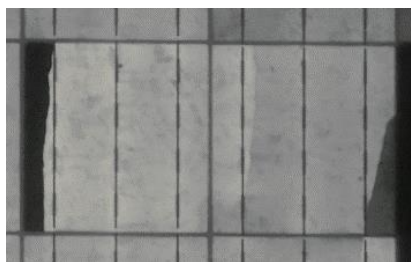
- Soiling measurements were conducted measuring both the short circuit current and nominal power before and after cleaning. The estimated soiling loss is on average 0.8%.
- The amount and type of cracks found in the selected modules during the electroluminescence inspection, reduce the nominal power of the PV plant by ca. 3%. This statement is based on the extrapolation of the results of the sample measurements.

Figure 15: Examples of cracks

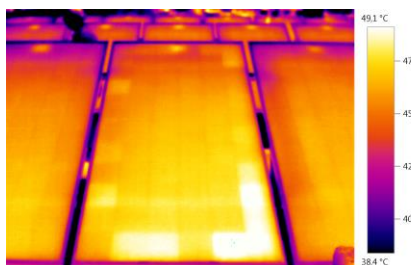
- PID causes power losses close to 15% on system level. The degradation is in a fairly advanced stage.

Figure 16: PID affected module

- An anti-PID measure, such as anti-PID box, shall be implemented in order to stop or reverse the degradation. PV modules showing power drops above the warranty conditions shall be replaced. If the replacement is not possible, the modules shall be regrouped in power classes within the same string and assigned to individual MPPT.
- The modules with the same tilt and azimuth shall be grouped in strings with the same MPPT.

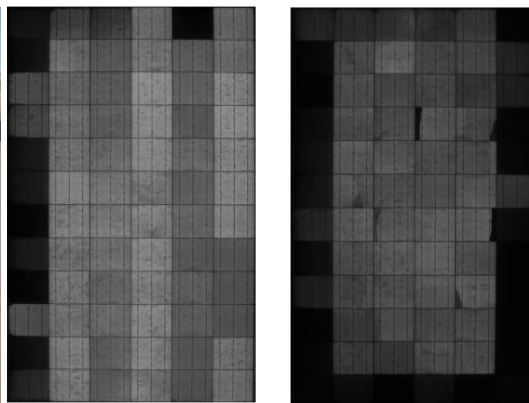
- Cable ties broke hence the module cables and connectors were loosely hanging.
- Some parts of the cables are exposed to UV radiation. Pipes conveying cables are brittle and some parts have already broken.
- There is no overvoltage protection in the inverter room.
- PID presence was confirmed via IR and EL inspections.

Figure 26: PID affected modules

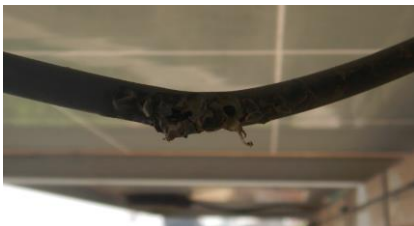
- The module connectors show damages since they were opened with improper tools.
- A loose connection of the module connectors has caused burning.
- A significant number of modules show mechanical damages on the front glass.
- Some fuses in the combiner boxes have burned.
- Cables damaged by monkey bites were observed.

Figure 27: Monkey bites

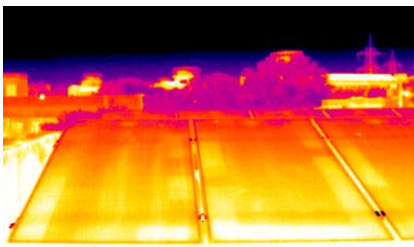
- There is no weather station, and hence no PR monitoring.
- The PV plant is partly surrounded by buildings which cast shadows onto the modules.
- PID presence was detected via IR and EL inspection.

Figure 28: PID modules

- The significant number of broken modules could lead to a performance loss of at least 7% at the system level.
- Based on the simulation, the shading losses due to the surrounding buildings is ca. 4.8%.
- PID was found to be in a fairly advanced stage. This could result in a performance loss of as high as 10% at the system level, based on PI Berlin experiences (on-site measurement was not possible).

- Anti-PID measures shall be implemented in order to stop or reverse the degradation. PV modules showing power drops above the warranty conditions shall be replaced. If the replacement is not possible, the modules shall be regrouped in power classes within the same string and assigned to individual MPPTs.

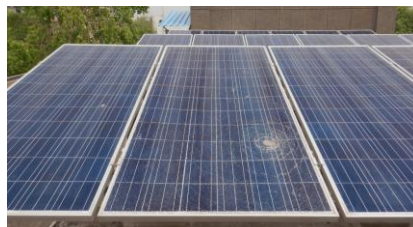
Figure 30: Broken module

- The broken modules shall be replaced with new modules.
- The cleaning cycles shall be increased based on the results of a soiling study that adjusts the cleaning needs to each season.

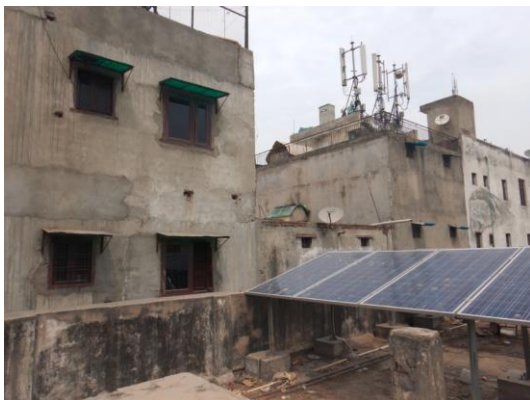
Figure 34: Buildings near the system

- A restringing of the modules from the shaded areas shall be conducted in the following way: modules with similar shading conditions shall be installed in the same string or at least assigned to individual MPPTs.

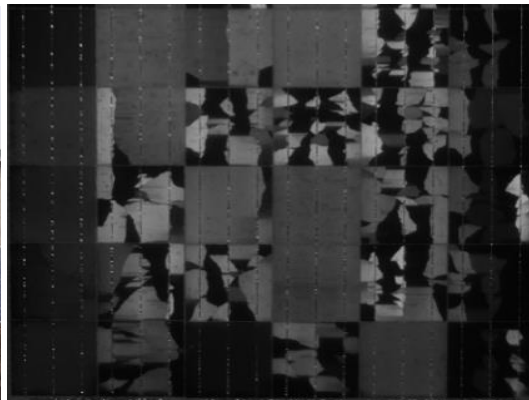
Figure 35: Module affected by glass breakage

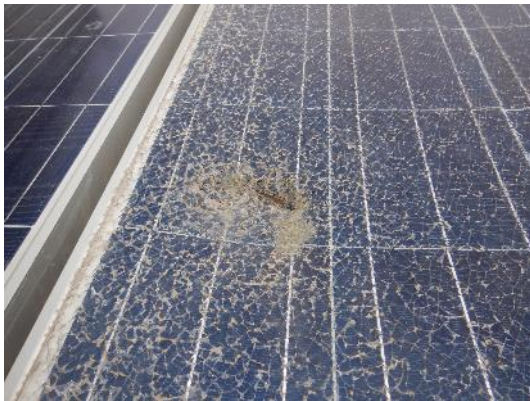
Figure 36: Module glass breakage

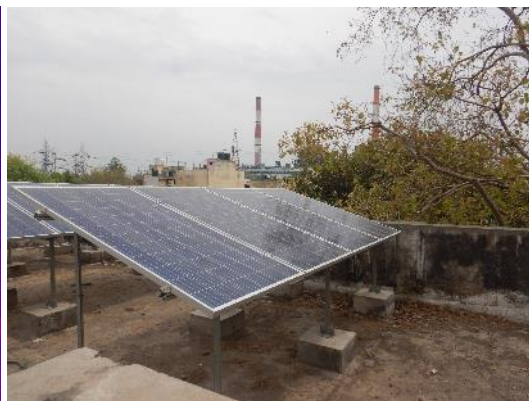
Figure 39: Trees causing shading

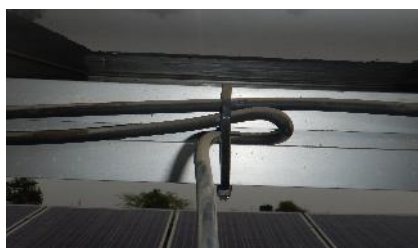
- Burned AC cables were reported a couple of times, as well as AC switches, leading to significant availability losses.
- There is no weather station, and hence no PR monitoring.
- Some of the module cables are fixed exceeding the minimum bending radius.

Figure 40: Small bending radius

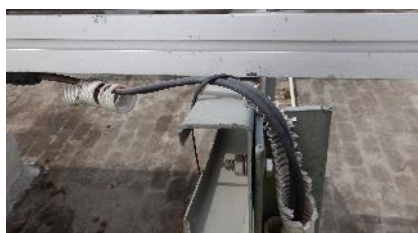
- Tubes protecting cables are not robust and some have already broken.

Figure 41: Broken tube (UV exposed)

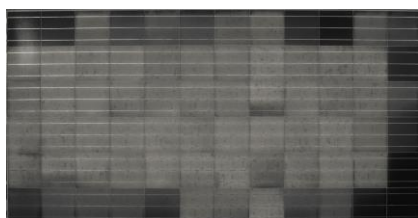
- Near shading is caused by nearby trees.
- PID presence was detected via IR and EL inspections.

Figure 42: EL image of a PID module

- PID leads to a performance loss of as high as 26% at the module level based on the measurements conducted on site. The degradation is in a fairly advanced stage. The impact at the system level is estimated to be around 10%,

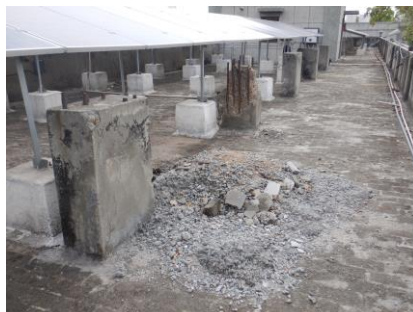
- A soiling loss of 7.4% was determined from IV curve measurements of a module before and after cleaning.

Figure 43: Possible source of soiling

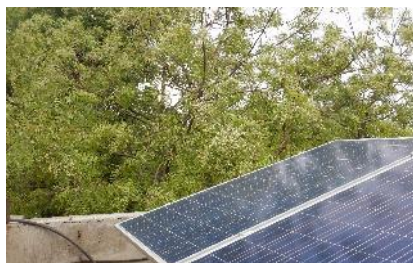
- Near shading losses are estimated to be 3.1% at the system level.

Figure 44: Trees cause shading

- A weather station, or at least an irradiation sensor on the module plane, shall be installed so that the performance of the system can be properly determined.
- The trees surrounding the system shall be trimmed if allowed. Otherwise, a restringing of the modules shall be conducted in the following way: modules with similar shading conditions shall be installed in the same string or at least assigned to one MPPT.
- The cleaning cycles shall be increased based on the results of a soiling study that adjusts the cleaning needs to each season.
- Anti-PID measures shall be implemented in order to stop or reverse the degradation. PV modules showing power drops above the warranty conditions shall be replaced. If the replacement is not possible, the modules shall be regrouped in power classes within the same string and assigned to individual MPPT.

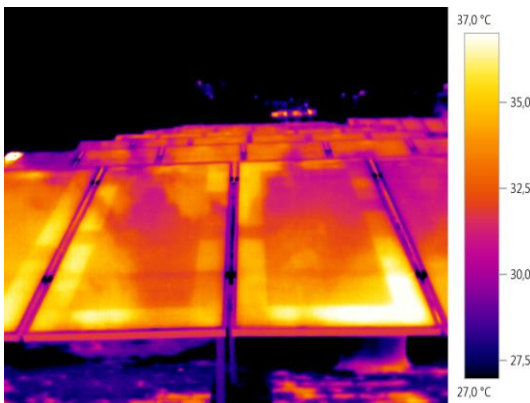
Figure 48: Modules affected by PID

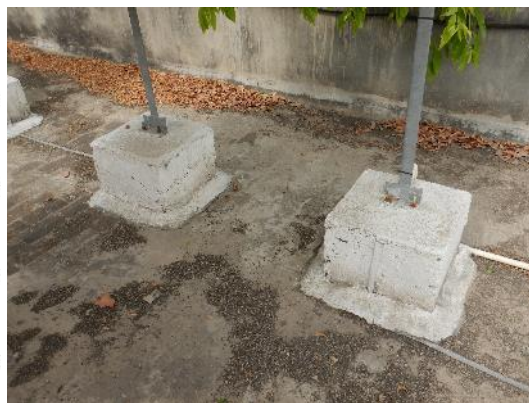
Figure 49: Mounting system fixation

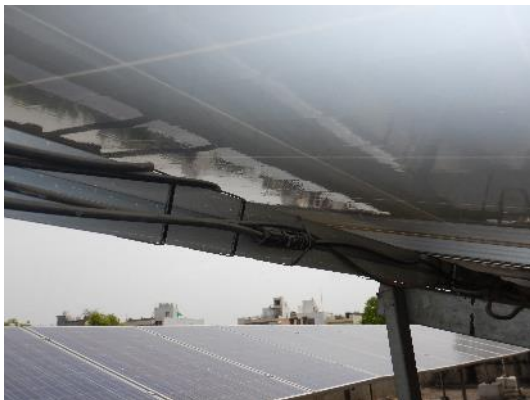
Figure 50: Cable fixation

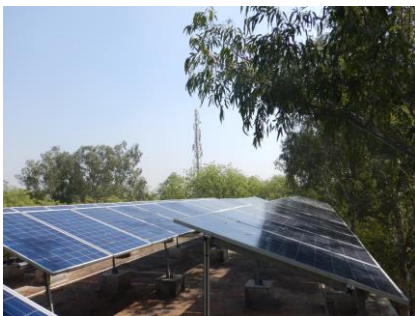
- Many areas are heavily shaded by trees.

- A weather station, or at least an irradiation sensor on the module plane, shall be installed so that the performance of the system can be properly determined.
- The nearby trees shall be trimmed regularly. Otherwise, a restringing of the modules shall be conducted in the following way: modules with similar shading conditions shall be installed in the same string or at least assigned to one MPPT.
- Anti-PID measures shall be implemented in order to stop or reverse the degradation. PV modules showing power drops above the warranty conditions shall be replaced. If the replacement is not possible, the modules shall be regrouped in power classes within the same string and assigned to individual MPPT.

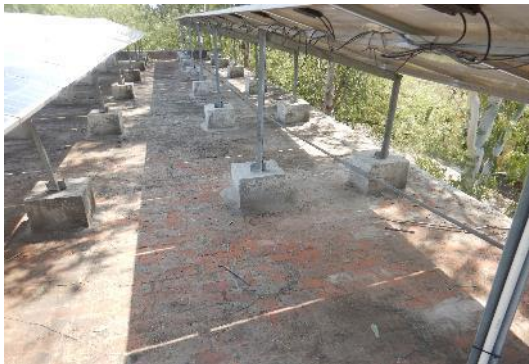
Figure 59: Foundation of the mounting structure

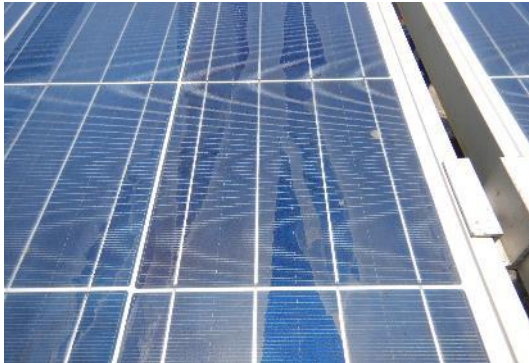
Figure 61: Soiling on the module surface

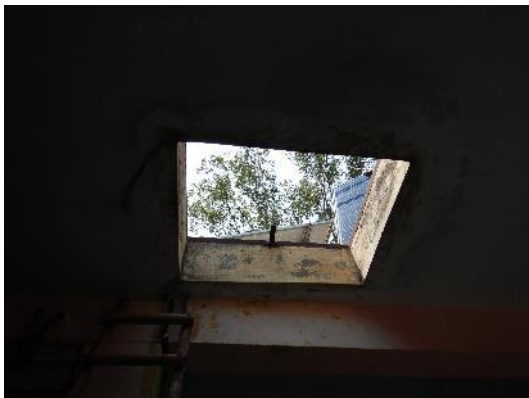
Figure 63: Challenging access to the system

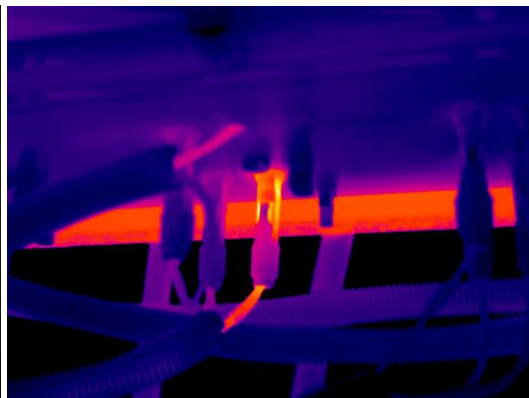
Figure 64: Abnormal temperature of a connection

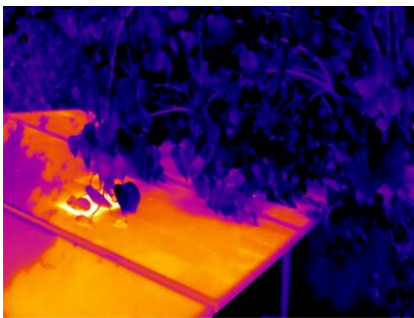
- Many areas are heavily shaded by trees.

Figure 66: Near shadings disregarded.

- Soiling losses were determined based on the measurements on site to be 3% on average.
- Based on the simulation, near shading losses are estimated to be 6% at the system level.
- PID loss was determined based on the on-site measurements and can be as high as 26% at the module level. The degradation has already reached advanced stage and reduces the system performance by at least 10%
- According to the amount of cracks discovered via EL imaging, the system is not expected to have a large power losses due to inactive areas.

- The trees surrounding the system shall be trimmed if allowed. Otherwise, a restringing of the modules shall be conducted in the following way: modules with similar shading conditions shall be installed in the same string or at least assigned to one MPPT.

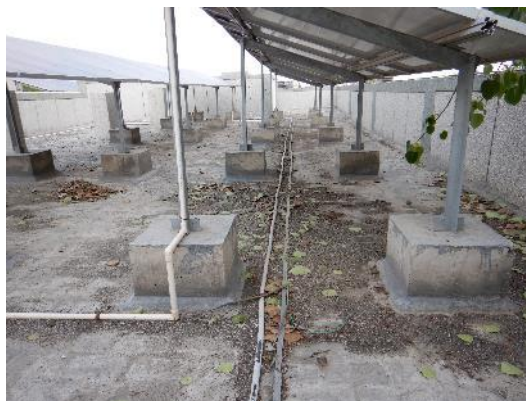
Figure 70: Foundation of the mounting structure

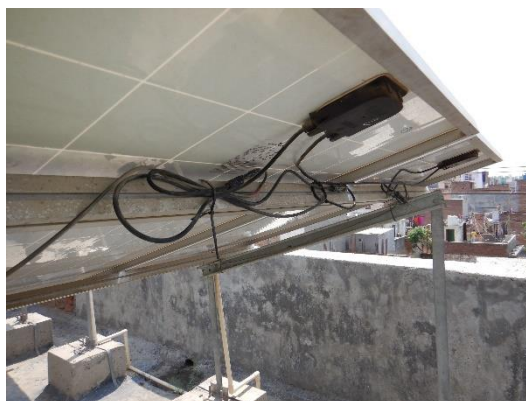
Figure 74: Cable fixation

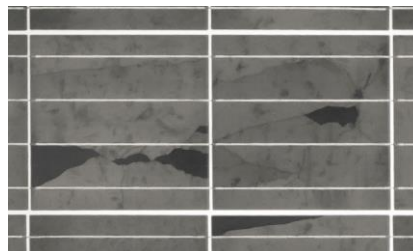
- Moving between module rows is usually done by crossing over the modules, which often results in modules being stepped on. Since the modules are stepped on, cell damages are inevitable (cracks and broken cells). They could also occur during installation since the access to the roof is difficult.

- The simulation shows significant shading losses caused by trees, which are close to 15%.
- Based on the amount of cracks and broken cells and corresponding inactive areas, the power loss is estimated to be 5% at the system level.

Figure 80: Cracks on a module

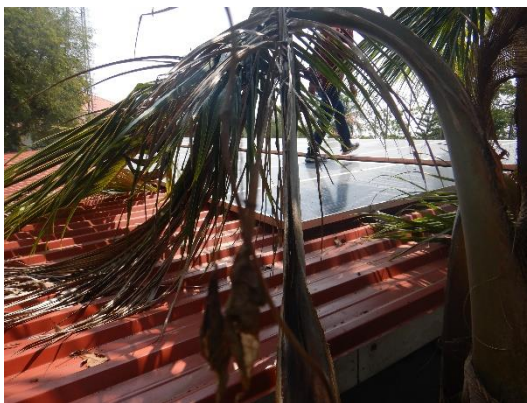
Figure 84: Challenging access to the system

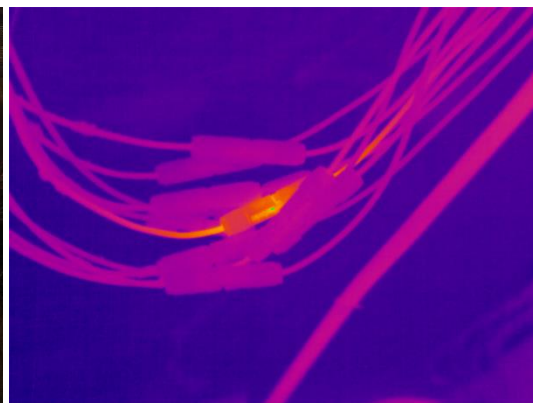
Figure 85: Hot cables at the inverter

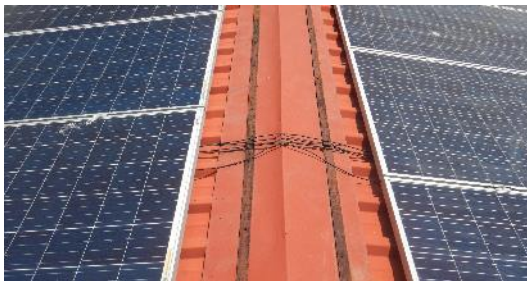
Figure 86: Cables exposed to UV radiation

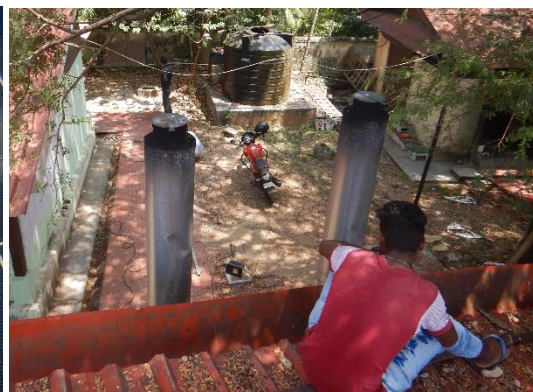
Figure 89: Diesel exhaust located next to the system

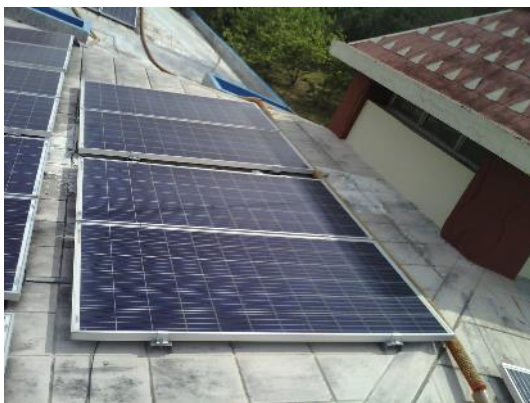
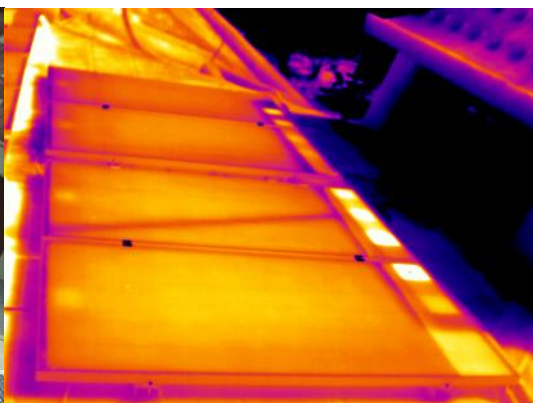
Figure 97: Shading from roof elements (left: real image, right: IR image)

- A weather station, or at least an irradiation sensor on the module plane, shall be installed so that the performance of the system can be properly determined.
- The trees surrounding the system shall be trimmed if allowed.
- For the modules shaded by the objects on the roof, a restringing shall be conducted in the following way: modules with similar shading conditions shall be installed in the same string or at least assigned to one MPPT. Otherwise, the objects shall be relocated.
- A manual cleaning of the modules shall be scheduled.
- The cables shall be kept away from possible mechanical damages.

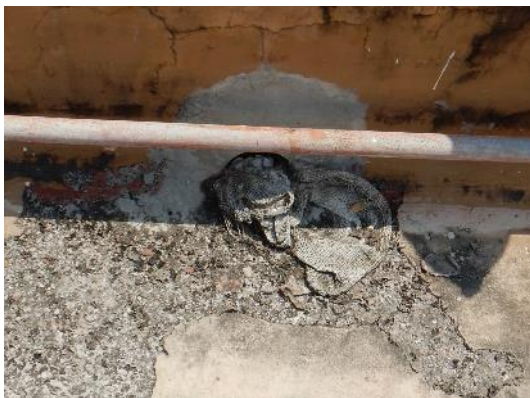
- The drains are blocked and the cables are exposed to UV radiation. Discoloring of the cables was observed. The cables are not fixed and laid properly. They were seen messily laying on the roof, vulnerable to radiation and mechanical damages.
- Pipes and tubes conveying cables are not sealed, and they are not robust.
- There is no weather station, and hence no PR monitoring.
- Near shading is caused by nearby trees and some of the objects on the roof.

Figure 98: Blocked drainage

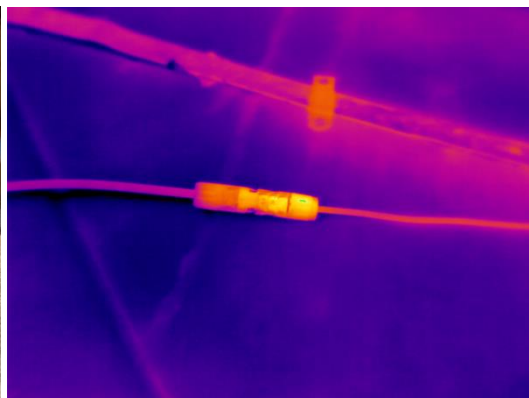
Figure 99: Abnormal temperature of a connector

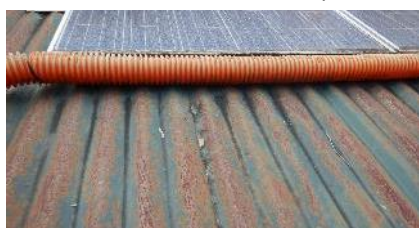
- The soiling is caused by a combination of smog and particles from the exhaust of the generators nearby.
- There is no weather station, and hence no PR monitoring.
- The carport in the parking area, on which part of the PV system is installed, is not stable and the structure is rusty.

Figure 101: Rusty roof

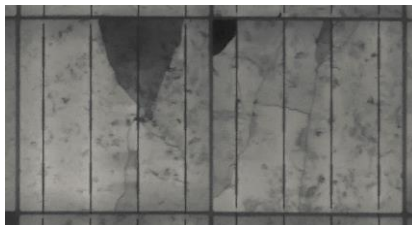
- Cables have been damaged by UV radiation. The pipes conveying the cables are brittle and are partly broken.
- Cracks of different severities were detected via EL inspection.

- Soiling losses were determined to be 10% on average, based on the on-site measurements.
- Cell cracks are estimated to result in 7% performance loss at the system level

Figure 102: Cracks on a module

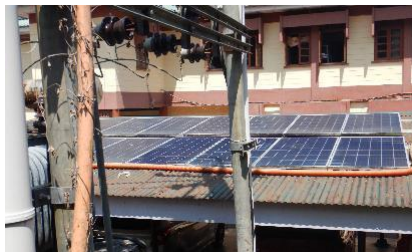
- The shading losses caused by the cables and the poles are found to be insignificant based on the simulation.

Figure 103: Shading from cables and poles

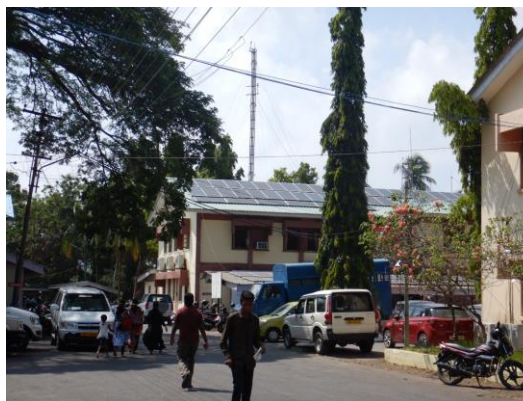
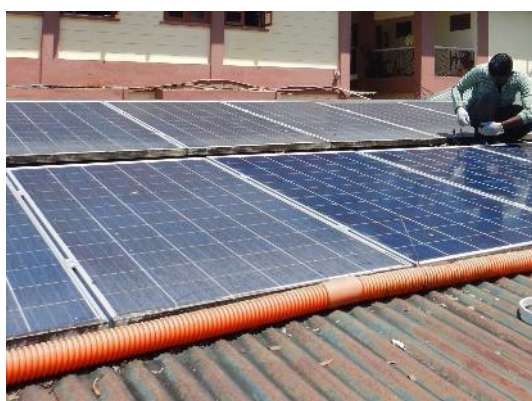
Figure 106: Dirty and clean modules

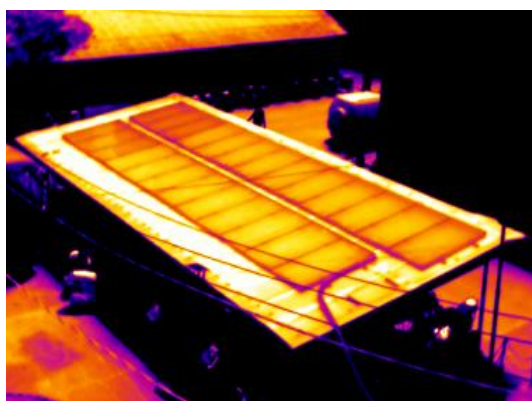
Figure 108: IR image of parking section of the system

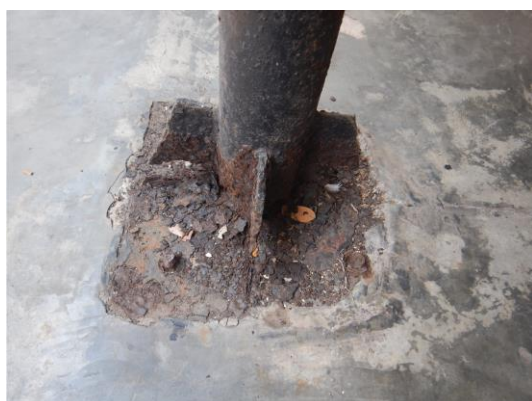
Figure 110: Examples of poor structural integrity

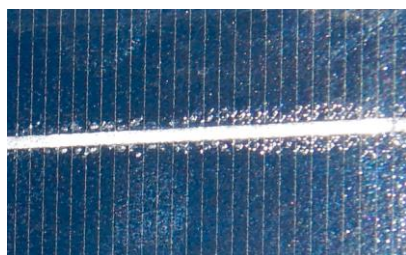
- Pipes carrying cables are brittle and some parts have already broken, exposing cables to UV radiation. The colors have already started to fade. Delamination and cell corrosion were observed on the front side of the modules.

Figure 111: Delamination

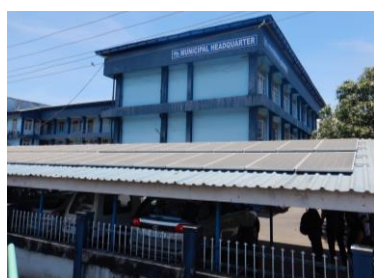
- Heavy soiling has been detected on site. The dense traffic (smog) in the street next to the system increases the dust accumulation on the modules.
- There is no weather station in any part of the system and hence, no PR monitoring.
- Electroluminescence imaging confirms the presence of cell damages caused during the installation and O&M activities.

Figure 112: Modules are heavily soiled

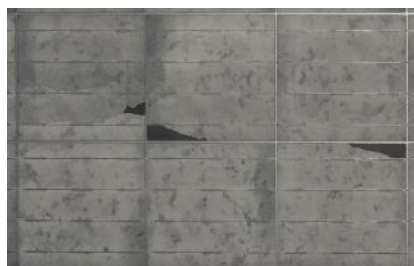
- The EL images show a few cracks on the inspected modules. This could result in a performance loss of 4% at the system level.

Figure 114: Cracks on a module

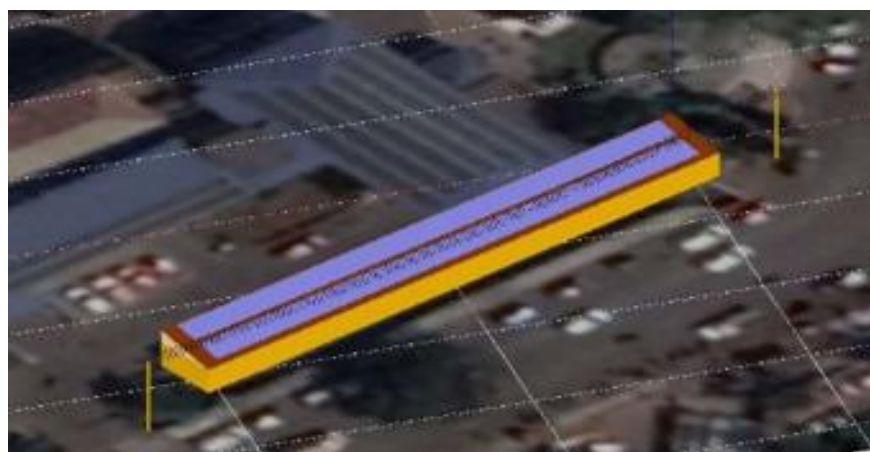
- The simulation shows shading losses caused by the cables of 1.5%.

Figure 115: 3D scene

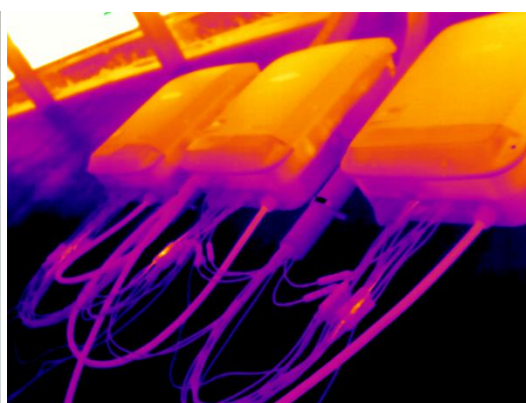
Figure 131: Faulty connections (IR)

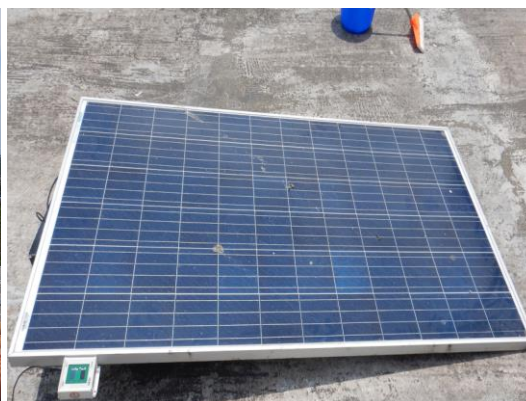
Figure 133: Bird drops on module glass

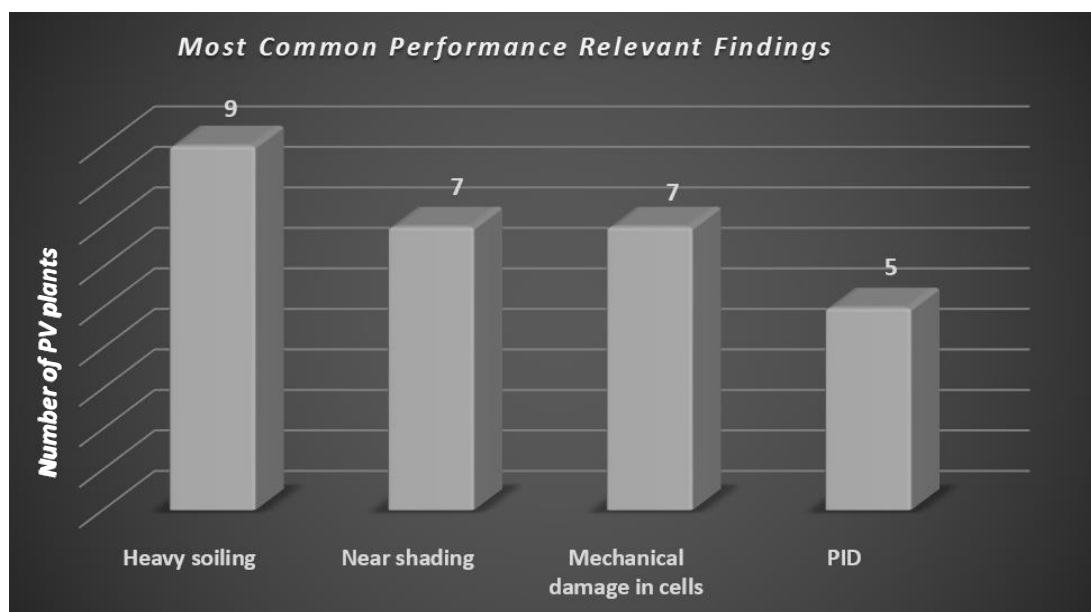
Figure 143: Chart showing in how many PV plants each finding is present (sample: 10 plants)

It can be seen how *heavy soiling* and *near shading* appear in almost all PV plants. The appearance of *Potential Induced Degradation (PID)* in half of the PV plants is a finding associated to unexpected module degradation mechanisms caused by a combination of (i) negative potential, (ii) high temperatures and (iii) high humidity rates. PID is a defect that can be prevented taking the appropriate measures during the design phase. Finally, *mechanical damages in cells* which is related to the electromechanical integrity of the modules, is a defect that also appears in a large number of sites and is caused by improper module handling during the installation and operation phase².

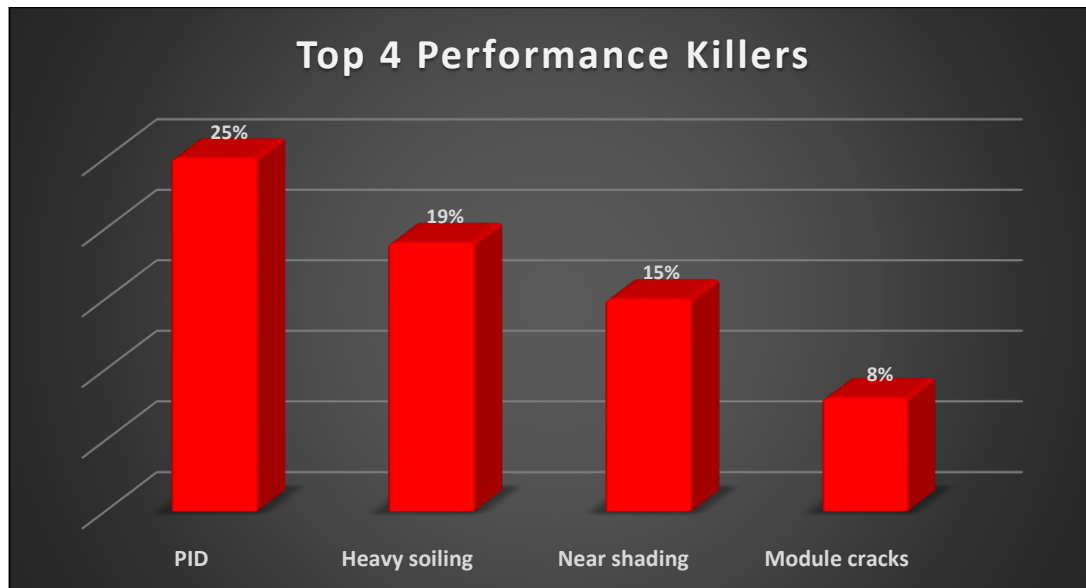
Figure 144: Top 4 findings with the highest performance impact on the inspected PV plants

The graph above shows how an advanced stage of *Potential Induced Degradation (PID)* can lead to a loss of global production at the PV plant level of more than 25%. In some of the analyzed plants, this degradation value has been reached in less than two years⁴. This rapid

According to PI Berlin calculations, the global losses at the PV plant level caused by *PID* exceed 25% in 2 years, while the losses associated with soiling can widely exceed 19% in the dry season.
