Evaluation of Underperforming Rooftop PV Plants in India – Moving from kW to kWh

Part III: Evaluation of 10 Rooftop PV Plants in Pune

Report Number: 201802070_III_v1
Berlin, 25.06.2020

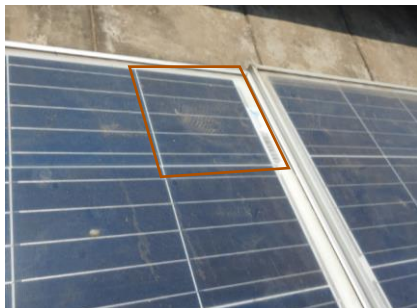
Figure 10: Shoe footprints

- Foot prints, likely from walking on top of the modules, were spotted throughout the plant.

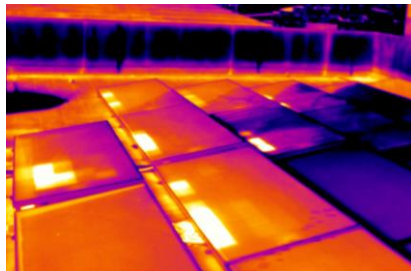
Figure 12: Soiling on the bottom cell string

- Although the soiling induces a shading in the bottom cell string, the landscape orientation reduces the impact of the current reduction.

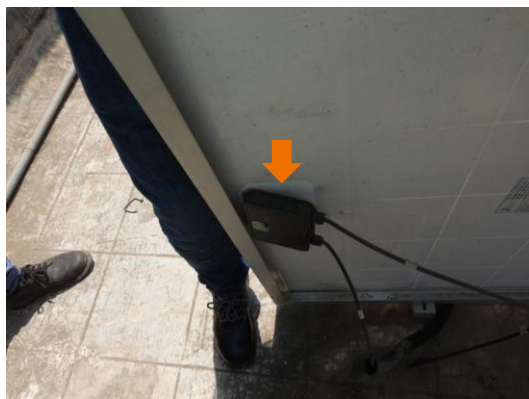
- During the module sample selection, the first modules selected exposed a detached J-box likely due to overtightened DC cables.
- The module installation on the East side of the system was performed gluing the clamps to the floor, hampering O&M.
- The spacing between modules and ground does not allow for an efficient convection.
- No weather station has been installed. Furthermore, the Performance Ratio is not tracked.

Figure 19: Detached J-box

- In order to guarantee module long-term reliability and safety, the module J-boxes shall be assessed. Modules with open or detached J-boxes shall be replaced.
- Modules with a large amount of cracks shall be grouped in the same string or at least assigned to one MPPT. The grouping shall be conducted based on an infrared inspection with high irradiation levels and after cleaning activities.
- The manual cleaning cycles shall be implemented and scheduled based on the results of a soiling study that adjusts the cleaning needs to each season.

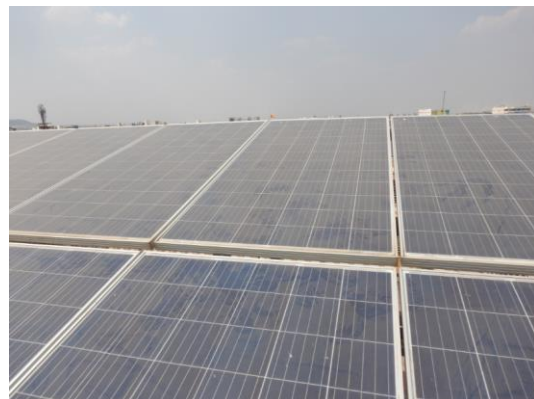
Figure 22: Evidence of crawling on the modules

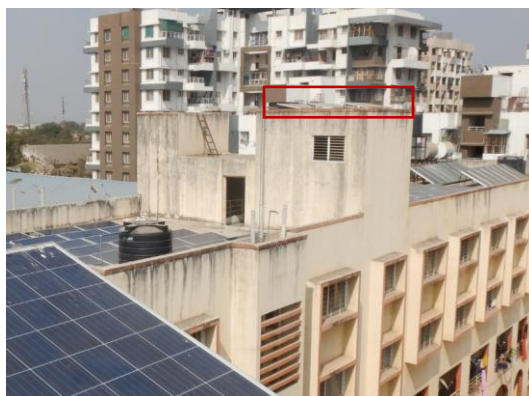
Figure 23: Module disregarded from O&M scope

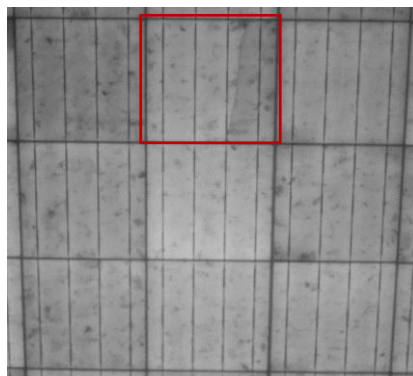
- A reduced sample of EL imaging did not reveal a significant amount of cracks or any other module failure types.

Figure 28: Sample from the EL imaging

- It is recommended to perform a yearly thermographic inspection to the modules at high irradiances to track the evolution of the cracks.

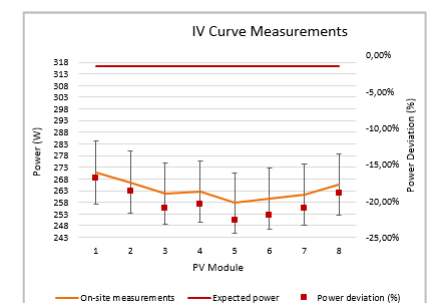
Figure 30: Onsite power measurements

- The average module under-performance is ca. 12% (accounting for a 4.7% soiling losses).

- IV curve measurements from a larger module sample should be performed to validate the current power performance of the modules against the manufacturer warranties.

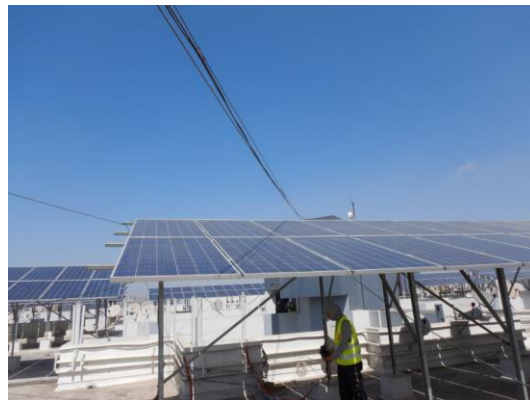
Figure 39: Cables casting shading on the modules

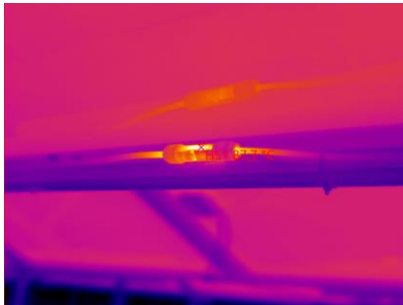
- The thermography (IR) inspection revealed MC4 connectors with abnormal temperatures.

Figure 40: Warm MC4 connector

- Thermography (IR) inspection shall be performed to find out the amount of connectors with abnormal temperatures, followed by their suitable replacement.
- Thermography (IR) inspection of the modules shall be performed annually to monitor the evolution of the warm cells and hotspots.
- The outlets of the inverter fan shall be continuously clean (part of the O&M) to avoid inverter overheating.

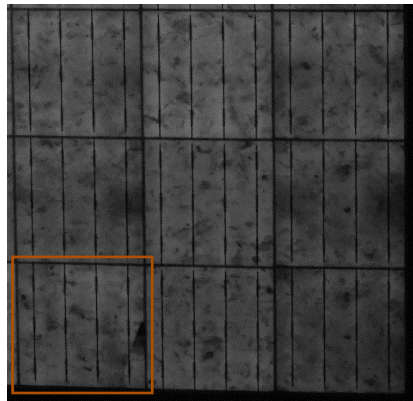
- Based on the interrow spacing, the simulation estimates near shading losses of ca. 3% on system level.
- Electroluminescence imaging did not reveal significant or severe cracks in the selected module sample.

Figure 42: No significant cracks (EL imaging)

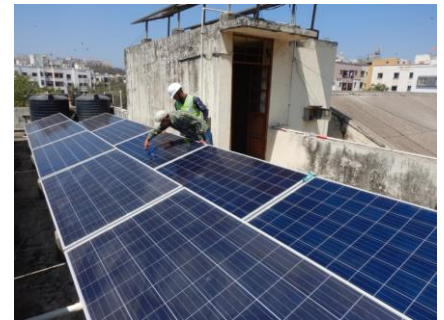
Figure 44: Recalculation of cleaning cycles

- A weather station, or at least an irradiation sensor on the module plane, shall be installed so that the performance of the system can be properly determined.
- Manual cleaning cycles shall be increased based on the results of a soiling study that adjusts the cleaning needs to each season.

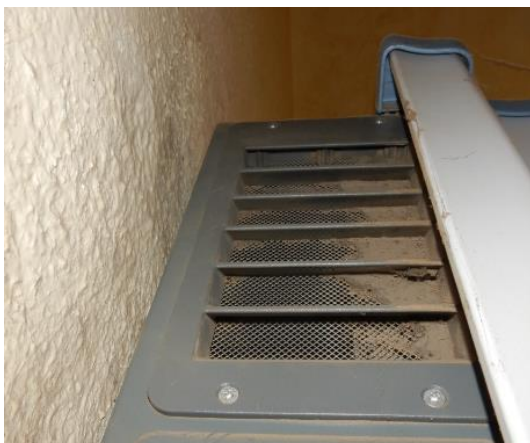
Figure 52: Inverter fan filters (outlet) partially blocked

- No weather station has been installed and the Performance Ratio is not tracked.
- The filters of the inverters should be cleaned.
- Open fastening screws were observed on the fixing clamps.

- A weather station, or at least an irradiation sensor on the module plane, shall be installed so that the performance of the system can be properly determined.
- Due to the high air pollution in Pune, it is advisable to clean the modules even more regularly.
- The loose hanging cables should be fixed and the bending radii checked.
- Fixing the fastening clamps is essential to ensure the safety of the system.
- The simulation of the system showed a shading loss of 2.7%.

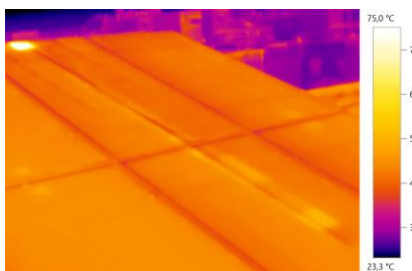
- Heavy partial pollution creates hotspots. These not only lower the yield but also make the modules age faster.

Figure 57: Hotspots created by pollution

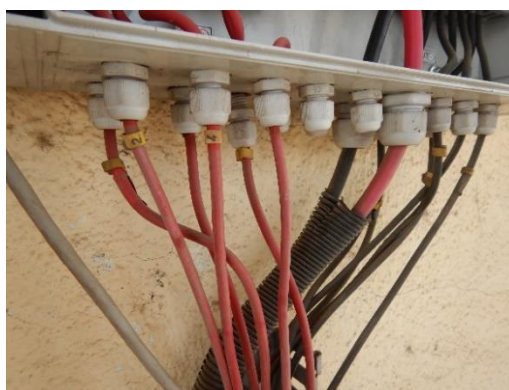
Figure 62: Unsealed seals

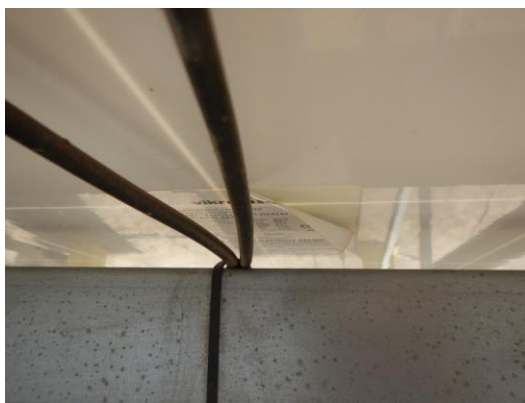
Figure 74: Modules with label detachment issues

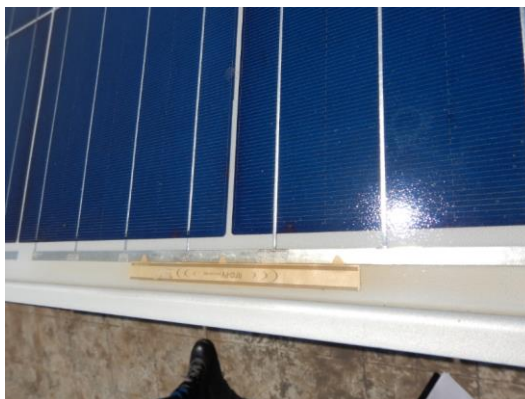
- Through visual inspection, browning on the module, backsheet degradation and advance corrosion in the grounding cables (distribution box), among other failure types were exposed.

Figure 76: Browning effect on RFID tag

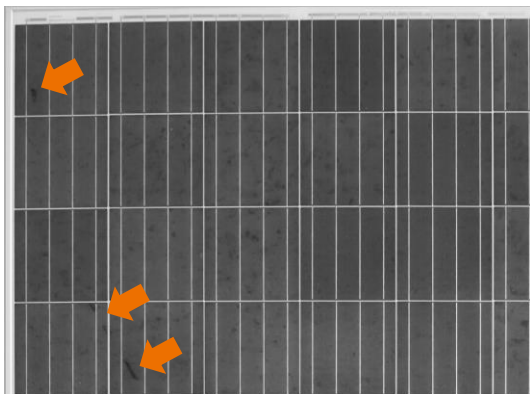
- Electroluminescence imaging did not reveal a significant amount of cracks. However, module backsheet scratches could lead to safety hazards and increased risk of inverter disconnection due to loss of insulation.
- A soiling loss of 5.9% was determined from IV curve measurements of a sample module before and after cleaning.
- The near shadings are responsible for an irradiation reduction on the tilted plane of approx. 1.5% at the system level.

Figure 79: Scratch in backsheet (EL imaging)

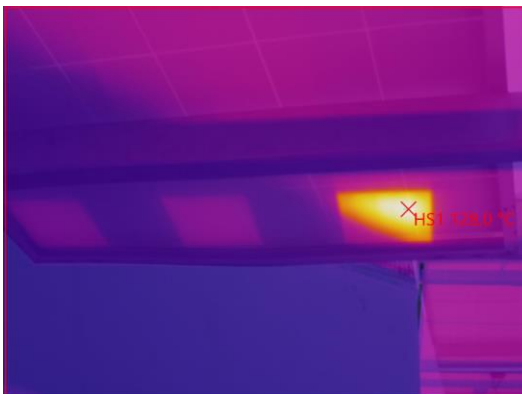
Figure 80: Hotspots likely induced by shading

- The module most affected by the shades from the shading structure can be easily relocate. This will reduce the impact of the shadings on the whole string. Furthermore, after the relocation, modules with hotspots (>100°C) shall be monitored to assess the damage and their possible replacement.
- Grounding cabling shall be replaced to guarantee a proper grounding throughout the system.
- The cleaning cycles shall be increased and defined based on a soiling study that adjusts the cleaning needs to each season. Cleaning once a month during the dry season might not suffice.

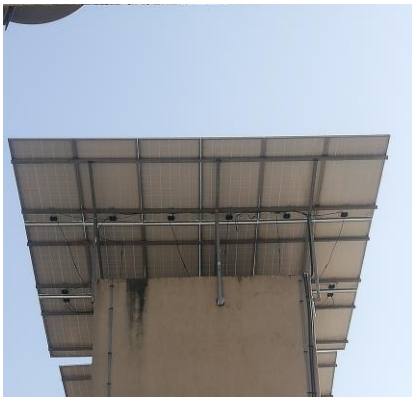
- No weather station has been installed and the Performance Ratio is not tracked.
- The PV system is built with an overhang of up to 2 meters over the roof edge. Static safety is therefore not guaranteed.

Figure 81: Overhanging modules

- The design should be checked for static stability.
- A weather station, or at least an irradiation sensor on the module plane, shall be installed so that the performance of the system can be properly determined.
- All strings should be checked for closed module plugs since the measured power loss in the examined subsystem was 37%.
- The modules should be cleaned regularly.
- The loose hanging cables should be fixed and the bending radii checked.
- An anti-PID measure, such as anti-PID box, shall be implemented in order to stop or reverse the degradation.

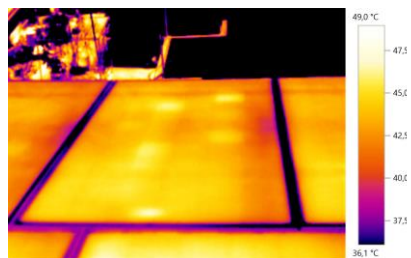
- To the negative side of the string, the modules may show first signs of PID.

Figure 85: First signs of PID

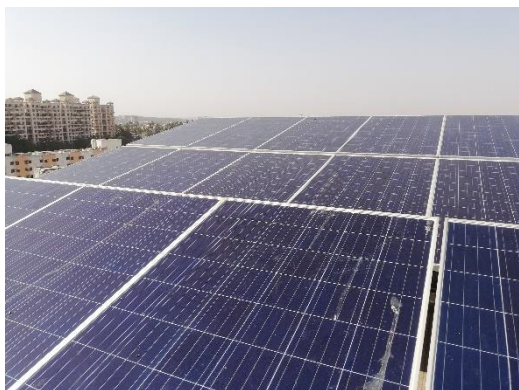
Figure 87: Partial pollution

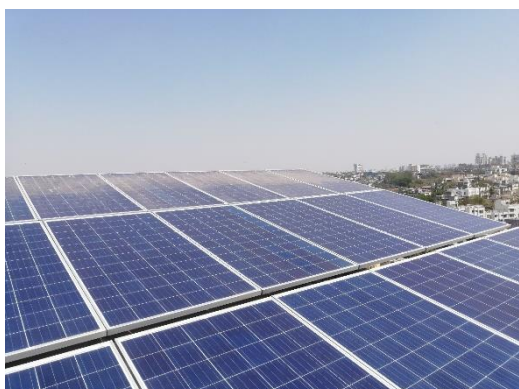
Figure 89: Dirty modules in hard-to-reach areas

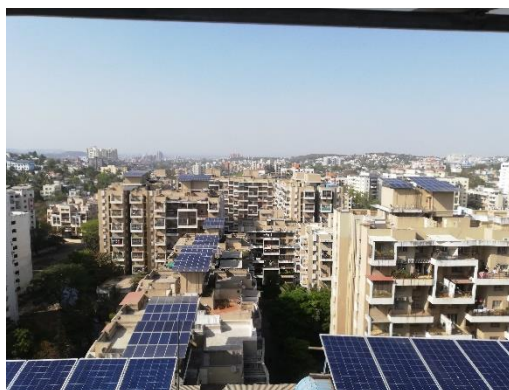
Figure 92: Dirty modules in hard-to-reach areas

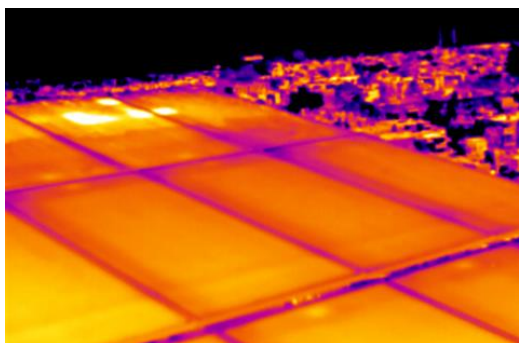
Figure 93: Hotspots created by pollution

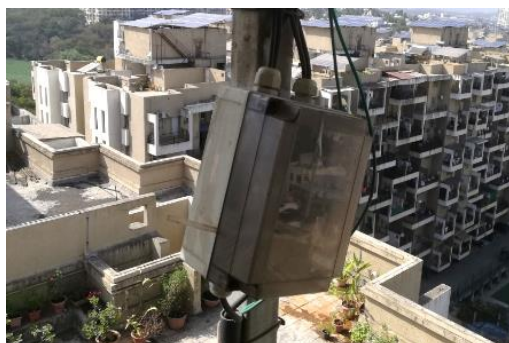
Figure 94: Fuse box not properly fixed

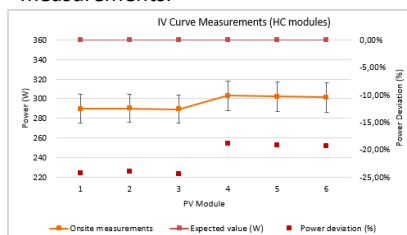
- Soiling losses were determined based on the measurements on-site to be 4.2%, on average.
- The new modules installed early this year (Half-cut cells) showed a significantly lower performance via on-site IV curve measurements.

Figure 97: Onsite power measurements (HC cell)

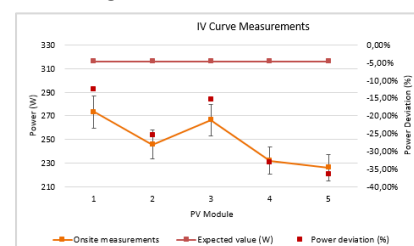
Figure 100: Onsite power measurements (full cell)

- A weather station, or at least an irradiation sensor shall be installed on-site to obtain reliable information, i.e., for the plant performance ratio calculation.
- Modules with multiple cracks shall be regrouped in the same string, or at least assigned to one MPPT. The grouping shall be conducted based on infrared inspection with high irradiation levels and after cleaning activities.
- The cleaning cycles shall be increased and defined based on a soiling study that adjusts the cleaning needs to each season. Cleaning once a month during the dry season is not enough.
- PV modules showing power drops above the warranty conditions shall be replaced. If the replacement is not possible, the modules shall be regrouped in power classes within the same string and assigned to individual MPPT.

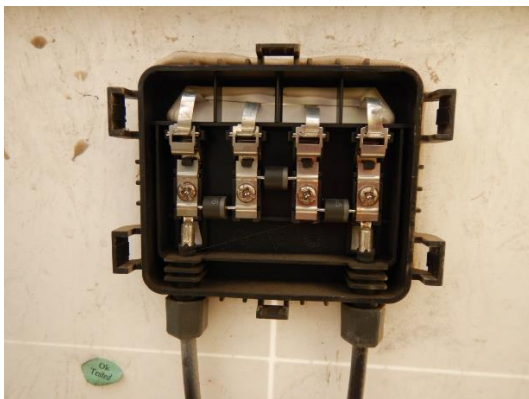
- The modules present different types of J-box failure types, e.g., overheated, open or missing lid.
- String cables damaged by, or in contact with sharp edges were spotted.
- From the module samples, the on-site IV curve measurements indicated that the power performance lies 25% and 19%, beneath the minimum expected value (according to label values and natural degradations), for full cell and HC cell, respectively.

Figure 104: Module with open Jbox lid (VI)

- Modules with any defect on the J-box shall be immediate replaced (safety, operation and reliability issues).

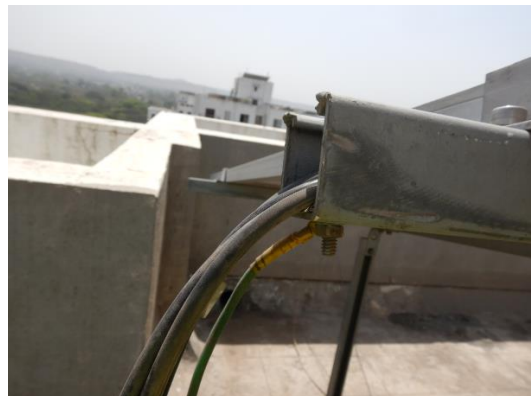
Figure 109: String cables in contact with sharp edges

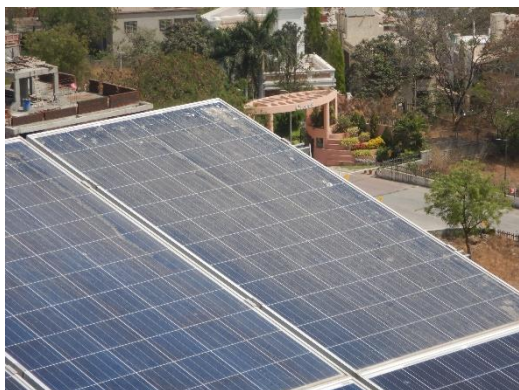
Figure 116: Heavily soiled modules

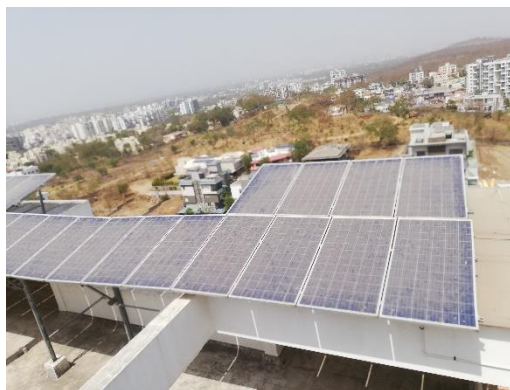
Figure 117: Heavily soiled modules

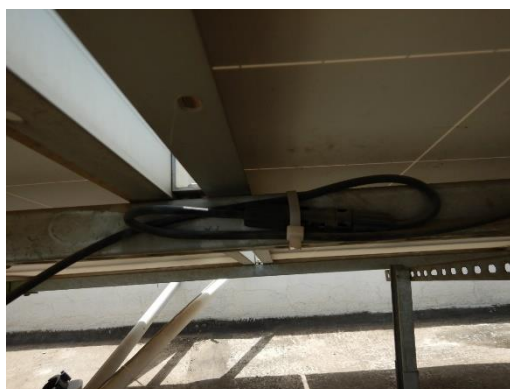
- Some parts of the cables are exposed to UV radiation and the bending radii have not been observed.
- Several shading problems were found caused by roof structures.
- Some of the strings measured had lower outputs.

Figure 119: Bending radius too small

- The individual beams of the mounting structure should be reinforced.
- A weather station, or at least an irradiation sensor on the module plane, shall be installed so that the performance of the system can be properly determined.
- The cables and plugs should be checked for temperature and functionality.
- The modules should be cleaned regularly.
- The loose hanging cables should be fixed and the bending radii checked.
- The causes of the local shadings should be removed.
- The filters of the inverter should be cleaned.

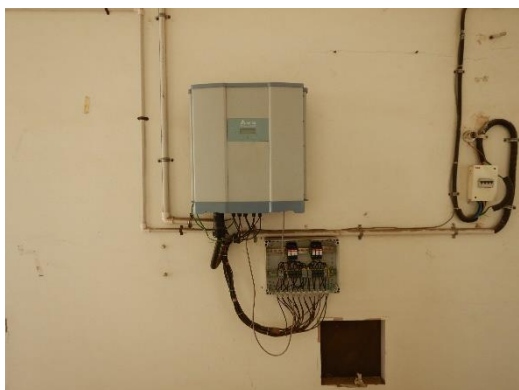
Figure 120: Inverter and Combiner Box

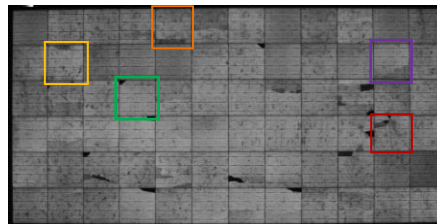
Figure 126: Mechanical damage on modules

- Based on the crack distribution and type found during the electroluminescence inspection, the module nominal power could be reduced by 4-8%. Furthermore, these types of cracks could eventually lead to inactive areas and higher power loss in the midterm.
- Modules with inactive cell strings could underperform 33% to 66% depending on the amount of affected strings. The extrapolation of the inspected sample to the whole system leads to a loss of 6% on string level.

- Modules underperforming above the warranty conditions shall be replaced. If the replacement is not possible, the modules shall be re-grouped in power classes within the same string and assigned to individual MPPT in combination with the amount and type of cracks.

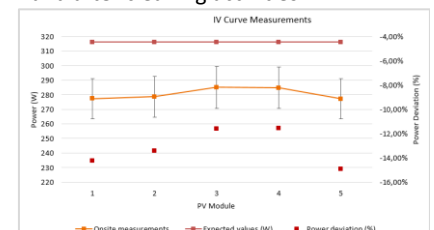
Figure 128: Onsite power measurements

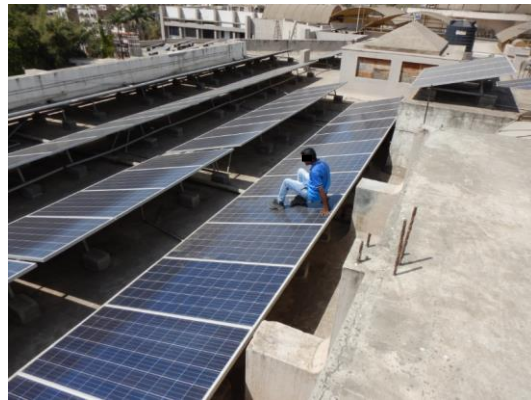
Figure 131: Personnel walking on the modules

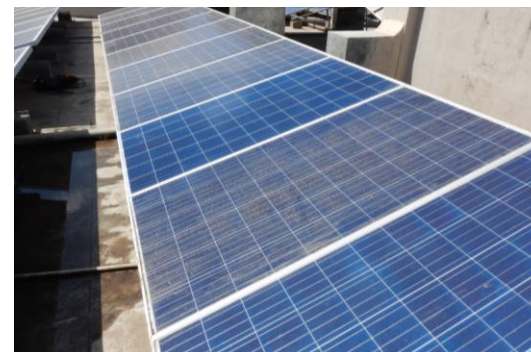
- Soiling measurements were conducted via short circuit current reduction and nominal power, before and after cleaning, with irradiances higher than 1000 W/m². The estimated soiling factor is in the range of 4-6.2%.
- Due to near objects and microshading, the simulation estimates near shading losses of ca. 4.3% on system level.

Figure 135: Module comparison from cleaning activities

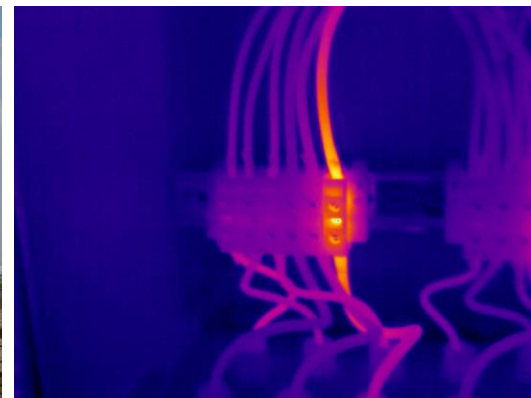
Figure 137: Warm string cables in the combiner box

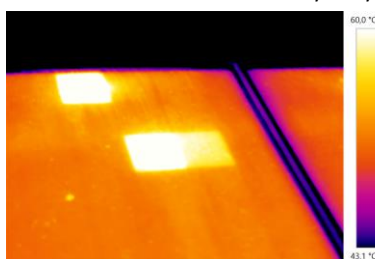
- Soiling measurements were conducted before and after cleaning. The estimated soiling loss is on average 10.6%. The measurements were carried out on the less polluted modules. Higher losses are to be expected in other areas of the plant.
- Heavy partial pollution creates hotspots. Some modules were extremely dirty.

Figure 140: Hotspots induced by pollution

- The modules should be cleaned regularly.
- The broken modules should be replaced with new modules.
- The simulation of the system showed a shading loss of 3.5%. This value refers to the part of the system with fewer shading problems.

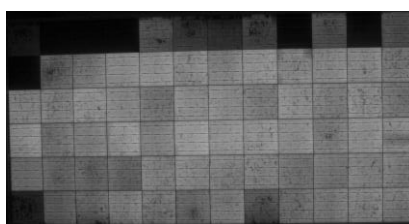
- PID presence was detected via IR and EL inspection. The impact at the system level is estimated to be around 10%.

Figure 141: PID presence via EL

- Anti-PID measures should be implemented in order to stop or reverse the degradation. PV modules showing power drops above the warranty conditions shall be replaced. If the replacement is not possible, the modules shall be regrouped in power classes within the same string and assigned to individual MPPTs.

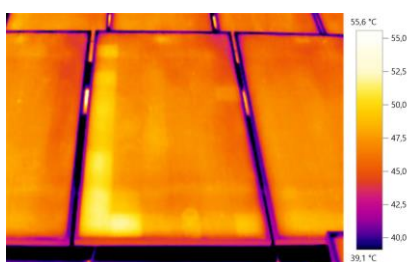
Figure 142: PID presence IR

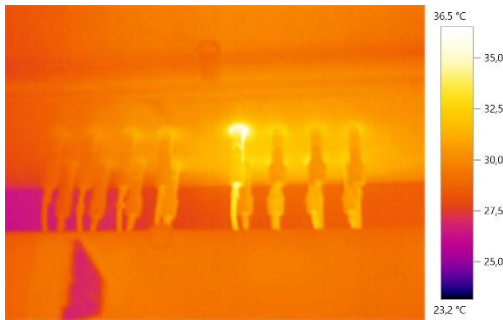
Figure 144: Hot connectors

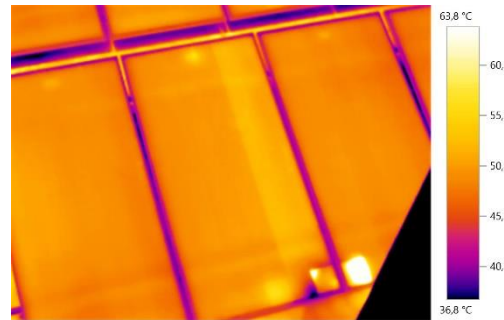
Figure 145: Module effected by shading (diode)

- A restringing of the modules from the shaded areas should be conducted in the following way: modules with similar shading conditions should be installed in the same string or at least assigned to individual MPPTs.

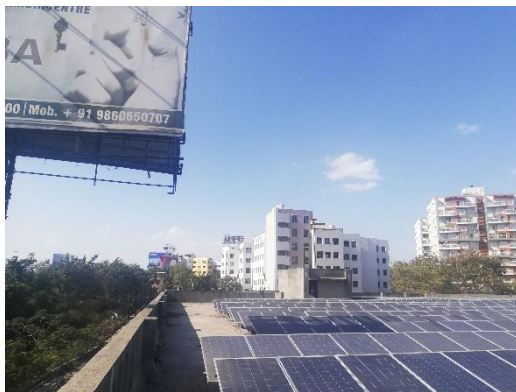
Figure 146: Shading

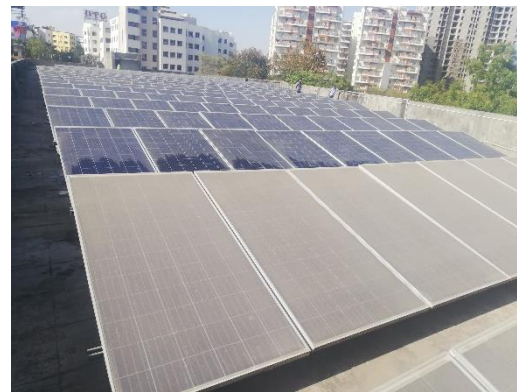
Figure 147: Dirty modules

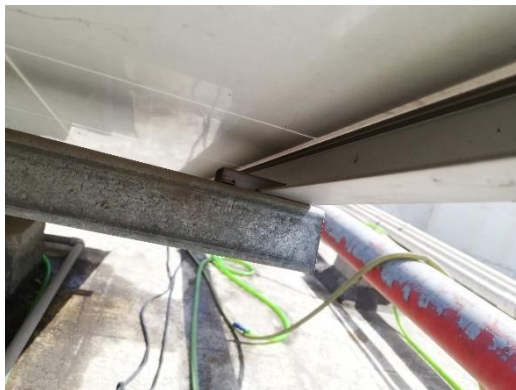
- The complicated clamping system makes maintenance of the modules almost impossible.
- The back sheet shows signs of aging in the form of cracks.

Figure 148: Unfavorable clamping system

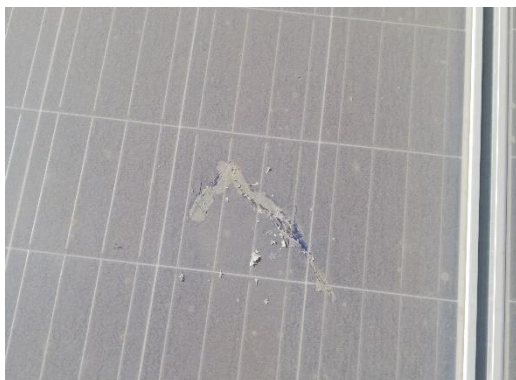
Figure 150: Layer of accumulated dust

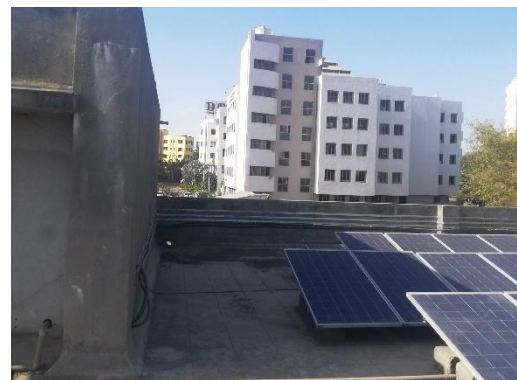
Figure 151: Shading on module
