Evaluation of Underperforming Rooftop PV Plants in India – Moving from kW to kWh

Part IV: Evaluation of 10 Rooftop PV Plants in Surat

Report Number: 201802070_IV_v1
Berlin, 24.06.2019

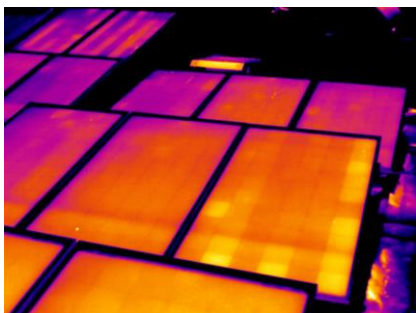
- Heavy soiling caused by nearby industrial area and bird droppings have been detected.
- Due to the limited access to the roof, it is likely that the modules suffered from mechanical stress during transport, handling and installation.
- A few installation failures were discovered, such as scratches in the module backsheet, disregard of bending radius and cables in contact with sharp edges and exposed to UV load.
- The irradiation sensor on the plane (GTI) was poorly installed and at a different angle than expected.
- Through IR inspection, several modules with warm cells, inactive strings and shading induced hotspots were detected.

Figure 10: PID affected module

- An anti-PID measure, such as anti-PID box, shall be implemented in order to stop or reverse the degradation.

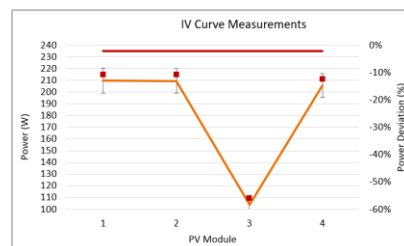
- The losses due to near shadings (trees) could represent 7% less irradiance loss, based on a representative simulation.
- The inconsistency in the module tilt angle, combined with the deviation from the optimum azimuth, lead to ca. 3% yield loss from the optimum orientation.
- An average soiling factor of 6% was determined from IV curve measurements of sample modules, before and after cleaning.

Figure 12: On-site power measurements

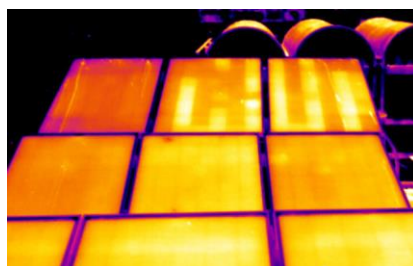
- The PID effect could be responsible for more than 20% of performance losses on system level. Individual module measurements showed nominal power drops higher than 55% (104W) in the modules with negative polarity.

Figure 13: Modules in short circuit (IR)

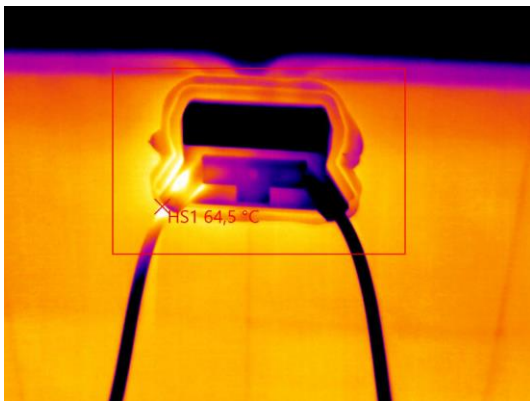
- Product failures at module level were detected, such as open J-boxes or hot cables at the J-box from poor soldering or clamping.

Figure 18: J-boxes with hot joints (soldering/clamping)

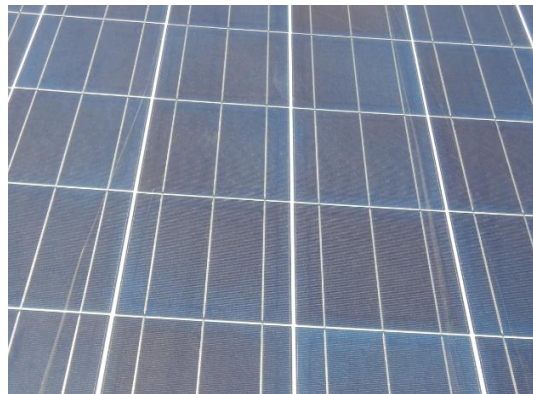
Figure 21: Cell "framing" or discoloration effect

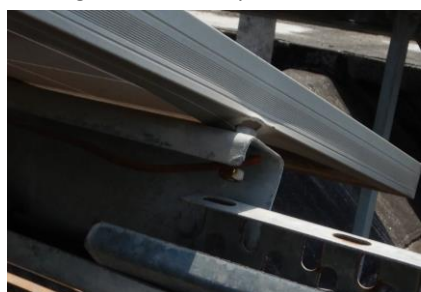
- The system is not properly grounded.
- The screws of the fastening clamps are not tightened correctly.

Figure 24: Screws of the fastening clamps

- The missing fastening screws should be replaced and all screws should be checked.
- An anti-PID measure, such as anti-PID box, should be implemented in order to stop or reverse the degradation.
- The trees surrounding the system should be trimmed if allowed. Otherwise, a restringing of the modules should be conducted in the following way: modules with similar shading conditions should be installed in the same string or at least assigned to one MPPT.
- PV modules showing power drops above the warranty conditions should be replaced. If the replacement is not possible, the modules should be regrouped in power classes within the same string and assigned to individual MPPT.

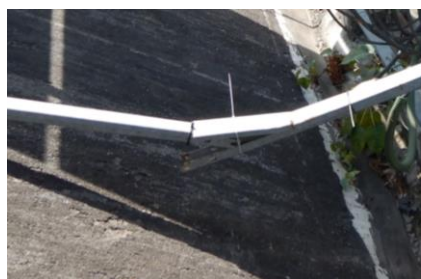
- The angle of the irradiation sensor deviates slightly from the module angle.
- Some parts of the cables are exposed to UV radiation. Pipes conveying cables are open and some parts have already broken.

Figure 25: Broken cable ducts

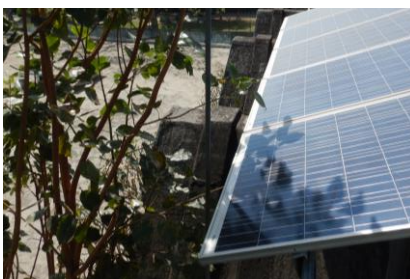
- Near shading is caused by nearby trees.

Figure 27: Near shading by trees

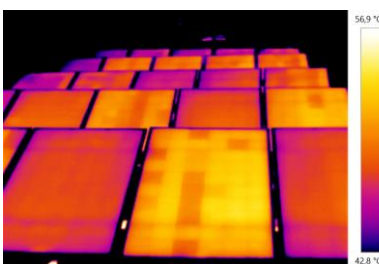
- PID leads to a performance loss of as high as 29% at the module level based on the measurements conducted on site. The degradation is in a fairly advanced stage. The impact at the system level is estimated to be around 10%.

Figure 28: Modules with PID

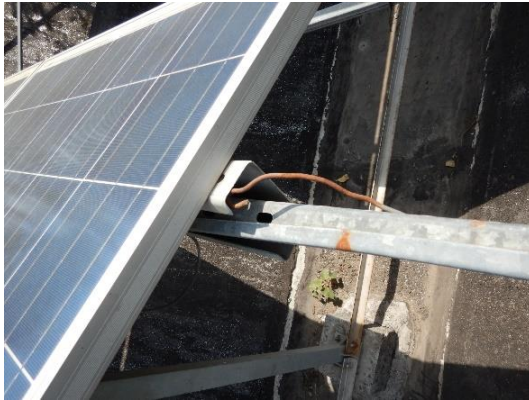
Figure 31: Non-functional grounding

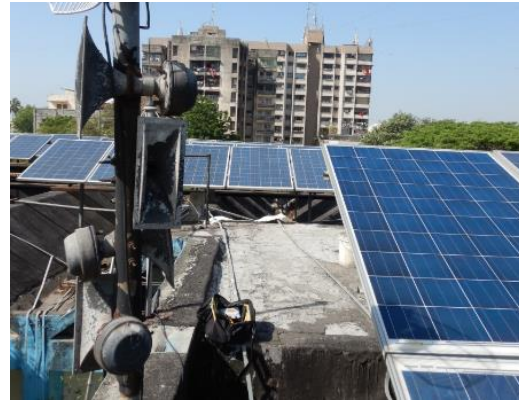
Figure 32: Shading by objects in the building

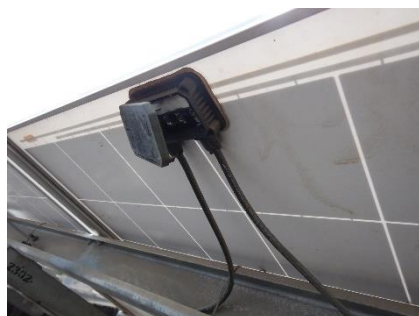
- The outer modules are installed on a very shaky mounting structure.
- The modules present different types of J-box failure types, e.g., overheated, open or missing lid.

Figure 39: Open J-Box lid

- Modules with any defect on the J-box should be immediate replaced (safety, operation and reliability issues).
- The simulation of the system showed a shading loss of 1.3%.

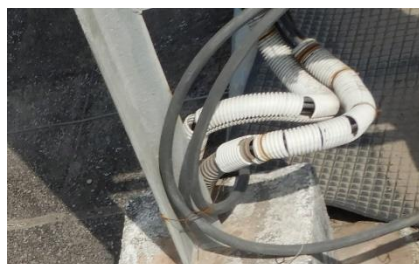
- The cables of the irradiation sensor are not installed correctly.
- Some parts of the cables are exposed to UV radiation. Some cable ducts are brittle and some have already broken.

Figure 40: Broken cable ducts

- The mounting structure shall be retrofitted / strengthened.
- An anti-PID measure, such as anti-PID box, should be implemented in order to stop or reverse the degradation.
- All DC wiring should be properly maintained.
- PV modules showing power drops above the warranty conditions should be replaced.

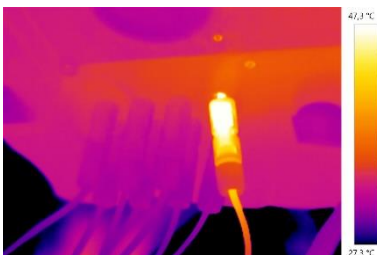
- Based on the measurements on-site, the soiling losses were determined to be 4.2%, on average.
- The thermographic examination showed some overheated plugs.

Figure 41: Overheated plugs

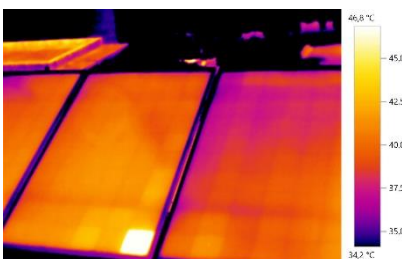
- First signs of a possible PID problem were recognized.

Figure 42: PID affected modules

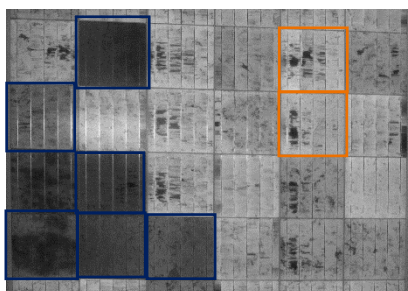
- The electroluminescence investigation confirmed the PID suspicion and showed further damage such as micro cracks and isolated parts.

Figure 43: PID affected module sample

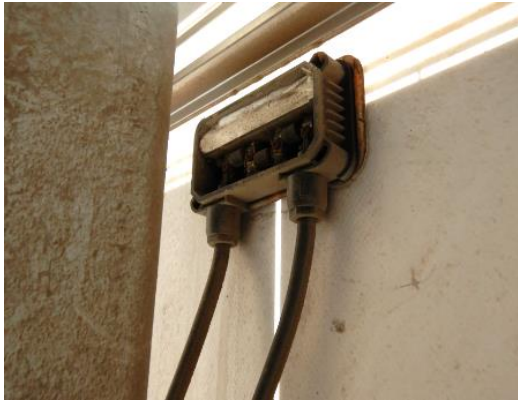
Figure 46: Open J-box

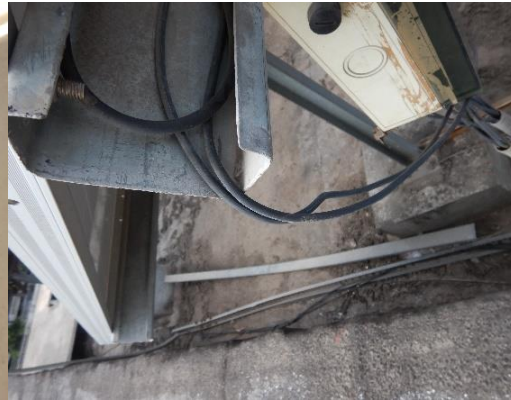
- The modules present different types of J-box failure types, e.g., overheated, open or missing lid.
- String cables damaged by, or in contact with sharp edges were spotted.
- Cable ties broke, hence the module cables and connectors are loosely hanging.
- The connectors of the string cables on the inverters have fallen off.
- Some cables are only connected with duct tape.

Figure 47: Cables in contact with sharp edges

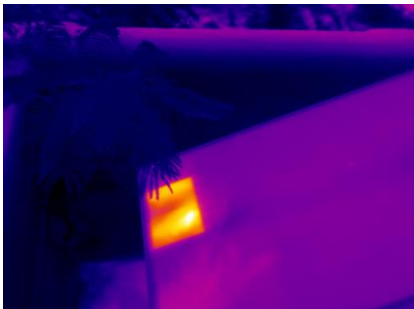
- The plant was installed facing East. If the system was designed to bring the maximum yield, the current azimuth (-90°) represents -10.7% loss towards the optimum irradiation on the plane.
- The irradiation sensor is installed at the wrong tilt, and is significantly shaded and soiled.
- Significant near shading effects are caused by the trees surrounding the system.

Figure 54: Shading inducing hotspot

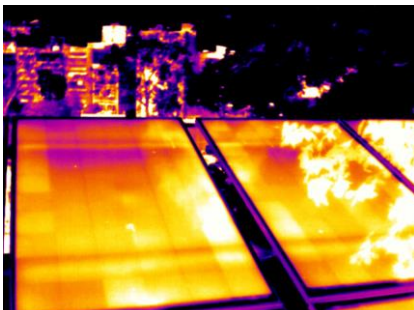
Figure 55: Modules with apparent PID effect

- PID, at initial stages, could be responsible for 15% of the losses on system level. The degradation is in on intermediate stage.
- Although open J-boxes might not have an impact on the performance, for now, this is an important safety issue that should be addressed. Nearly 40% of the modules were missing the lid.
- The near shadings are responsible for an irradiation reduction on the tilted plane of approx. 4.9% at system level.

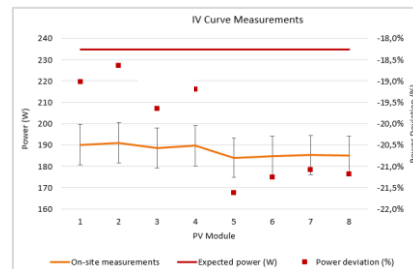
- Soiling measurements were conducted measuring both the short circuit current and nominal power before and after cleaning. The estimated soiling loss is on average 2.9%.

Figure 56: On-site measurements

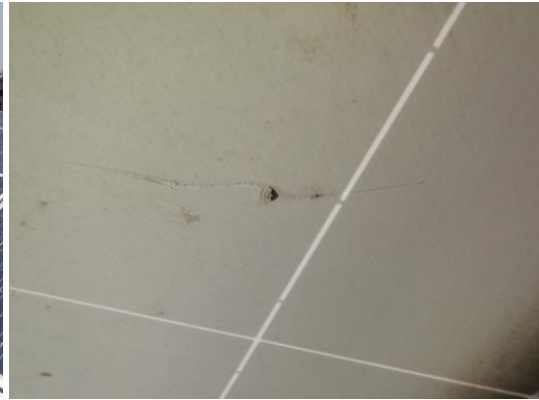
- A combination of installation failures were also present: backsheet scratches, open and loose connectors, mounting structures with sharp edges and corroded elements.

Figure 61: Module with scratch in the backsheet

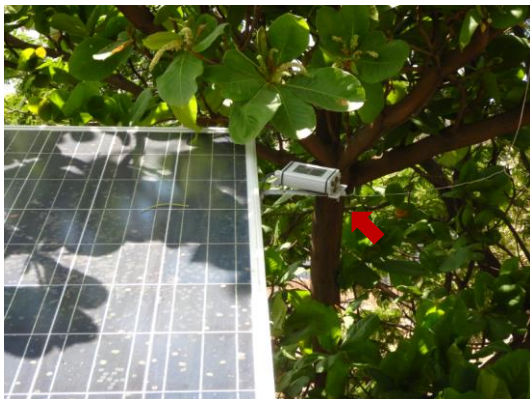
Figure 62: Shading and irradiation sensor situation

- The irradiation sensor should be properly reinstalled, cleaned and calibrated to ensure accurate readings.

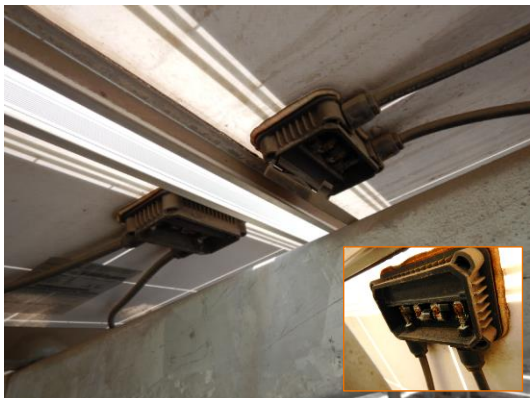
Figure 66: Modules with open J-boxes (ca. 40%)

- Considering safety and system long-term reliability, the module J-boxes shall be evaluated. Modules with exposed J-boxes (corrosion in the diodes) shall be immediately replaced.
- Manual cleaning cycles shall be increased based on the results of a soiling study.
- An anti-PID box shall be installed to stop module degradation.
- PV modules showing power drops above the warranty conditions shall be replaced. If the replacement is not possible, the modules shall be regrouped according to power and defect classes, within the same string and assigned to individual MPPT (based on infrared inspection with high irradiation levels and after cleaning activities).

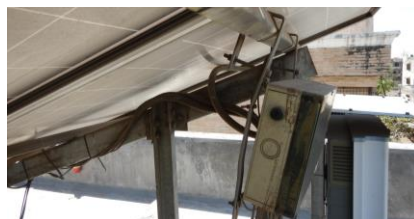
- The cables of the irradiation sensor are not installed correctly.
- The cable ducts are brittle and some are broken.
- The combiner box is not attached correctly.

Figure 70: Improper attachment - combiner box

- Modules with manufacturing defects (i.e., delamination) shall be replaced.
- Modules with any defect on the J-box should be immediately replaced (safety, operation and reliability issues).
- The modules contaminated by cement should be cleaned.
- All of the DC cabling, including the combiner box, should be maintained for proper attachment.
- PV modules showing power drops above the warranty conditions should be replaced. If the replacement is not possible, the modules should be regrouped in power classes within the same string and assigned to individual MPPT.

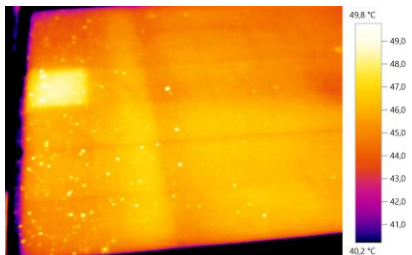
- Many modules are contaminated with cement residues that create hot spots.

Figure 72: Hot spot due to cement residues

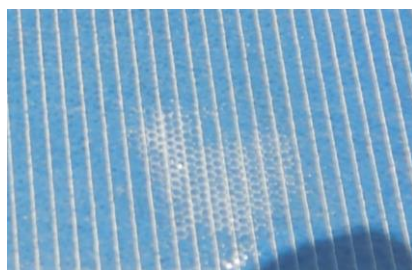
- The poorly produced cells were found in some modules.

Figure 73: Delamination issues

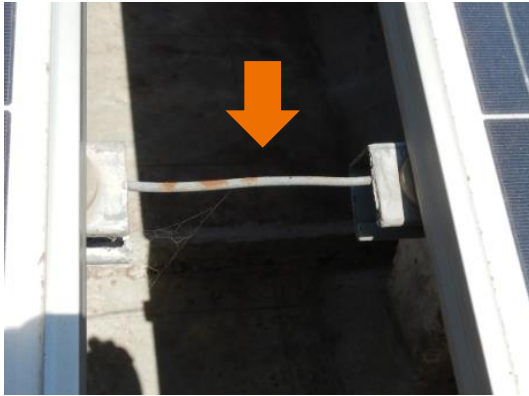
Figure 76: DC cables exposed to UV radiation

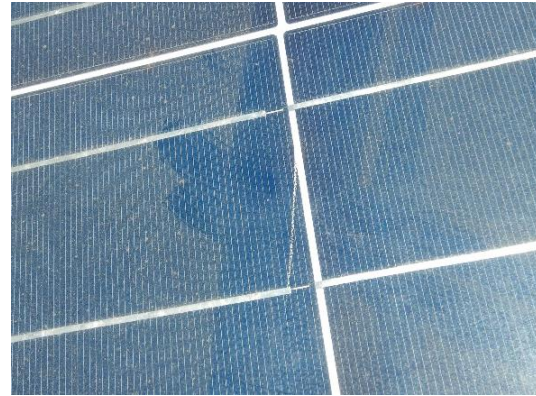
- Several modules have scratches in the front glass.
- The modules present different types of J-box failure types, e.g., overheated, open or missing lid.

Figure 77: Scratch on front glass

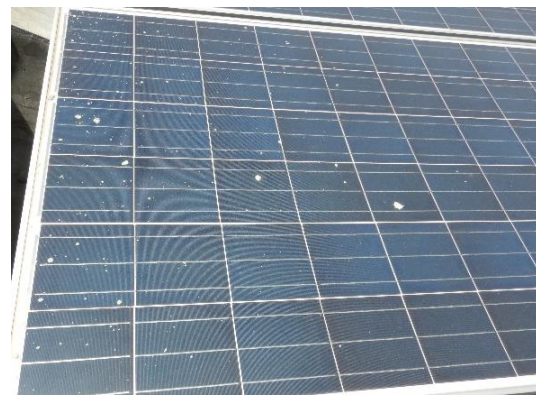
Figure 83: Contamination from cement

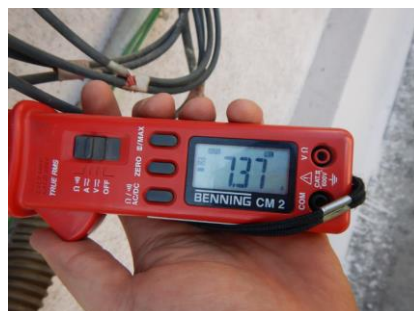
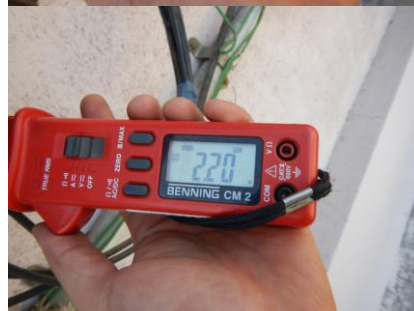
Figure 86: Differences in current among strings

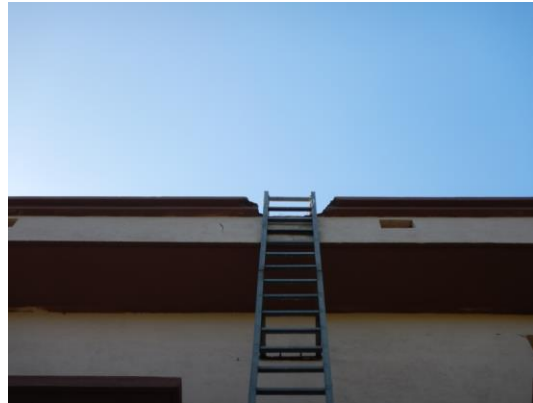
- The access to the roof is difficult. This could have caused module damages during handling and installation, which would likely lead to underperformance.
- The open wasteland in the proximity of the system could be responsible for increased soiling issues.
- Several modules were laying on the ground (disconnected) likely due to a combination of a challenging installation on the edge and strong wind loads.

Figure 90: Rooftop access (limited access to O&M)

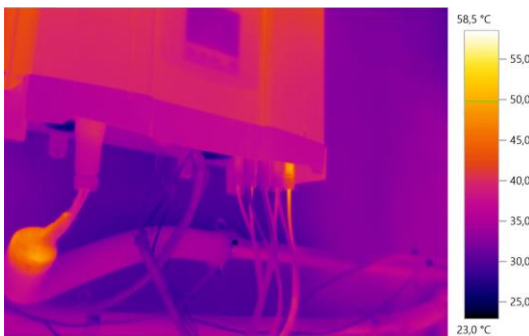
Figure 95: Hot connector at the inverter

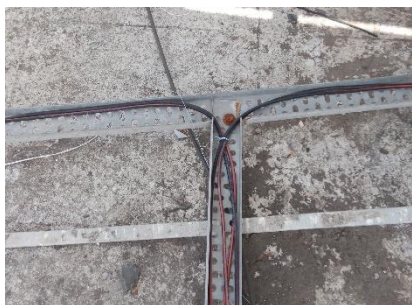
- The system grounding is not installed securely.
- String cables damaged by or in contact with sharp edges were spotted.

Figure 97: Cables in contact with sharp edge

- All DC wiring should be maintained.
- The cleaning frequency should be increased and the strong local contamination should be removed.
- PV modules showing power drops above the warranty conditions should be replaced.

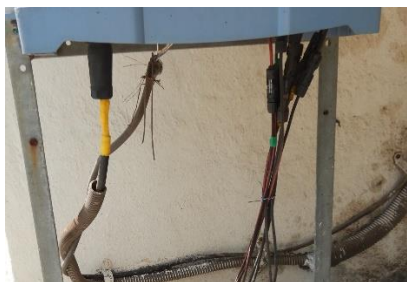
Figure 98: Broken cable ducts

- Cable ties broke, hence the module cables and connectors are loosely hanging.
- The bending radius of the string cables is respected only partially.
- Some parts of the cables are exposed to UV radiation. And some cable ducts have already broken.
- Some of the labels detach from the modules.

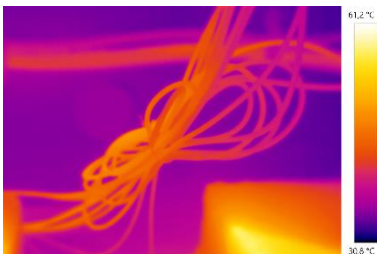
- In some places, the string cables are combined in cable bundles that heat up.

Figure 99: Overheated plugs

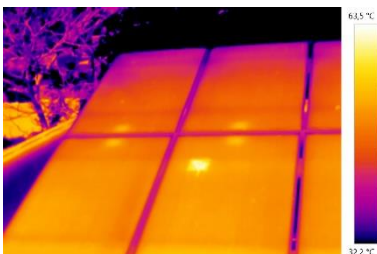
- Several hot spots were discovered in the plant.

Figure 100: Soiling induced hotspots

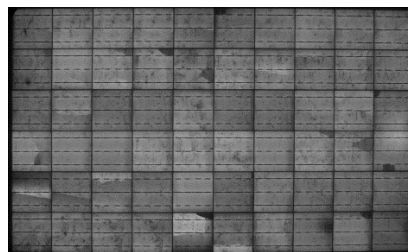
- Based on the amount of cracks and broken cells and corresponding inactive areas, the power loss is estimated to be 5% at the system level.

Figure 101: Microcracks and isolated parts

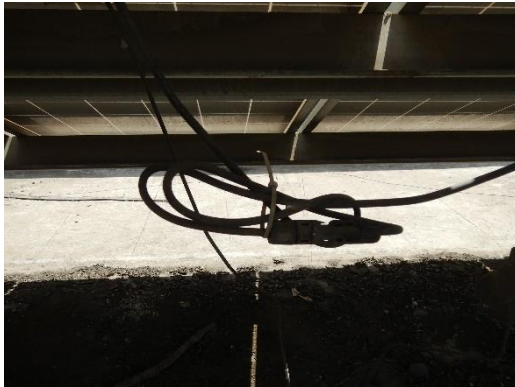
Figure 104: Critical bending radius

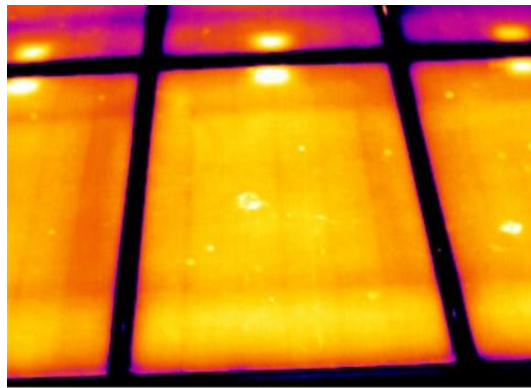
Figure 107: Hot spots induced by bird drops

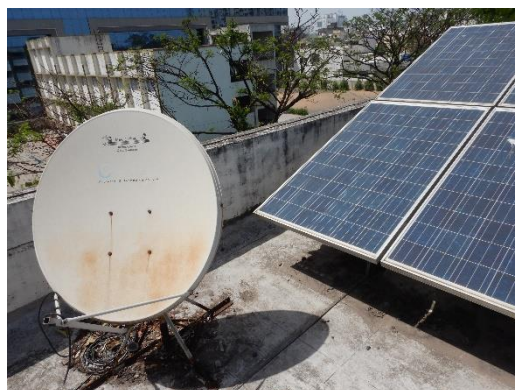
- Near shading is caused from nearby trees on the South side of the plant and installed antennas on the roof.
- There are modules with broken front glass.

Figure 111: Shading from antenna

- The shading caused by trees or roof structures should be mitigated.
- Broken modules shall be immediately replaced.
- Module product defects (detached labels) shall be monitored, whether the degradation continues (potential claim) or it has stabilized.
- The grounding of the entire system should be checked.
- The simulation of the system showed a shading loss of 5.9%.

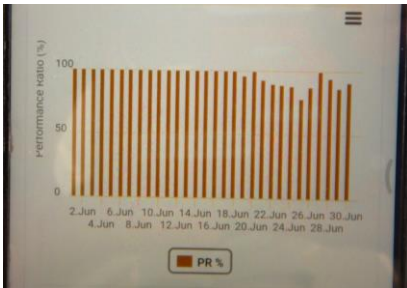
- String cables damaged by or in contact with sharp edges were spotted.
- The monitoring of the system shows PR values of 100%. This indicates incorrect input values from the sensors.

Figure 112: Mobile plant monitoring

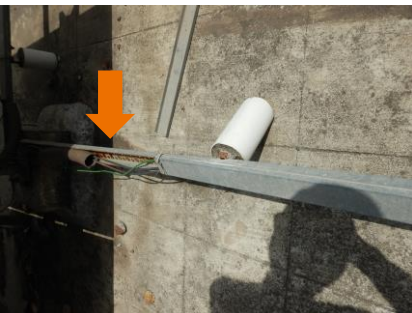
- The radiation sensor cables are not installed correctly.
- Some parts of the cables are exposed to UV radiation. Pipes conveying cables are open and some parts have already broken.

Figure 113: Broken cable ducts

- The entire DC wiring should be checked for safety.
- Broken modules that do not meet the warranty requirements should be replaced.
- Local shading caused by trees or cables should be removed.
- The frequency of cleaning should be increased and significant dirt should be removed.
- PV modules showing power drops above the warranty conditions should be replaced. If the replacement is not possible, the modules should be regrouped in power classes within the same string and assigned to individual MPPTs.

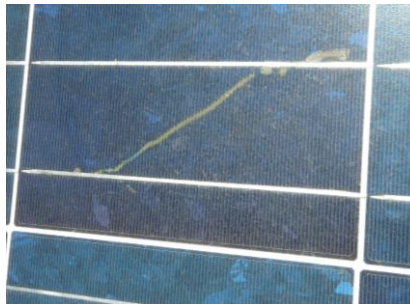
- Based on the measurements on-site, soiling losses were determined to be 5.2%, on average.
- Several modules with shunt damage were found during the visual inspection.

Figure 114: Snail trail pattern on module

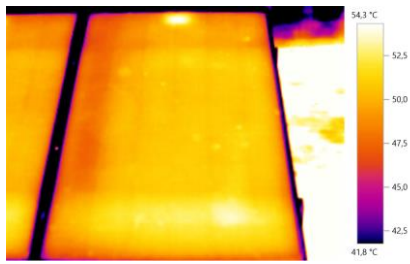
Figure 115: Near shading by trees

- Some parts of the plant are permanently shaded by trees or cables.

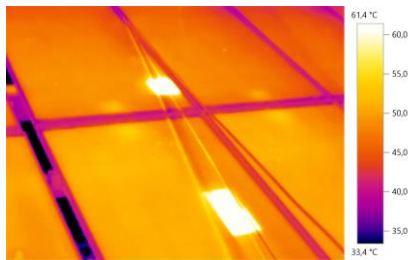
- Some modules have local contamination that leads to hotspots.

Figure 116: Shading induced hotspots

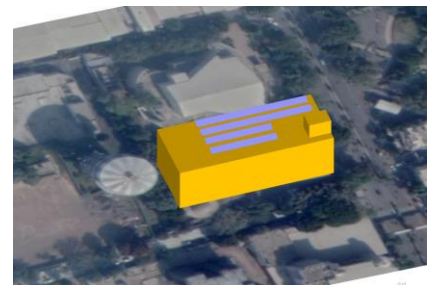
Figure 118: 3D model constructed in PVsyst

- The radiation sensors should be calibrated.
- The simulation of the system showed a shading loss of 1.5%.

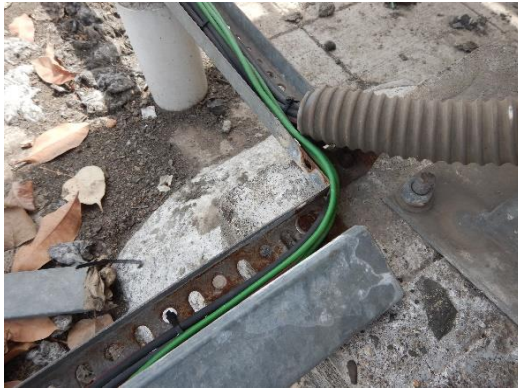
Figure 119: Non-functional grounding

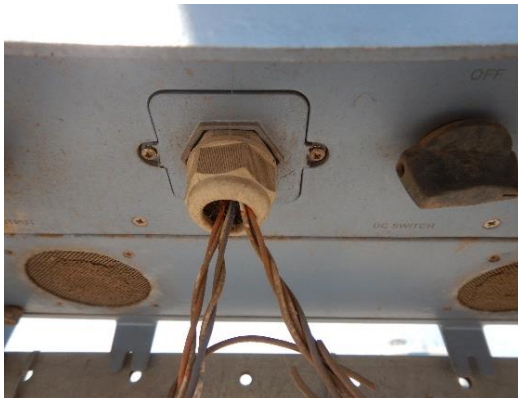
Figure 123: Poorly installed sensor cables

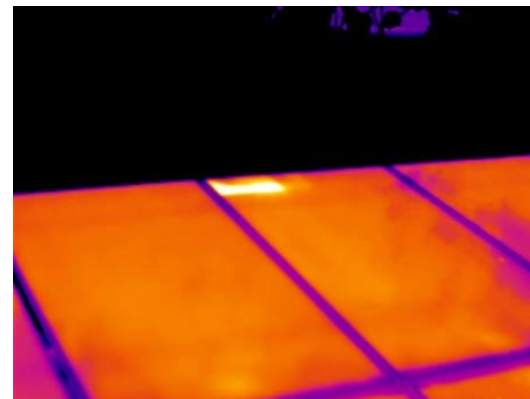
Figure 126: Shading situation: trees

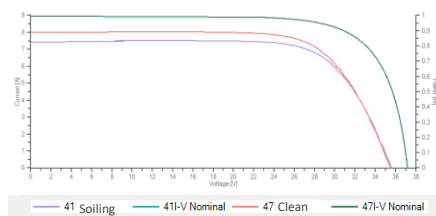
- Soiling measurements were conducted measuring nominal power before and after cleaning at irradiances higher than 900 W/m². The estimated soiling factor is in the range of 5-6%.

Figure 129: on-site soiling measurements

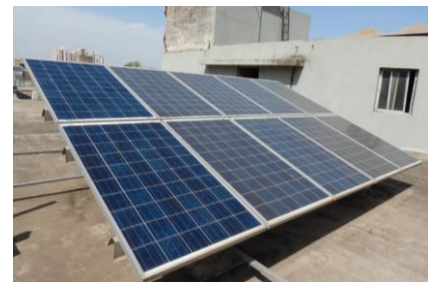
Figure 131: Improvement of cleaning cycles

- Modules with a large amount of cracks (including snail trails), shall be regrouped in the same string or at least assigned to one MPPT. The grouping shall be conducted based on infrared inspection with high irradiation levels and after cleaning activities.
- The manual cleaning cycles shall be implemented and scheduled based on the results of a soiling study that adjusts the cleaning needs to each season.

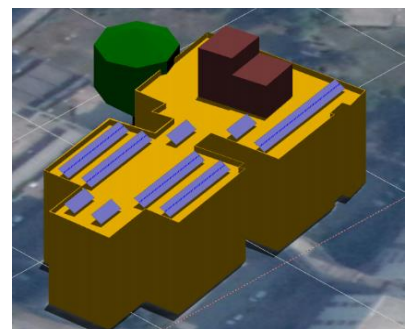
- The losses due to near shadings could represent 2.3% less irradiance loss, based on a representative simulation.
- Due to the limited access to the rooftop (staircases) it is likely that the modules suffered increased mechanical loads during transportation, handling and installation. The amount and type of cracks discovered via EL, as well as the snail trail distribution, could be an indicator of a performance drop between 5-10%.

Figure 132: 3D scene in in PVsyst

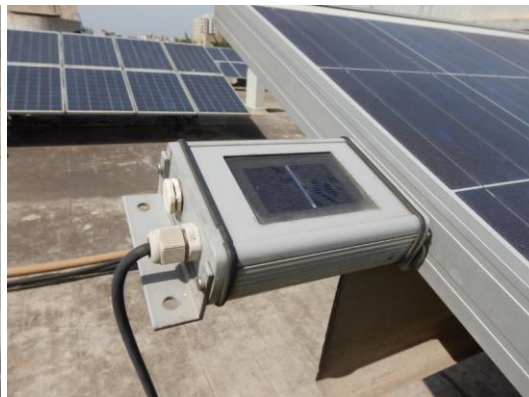
- Module defects, such as snail trails, label detachment, corrosion in the busbars, and modules with tight bending radius were discovered.
- The inverter fan filters (outlets) are partially blocked, leading to a higher risk of inverter shut down.
- The calibration date of the irradiation sensor was not provided.

Figure 140: Irradiation sensor – plane of array

- The lack of calibration of the irradiation sensor will not directly affect the performance of the system. However, the accurate recording of the onsite irradiation will provide confidence to the plant's KPIs.
- Damaged cables (sharp edges) shall be replaced. Furthermore, the minimum bending radius shall always be respected.
- Snail trails shall be monitored to validate whether they have stabilized over time.

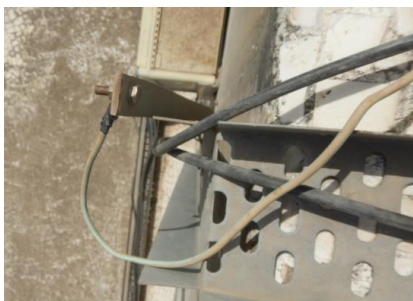
Figure 142: Damaged cables: sharp edges

- String cables were occasionally spotted in contact with sharp edges, showing initial signs of damage.
- The plant was installed in a single module landscape orientation, with a very limited interrow spacing.

- Damaged cables shall be replaced and those in contact with sharp edges shall be protected.
- The inverter configuration (i.e., "waiting for sun") shall be validated to eliminate the possibility of an internal failure. This issue shall be only related to "DC voltage not sufficient to allow for connection to the main network".

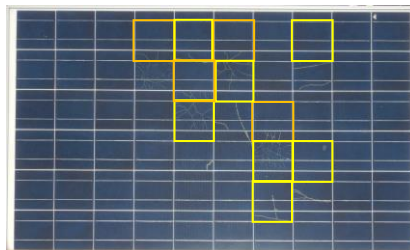
- Due to the difficult access to the roof, it is likely that the modules suffered mechanical stress during transport, handling and installation. The resulting microcracks are one of the sources of the snail trail effect in the modules.

Figure 143: Cell degradation (snail trails)

- The snail trails shall be monitored and assessed (via IR) whether the degradation has reached stabilization.
- Modules with snail trails within similar degradation shall be re-grouped in the same strings, or at least assigned to one MPPT. The grouping shall be conducted based on infrared inspection with high irradiation levels and after cleaning activities.

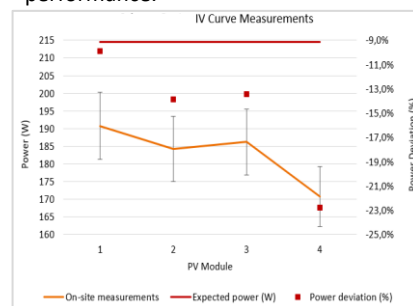
- Based on the simulation, shading losses are estimated to be 5% at the system level.
- Due to the inverter status during the IR inspection (disconnection, open-circuit), the thermographic analysis could not take place to evaluate PID. Based on on-site IV curve measurements, the PID effect could be responsible for 10-15% energy losses.

- The module sample tested on-site showed a significant drop in the expected performance.

Figure 144: On-site IV curve samples

- PV modules showing power drops caused by product defects above the warranty conditions shall be replaced (7 yrs in operation < 10yrs - 90% power performance).

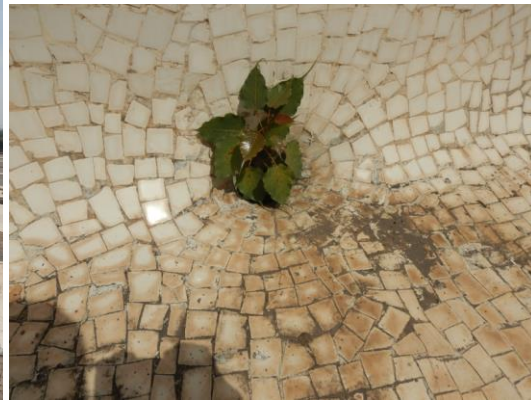
Figure 147: Drainage partially blocked

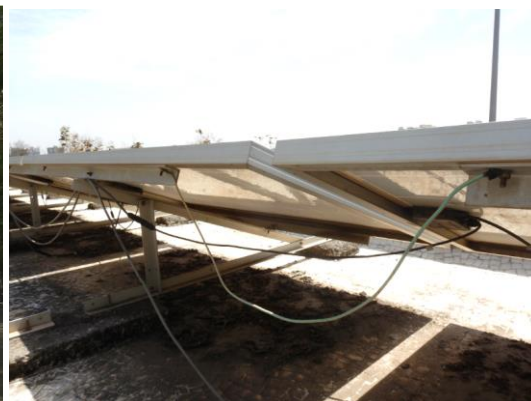
Figure 149: Equipotential bonding (cable management)

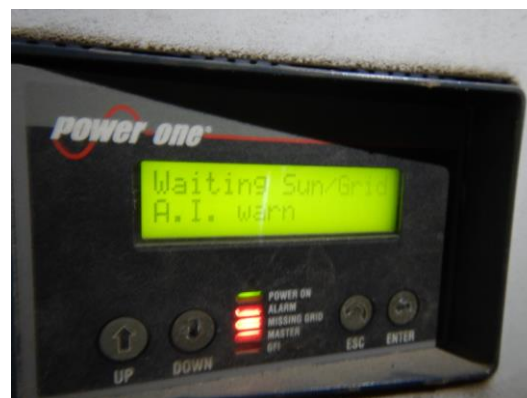
- Although installed next to a large field, moderate soiling was detected.
- The inverter was found in a stand-by mode, i.e., disconnected from the grid.
- The majority of the modules presented a snail trail pattern, from moderate to severe stages.

Figure 152: Inverter status (waiting sun/grid)

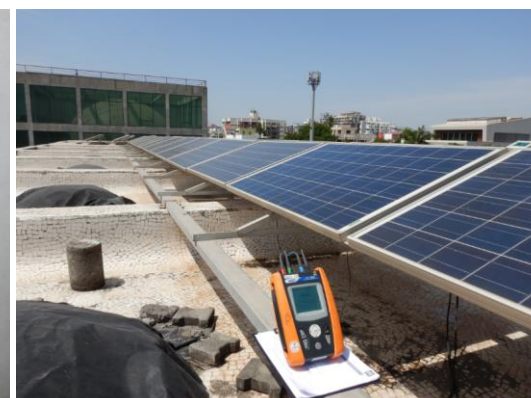
- An average soiling factor of 3% was determined from IV curve measurements of sample modules, before and after cleaning.
- The lack of calibration of the irradiation sensor will not directly affect the performance of the system. However, the accurate recording of the on-site irradiation will provide the plant's KPIs.

Figure 153: IV Curve & Soiling measurements

- Cleaning cycles shall be increased and defined based on a soiling study that adjusts the cleaning needs to each season. Cleaning once a month during the dry season is not enough.
