# Evaluation of Underperforming Rooftop PV Plants in India – Moving from kW to kWh

## Part I: Evaluation of 10 Rooftop PV Plants in Delhi

Report Number: 201802070\_V4  
Berlin, 09.07.2019

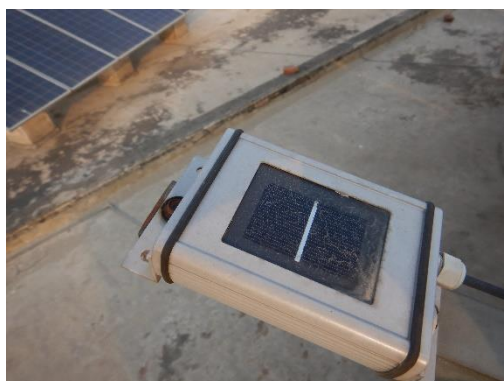
Figure 22: Dirty irradiation sensor

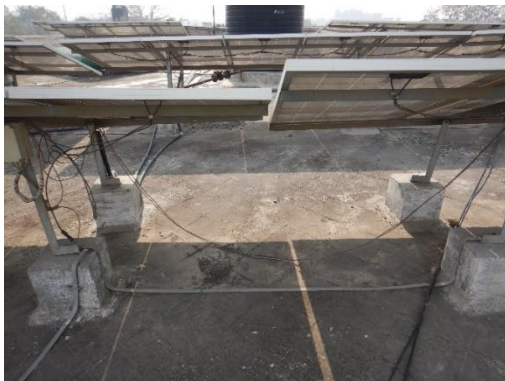
Figure 33: Inconsistent tilt

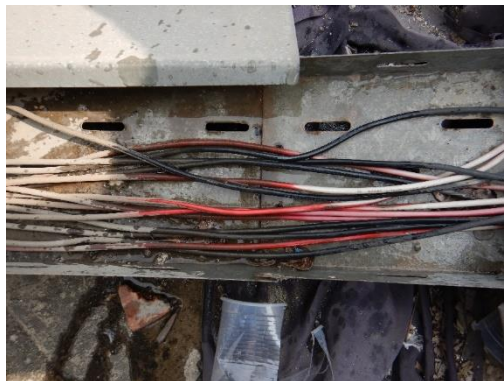
Figure 34: Inaccurate DC cable routing

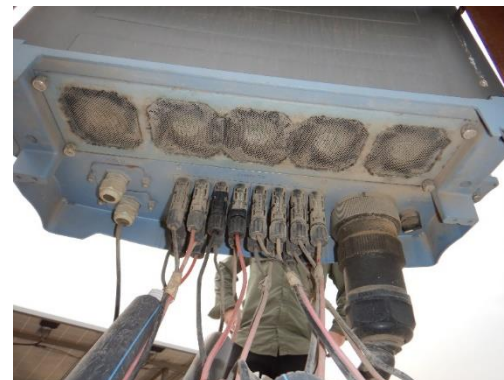
Figure 36: Dirty filters

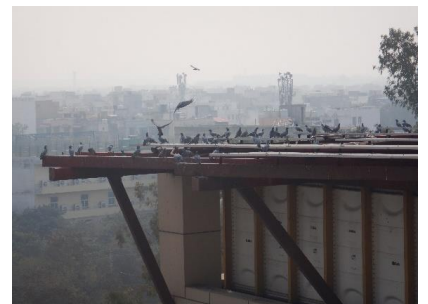
- Heavy soiling caused by bird drops has been detected. A large amount of birds gather on the rooftop system every day.
- Significant cell and modules damages caused by personnel during the installation and O&M activities.

Figure 42: Birds on the PV modules

- An improvement of the cleaning activities shall be conducted by increasing the cleaning cycles.
- Spikes against birds shall be installed at the upper edge of the modules.

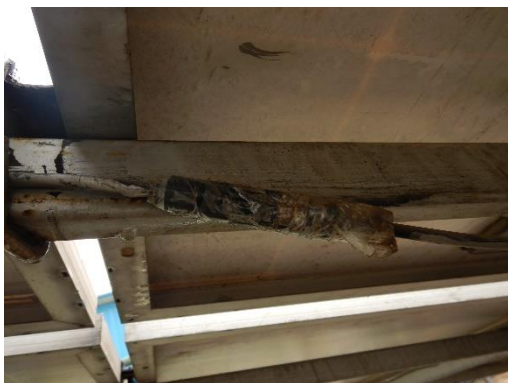
Figure 56: Inaccurate DC cabling

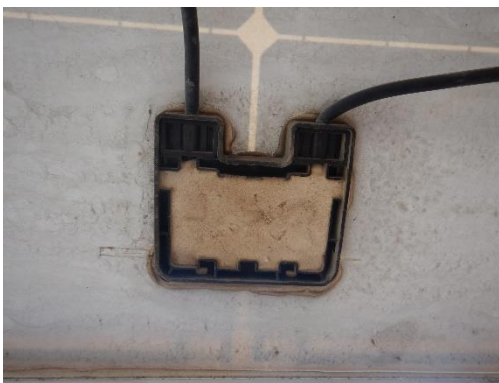
Figure 57: Junction box without lid

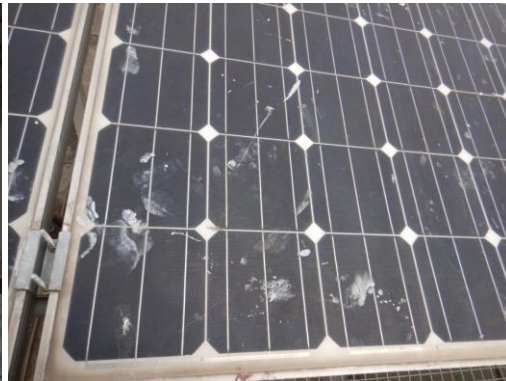
Figure 116: Dirty module surface

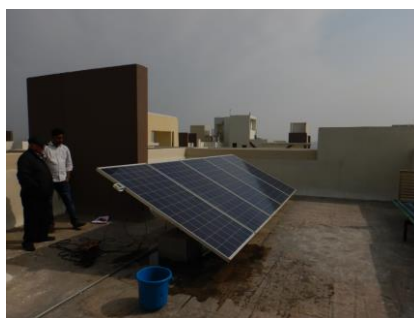
- Soiling measurements were conducted measuring both the short circuit current and nominal power before and after cleaning at irradiances higher than 900 W/m². The estimated soiling factor is in the range 1 – 4%.

- The cleaning cycles shall be increased and defined based on a soiling study that adjusts the cleaning needs to each season.
- It is recommended to shorten the strings in order to reduce the tripping and mitigate the impact of the near shading losses. A DC/DC converter at the inverter input may be needed. This could represent a 2-3% performance boost.
- The walls close to the shaded areas shall be covered with reflective material and the ground re-painted in order to increase the albedo effect. A performance boost of at least 5% is expected.

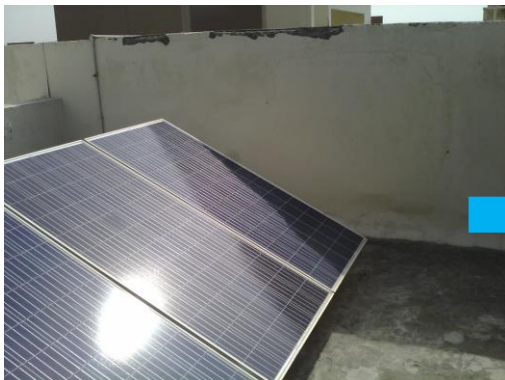
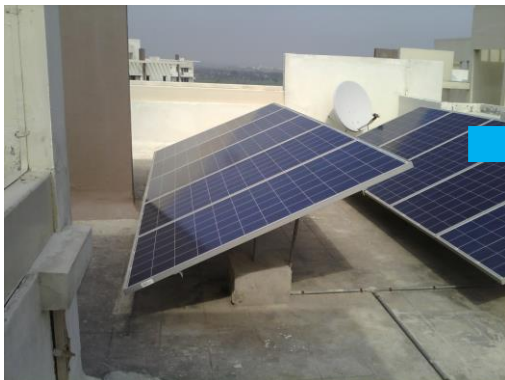
Figure 79: Near shading on the module surface (VI)

Figure 80: Near shading on the module surface (IR)

Figure 81: Near shading on the module surface (VI)

Figure 82: Near shading on the module surface (IR)

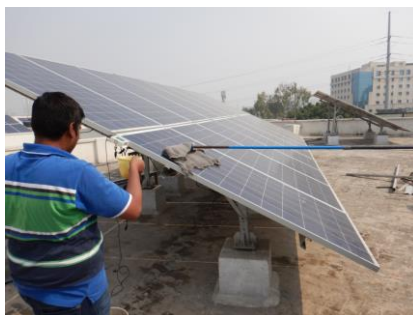
- Soiling measurements were conducted measuring both the short circuit current and nominal power before and after cleaning at irradiances higher than 800W/m². The estimated soiling factor is in the range of 8 – 9%.

- The cleaning cycles shall be increased and defined based on a soiling study that adjusts the cleaning needs to each season.
- Spikes against birds shall be installed at the upper edge of the modules.
- The irradiation sensor should be properly reinstalled and it should be of the same technology as the modules.

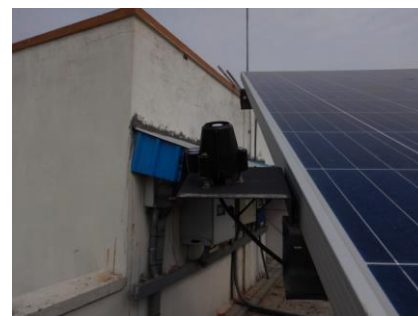
Figure 86: Irradiation sensor wrongly installed

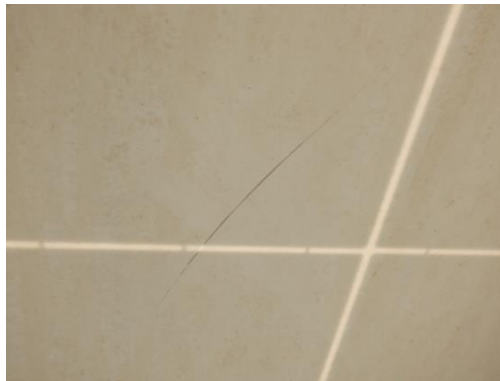
Figure 90: Scratched backsheet

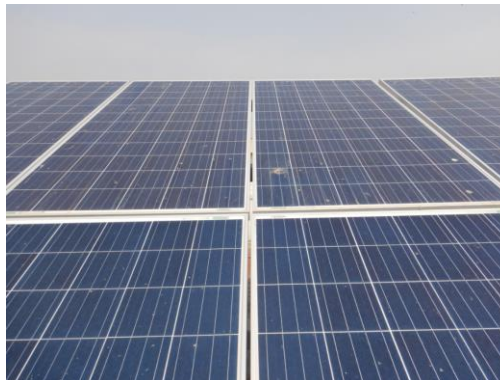
- Heavy soiling caused by bird droppings has been detected. A large amount of birds coming from the nearby wasteland, gather on the rooftop system every day.

Figure 92: Bird drops on the module surface

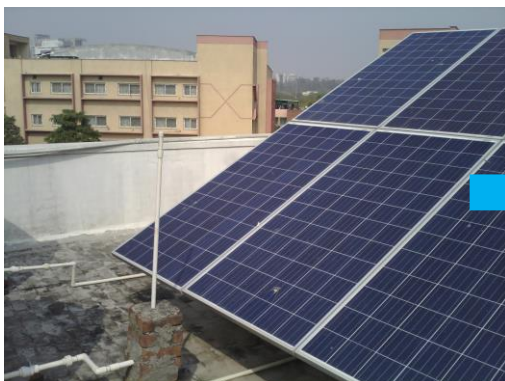
Figure 93: Near shading on the module surface (VI)

Figure 94: Near shading on the module surface (IR)

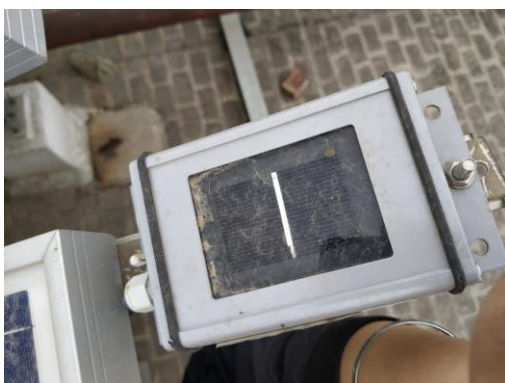
Figure 104: Dirty irradiation sensor

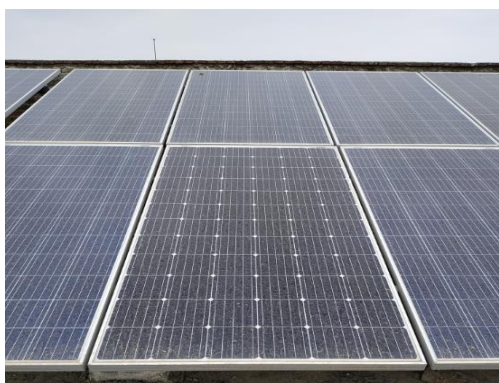
Figure 105: Mixing of poly and mono c-Si modules

- Modules with heavy cracks shall be grouped in the same string or at least assigned to one MPPT. The grouping will be conducted based on infrared inspection with high irradiation levels and after cleaning. These modules with cracks will be grouped in strings with same MPPT.
- Strings mixing two different technologies shall be rearranged in order to ensure that they are composed only by one technology type.
- The cleaning cycles shall be increased and defined based on a soiling study that adjusts the cleaning needs to each season. Cleaning once a month during the dry season is not enough.
- The irradiation sensor shall be cleaned and installed at the correct tilt.
- Increasing the albedo from 0.2 to 0.5 by covering the ground with white gravel leads to an increase of the irradiation on tilted surface of at least 1.5%.

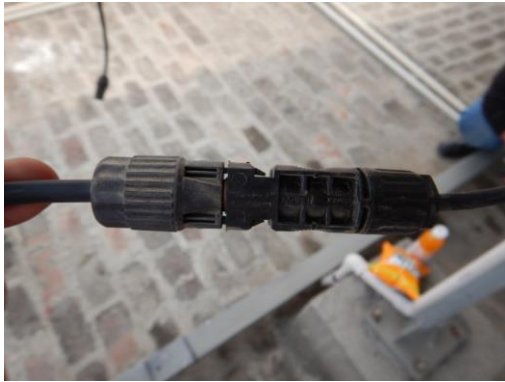
Figure 110: Open connectors

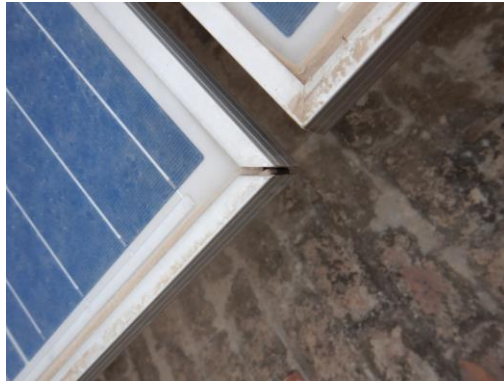
Figure 111: Unsealed module frame

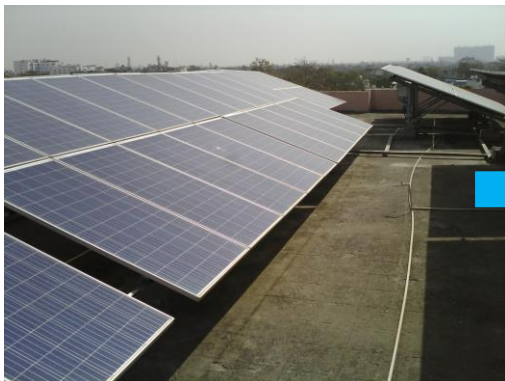
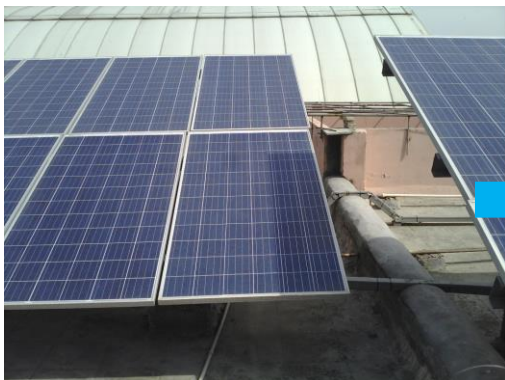
Figure 12: Near shading on the module surface (VI)

Figure 13: Near shading on the module surface (IR)

Figure 114: Near shading on the module surface (VI)

- The cleaning cycles shall be increased and defined based on a soiling study that adjusts the cleaning needs to each season. Cleaning once a month during the dry season is not enough.
- The tree in the south-east corner should be trimmed
- The irradiation sensor shall be cleaned and installed at the correct tilt.
- Increasing the albedo from 0.2 to 0.5 by covering the ground with white gravel leads to an increase of the irradiation on tilted surface of at least 1.3%.

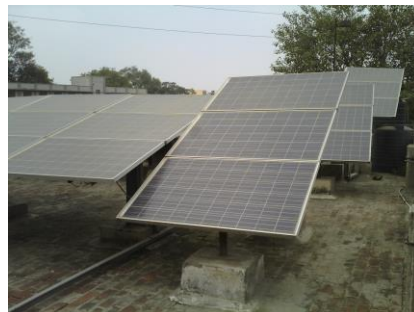
- The PV tables showed inconsistent tilts at the time of the visit. The mounting structure has a seasonal tracking system but the tilt is not kept consistent.
- Due to the difficult access to the roof it is likely that the modules suffered mechanical stress during transport, handling and installation. The electroluminescence inspection revealed a big number of cracks in the analyzed modules. This was evidenced by the large number of snail trails detected.

- The inconsistency of the module tilt leads to a mismatch loss of approximately 3%.

Figure 119: Inconsistent module tilt

- The tilt and shading angles throughout the system shall be homogenized.
- Modules with heavy cracks shall be grouped in the same string or at least assigned to one MPPT. The grouping will be conducted based on infrared inspection with high irradiation levels and after cleaning.

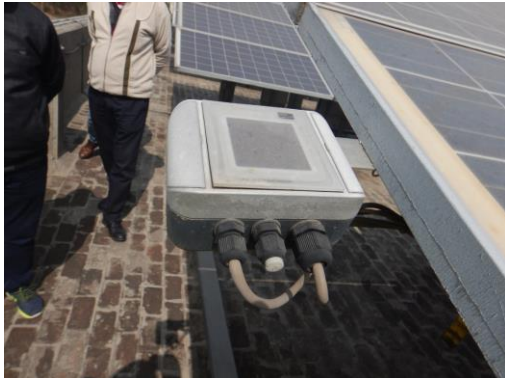
Figure 121: Dirty irradiation sensor

- All modules with faulty connectors shall be replaced.
- The lighting pole shall be relocated in order to avoid shadings on the North-West part.
- The irradiation sensor should be properly reinstalled and it should be of the same technology as the modules.

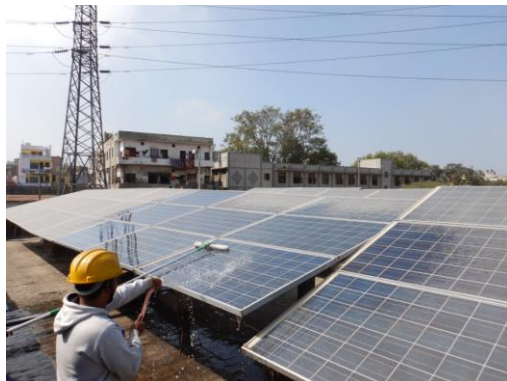
- Soiling measurements were conducted measuring both the short circuit current and nominal power before and after cleaning at irradiances close to 900 W/m<sup>2</sup>. The estimated soiling factor is in the range 7–10%.
- The amount and type of cracks found during the electroluminescence inspection is likely to induce a drop of the nominal power of around 8-10%. Many cracks are evidenced with clearly visible snail trails.

Figure 124: Cleaning prior to IV curve tracing

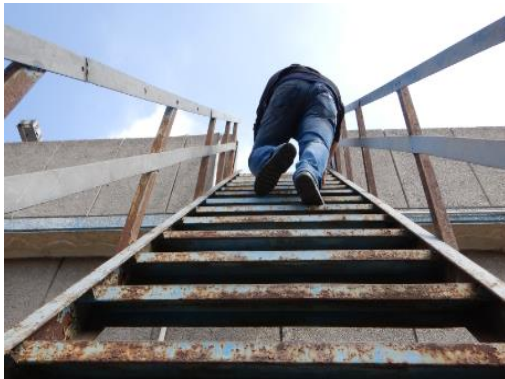
Figure 125: Difficult access during installation
